Fretz Park Recreation Center Summary

Address	6950 Belt Line Road Dallas, TX 75254
Building Purpose	Recreation Center
Original Year of Construction	1971
Building Area	14,815 SF
Inspection Date	August 2, 2016
Inspection Conditions	100° F, Sunny

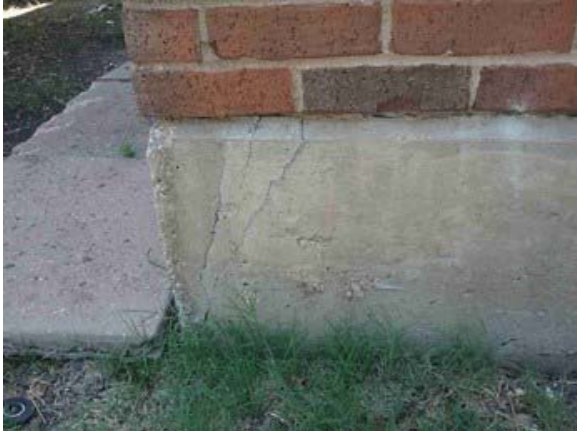
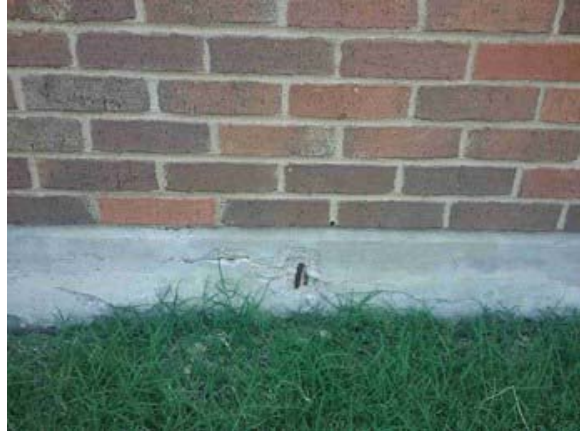
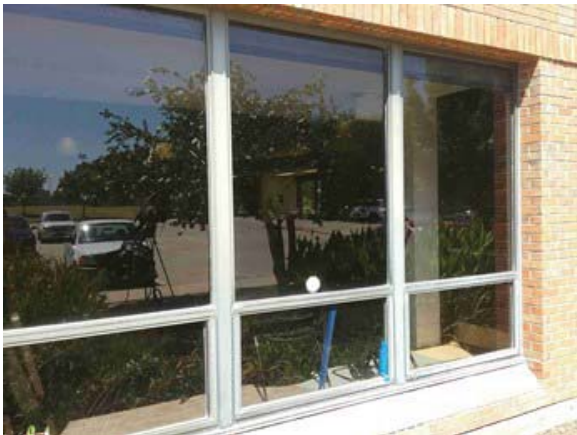
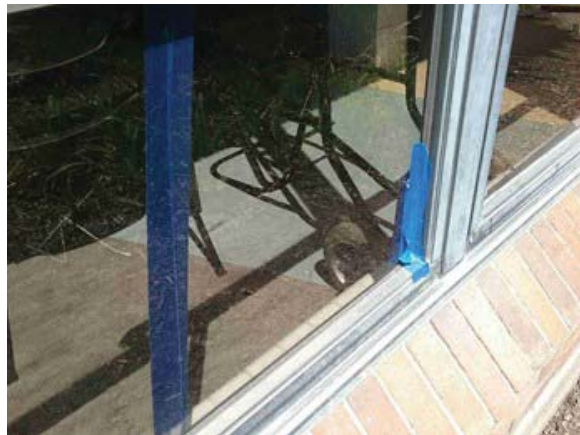
Subsystem	Condition and Deficiency Overview	System Condition Rating
B20 Exterior Enclosure		
Exterior Walls	<p>The exterior walls are constructed of a brick façade with a concrete foundation around the perimeter of the building.</p> <p>Deficiencies noted included several cracks in the foundation around the perimeter of the building. There were several locations where the concrete had spalled at the foundation, exposing reinforcing bars. There were several instances where previous repairs had been made to the mortar between bricks, but they appear to have been repaired correctly and there were no deficiencies observed.</p>	4 - Good
Exterior Windows	<p>The exterior windows consist of metal framed multi paned windows ranging in size from approximately 12-foot by 10-foot to 20-foot by 16-foot on the east, west and north sides of the building.</p> <p>Deficiencies noted included cracks in the glass in the east windows with tape placed over the crack.</p>	4 - Good

1. Conduct a structural assessment of the building foundation and make any necessary repairs.
2. Coat exposed rebar and repair spalled concrete on the building foundation.
3. Paint the metal window frames.
4. Replace the broken glass in the east windows.

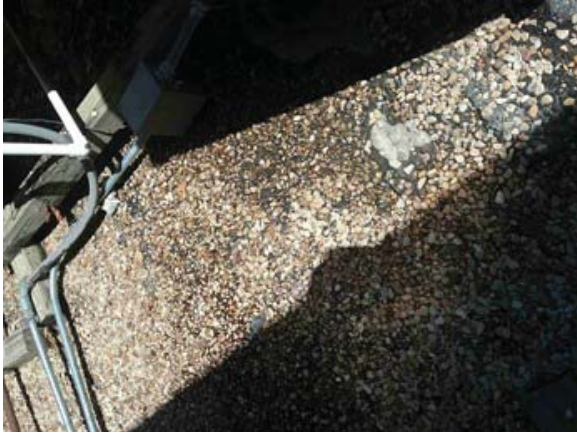
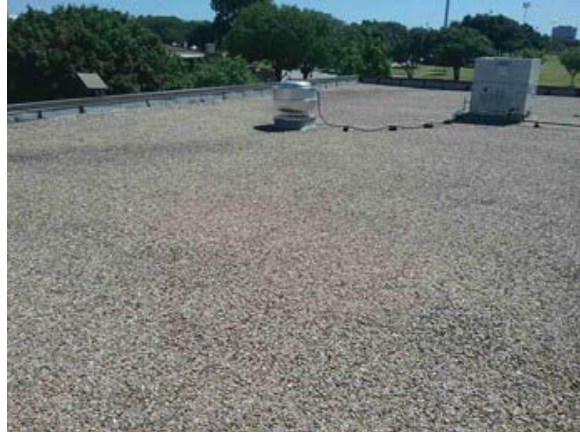
Exterior Doors	<p>There are two main public entrances located on the east and west sides of the building, consisting of metal framed glass doors. The remaining service doors are primarily metal and located along the southeast and west sides of the building.</p> <p>No deficiencies were observed or reported at the time of the assessment.</p>	4 - Good
B30 Roofing		
Roof	<p>The roof construction is built-up with gravel ballast system occurring over three levels. The roof is assumed to be installed in 1990 based upon the condition at the time of the assessment, and the typical design service life of the roofing material.</p> <p>Other roofing features include: Metal flashing around the perimeter of the roof, an access hatch at the lower level, and downspouts around the perimeter of the building.</p> <p>Deficiencies noted included standing water present at the lower roof level near the mechanical equipment. The gravel layer appeared thin in several areas.</p>	3 - Average

1. Determine source of ponding near mechanical equipment, make necessary repairs.
2. Replace the missing sections of gravel ballast on the built-up roof sections.

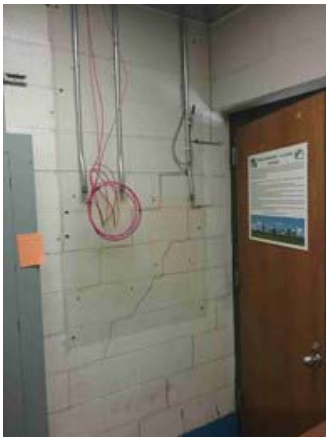
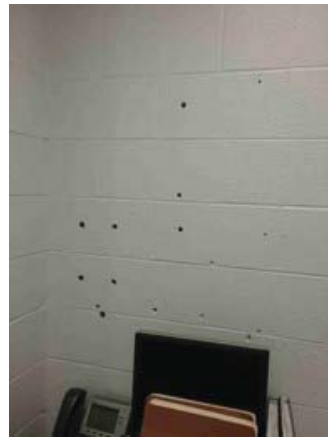
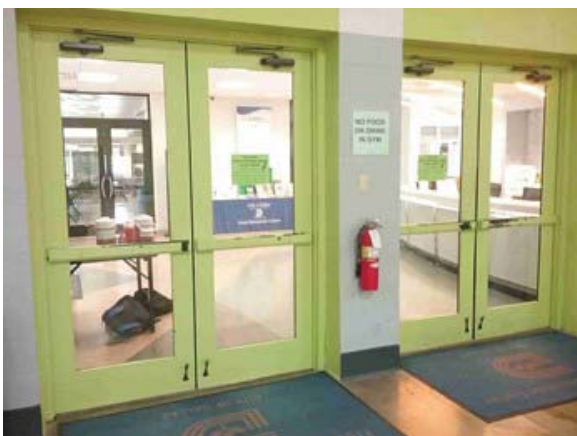
C10 Interior Construction		
Interior Walls	<p>The building generally consists of concrete masonry unit (CMU) interior walls. The main entry consists of a combination of brick, CMU block and gypsum board interior walls. There are several multi paned windows with metal frames, which are approximately 3-foot by 5-foot each located in the lobby at the east entry. There is a partition wall dividing the activity room.</p> <p>Deficiencies noted included large cracks in the CMU block walls in the multi-purpose storage room and electrical room. There were several approximately 1-inch circular holes in the CMU walls and two large holes</p>	3 - Average

Subsystem	Condition and Deficiency Overview	System Condition Rating
	in the CMU walls in the activity room storage closet.	
Interior Doors	<p>The interior doors leading from the lobby into the gym and the activity rooms are glass with a metal frame. The interior doors leading to storage areas are primarily wood or metal with a metal frame.</p> <p>Deficiencies noted included deterioration of the paint on the gym entrance doors.</p>	4 - Good
Interior Specialties	<p>The building has special interior construction such as counters in the kitchen, fire extinguisher cabinets throughout, a counter at the check-in desk with decorative back-lit panels, bleachers, and partitions between the bathroom stalls.</p> <p>No deficiencies were observed or reported at the time of the assessment.</p>	4 - Good
C20 Stairs		
Exterior Stairs	System not present.	N/A
Interior Stairs	System not present.	N/A
C30 Interior Finishes

1. Investigate origin of cracking in cement masonry unit (CMU) walls, and make necessary repairs.
2. Repair holes in the CMU block with sealant.
3. Repaint the hardware on the gym doors.

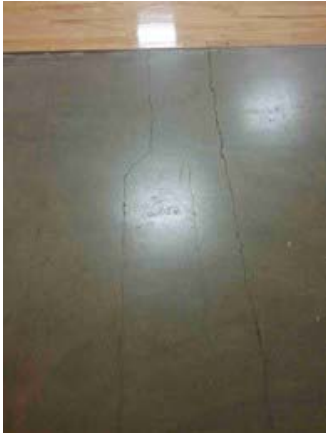
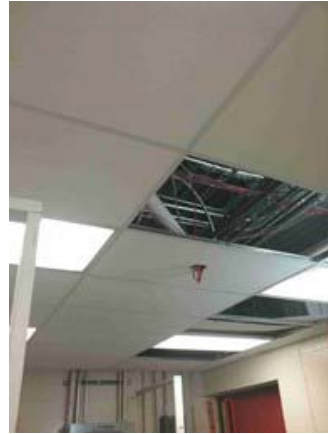
Interior Finishes

Interior Wall Finishes	<p>The building contains primarily painted concrete masonry unit (CMU) and gypsum board interior wall finishes. The restrooms contain ceramic tiled walls that extend onto the lobby walls. The kitchen contains both painted gypsum board and ceramic tiled walls. The janitorial closet contains painted CMU blocks and approximately 2-inch by 6-inch ceramic tile.</p> <p>No deficiencies were observed or reported at the time of the assessment.</p>	4 - Good
Interior Floor Finishes	<p>The activity rooms and the lobby contain vinyl composite tile (VCT) flooring. The gymnasium contains finished wood flooring and polished concrete. The storage closet in the gymnasium contains carpeted flooring. The restrooms and the janitorial closet contain approximately 24-inch by 12-inch ceramic tile flooring.</p> <p>Deficiencies noted included several minor cracks in the concrete flooring throughout the facility.</p>	3 - Average

Interior Ceiling Finishes	<p>The entry way and the electrical room contain acoustical ceiling tiles (ACT). The gymnasium contains exposed roof joists with acoustical panels. The activity rooms contain a metal suspended metal framing with metal acoustical panels. The ceiling in the storage closet in the activity room is exposed to the metal roof structure above. The restrooms have a painted gypsum board ceiling.</p> <p>Deficiencies noted included several missing ceiling tiles in the electrical room. There were metal ceiling tiles missing in the activity room.</p>	4 - Good
D10 Conveying		
Elevators, Lifts, and Escalators	System not present.	N/A
D20 Plumbing		
Plumbing Fixtures	The building has public restrooms for men and women located near the front desk. These restrooms have wall-mounted marble slab hand sinks	4 - Good

1. Repair the crack observed in the finished concrete floor; continue to monitor the area for further degradation as the structural integrity could be affected.
2. Replace the missing ceiling tiles throughout the facility.

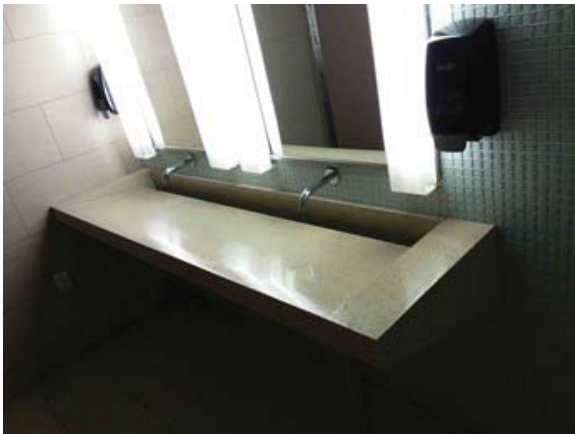
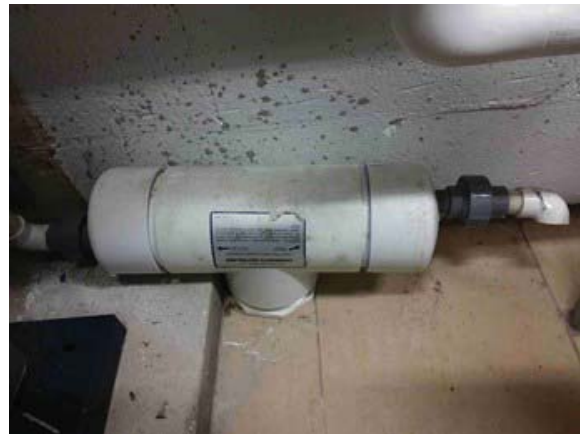
Plumbing

Subsystem	Condition and Deficiency Overview	System Condition Rating
	<p>with automatic sensor faucets, along with wall-hung toilets with manual flushing mechanisms. There are also wall-hung urinals in the men's restroom with manual flushing mechanisms. The janitorial closet has a floor-mounted mop sink. The water coolers are located in the alcove between the restrooms and in the gym.</p> <p>Other plumbing fixtures include: A three-bowl kitchen sink with two faucets, and a one-bowl hand wash sink; both located in the kitchen.</p> <p>Deficiencies noted included faucets located in both the men's and women's restrooms are loosely fastened to the wall.</p>	
Domestic Water Distribution	<p>The plumbing system has a domestic water service feed from a 2-inch reduced pressure zone backflow preventer to an 80-gallon PVI tank-type water heater with 199-MBH gas heating input, located in the janitorial closet. The water heater is equipped with a circulation pump and was manufactured in 2011.</p> <p>Deficiencies noted included a condensate neutralizer which was detached from the water heater with damaged connections.</p>	4 - Good

1. Repair the hand sink faucets to securely fit on wall.
2. Replace the condensate neutralizer for water heater.

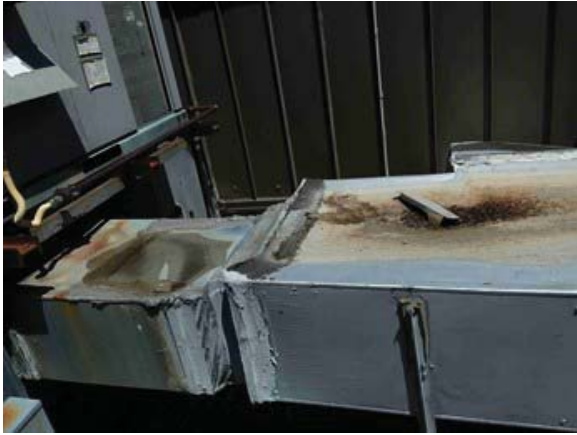
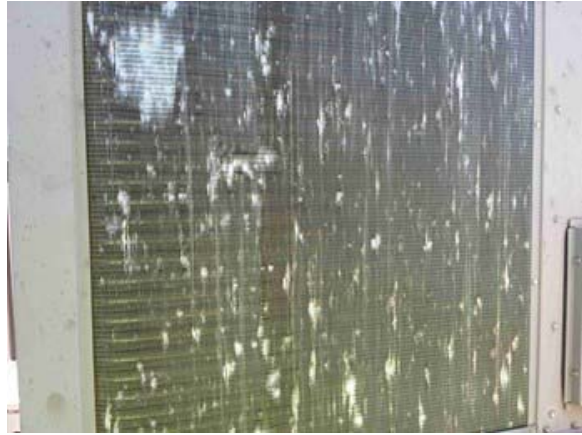
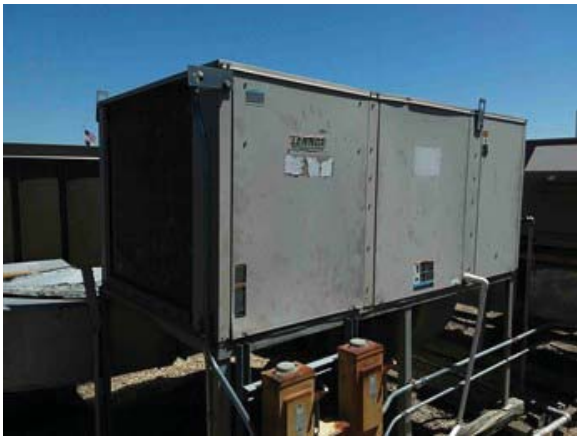
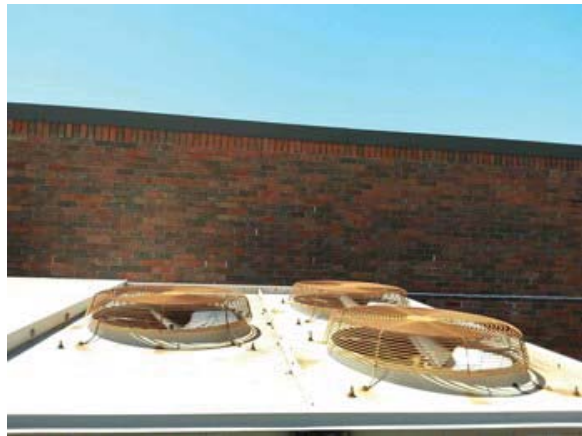
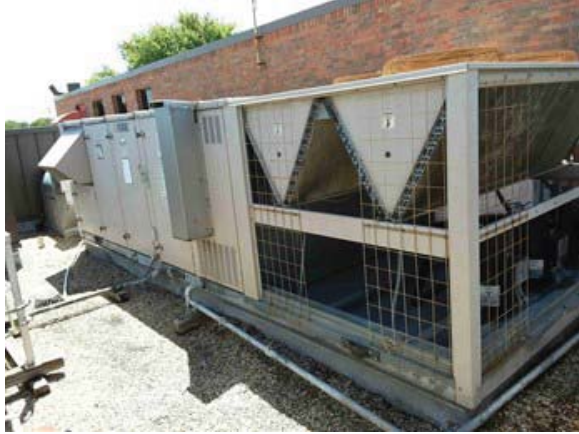
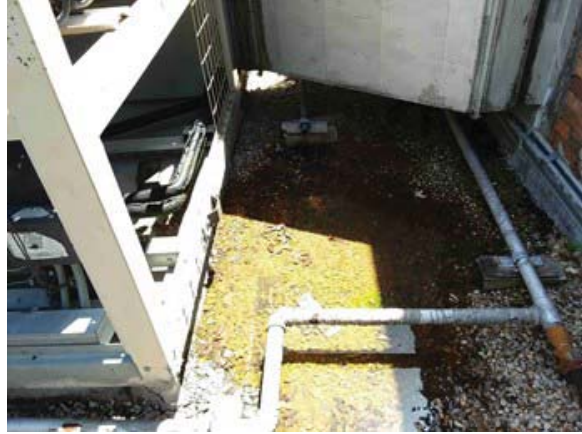
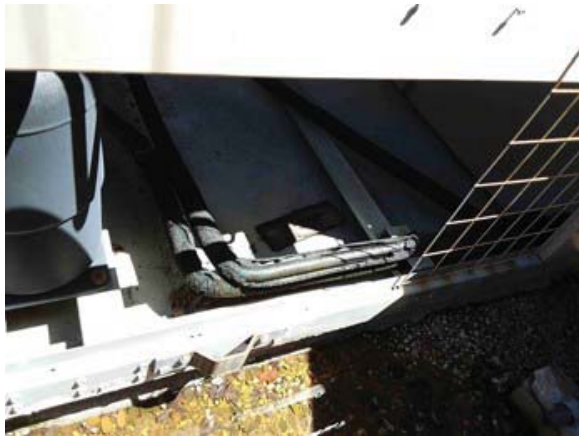
Mechanical/HVAC

Other Plumbing	<p>Other plumbing assets include: roof drains, floor drains and a floor sink. The floor drains are located in the public restrooms while the floor sink is used as a waste receptacle for the three-bowl kitchen sink.</p> <p>No deficiencies were observed or reported at the time of the assessment.</p>	4 - Good
D30 HVAC		
Mechanical / HVAC	<p>The major mechanical equipment consists of package units to service all of the heating, ventilating, and air conditioning (HVAC) system.</p> <p>There are six package rooftop units with direct-expansion cooling and gas heating. All but one unit have horizontal discharge with exposed ductwork on the roof. Four of the six units are elevated on supports. All six units have unique cooling and heating capacities which range from 3-ton with 75-MBH heat to 30-ton with 466-MBH heat.</p> <p>Supplemental mechanical equipment for the HVAC system includes two roof-mounted exhaust fans and two sidewall propeller exhaust fans. One exhaust fan serves the kitchen while the other serves restrooms.</p> <p>Deficiencies noted included three package rooftop units which were observed with moderate damage to their exposed ductwork; allowing water to pool in the indentions. Several package rooftop units were observed with moderate condenser fin hail damage and were utilizing R22 refrigerant which is being phased out of manufacturing and construction use. Several package rooftop units had corrosion issues on either their supports, condenser fan covers or the units themselves. Two package rooftop units were observed with excessive noise and vibration. The 30-ton unit had condensate leaking directly onto the roof and also had damaged refrigerant insulation.</p>	3 - Average

1. Repair or replace the damaged exposed rooftop ductwork.
2. Repair hail damaged condenser fins.
3. Plan for replacement of all HVAC equipment utilizing R-22 refrigerant, which is being phased out of manufacturing and construction use.
4. Repair and repaint the surface rusted package units.
5. Determine the cause of excessive noise and vibration of two rooftop units, and make necessary repairs.
6. Terminate condensate piping for the 30-ton unit at a code approved location.
7. Replace the damaged refrigerant pipe insulation to properly insulate and protect the piping.

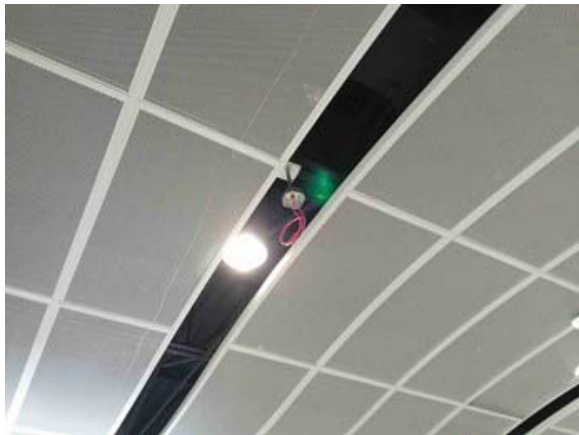
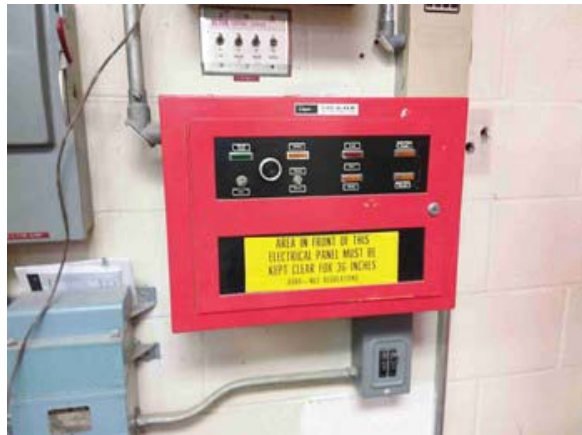
D40 Fire Protection		
Fire Alarm	<p>The building has a fire alarm system that consists of alarm and signaling devices such as horns, strobes, horn/strobe combinations, pull stations,</p>	2 - Poor

Subsystem	Condition and Deficiency Overview	System Condition Rating
	<p>and detectors.</p> <p>The fire alarm system control equipment includes a single-zone Simplex fire alarm control panel (FACP) which is not addressable.</p> <p>Deficiencies noted included many fire alarm devices which were not installed throughout the building. The fire alarm control panel appeared to be aged and potentially non-functional. It was reported by facility staff that the facility fire alarm system was under renovation but is currently in poor condition.</p>	
<p>Fire Protection/Suppression</p>	<p>The building has an automatic fire extinguishing system for the kitchen hood; the recreation area does not have a wet pipe system for all other spaces.</p> <p>The building also has supplemental, portable fire extinguishers for fire suppression.</p> <p>No deficiencies were observed or reported at the time of the assessment.</p>	<p>4 - Good</p>

1. Install fire alarm devices and notification devices such as horn/strobe combinations, pull stations, and detectors in proper locations, to finish current renovation.
2. Replace the aged fire alarm control panel.

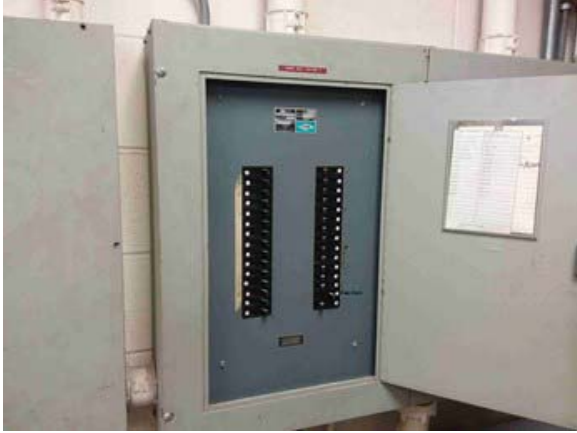
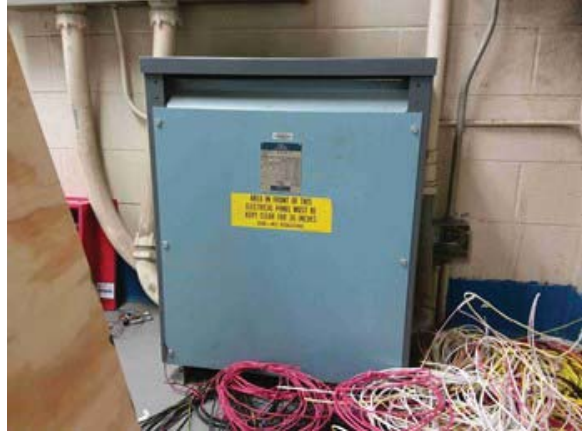
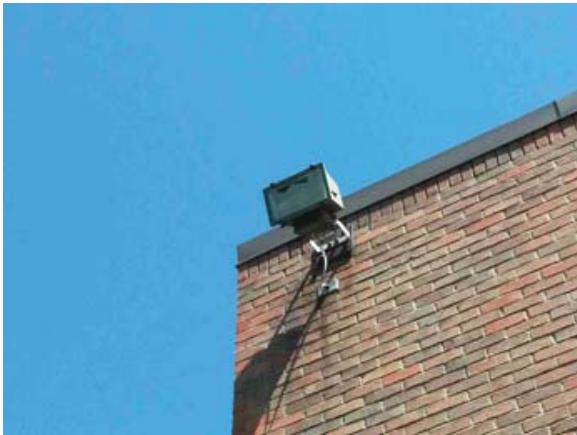
Electrical

<p>D50 Electrical</p>		
<p>Electrical Distribution</p>	<p>The electrical service enters the building at the 400-amp 277/480-volt main switchgear, which is located in the main electrical room and delivers power throughout the building. There are three 480-volt primary transformers that step-down to 120/208-volt secondary transformers; which feed power to 120/208-volt panelboards. These transformers and distribution panelboards are all located in the main electrical room.</p> <p>Deficiencies noted included several aged and out-of-date distribution panelboards, and an aged and out-of-date distribution transformer.</p>	<p>3 - Average</p>
<p>Lighting</p>	<p>The exterior lighting at the building consists of halogen spotlight fixtures that are located along most of the entire perimeter to light parking and walking areas.</p> <p>The interior lighting is made up of primarily T8 linear fluorescent fixtures with additional T12 linear fluorescent fixtures observed.</p> <p>Additionally, exit signs are seen throughout the facility in appropriate locations. Emergency lighting is not present unless battery packs are being used.</p> <p>Deficiencies noted included an exterior halogen spotlight was observed with a broken lens.</p>	<p>4 - Good</p>

1. Replace the aged electrical distribution panelboards as they appear past their typical design service life.
2. Replace the aged interior distribution transformer that is past its typical design service life.
3. Replace the damaged exterior halogen spotlight.
