Harry Stone Recreation Center Summary

Address	2400 Millmar Drive Dallas, TX 75228
Building Purpose	Recreation Center
Original Year of Construction	1957 (Expansion 2013)
Building Area	22,281 SF
Inspection Date	August 16, 2016
Inspection Conditions	78° F, Overcast

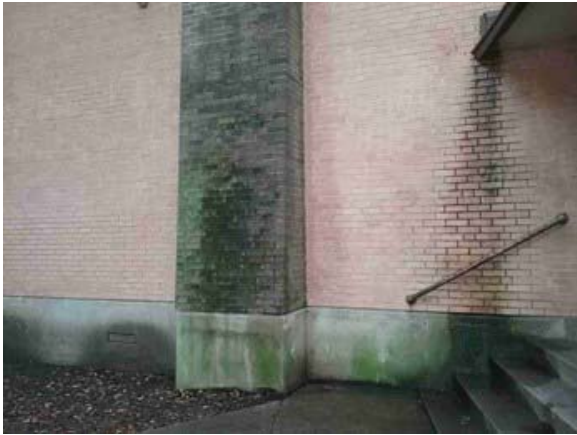
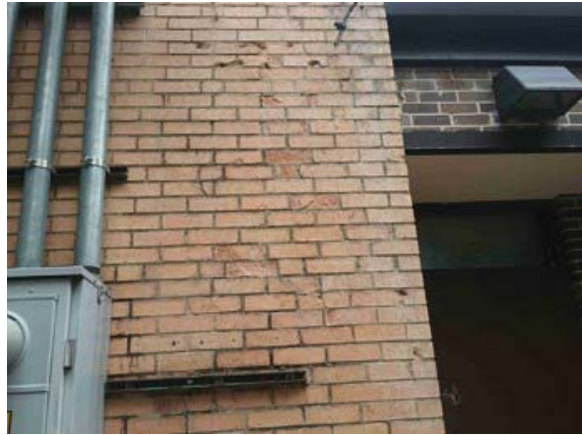
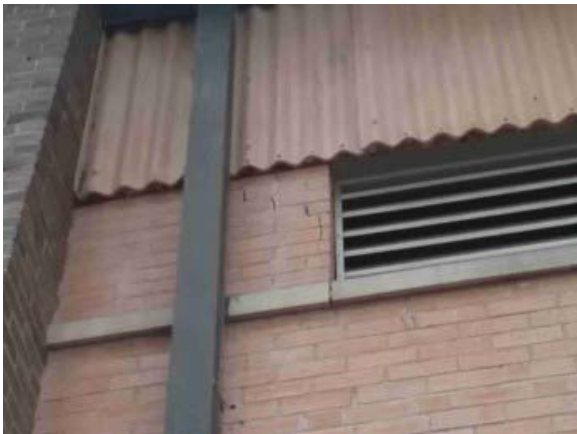
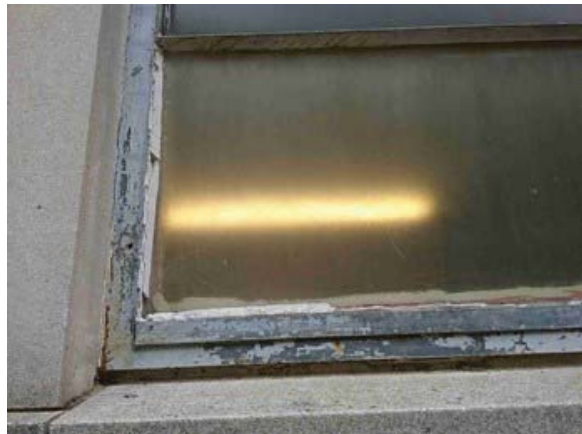
Subsystem	Condition and Deficiency Overview	System Condition Rating
B20 Exterior Enclosure		
Exterior Walls	<p>The exterior walls consist of a brick façade with corrugated metal panels installed around the top perimeter of the gym. There are metal air louvers installed on the west side of the building.</p> <p>Deficiencies noted included paint markings observed on the brick on the west patio. There were bricks that were chipped or damaged in multiple locations around the perimeter of the building. Multiple bricks around the perimeter of the building were stained. There was a crack observed in the bricks near the air louver on the west side of the building and in multiple locations on the south side of the building.</p>	3 - Average
Exterior Windows	<p>There are floor to ceiling windows of various shapes and sizes with tinted glass in multiple colors at the south east corner of the building near the main entrance. There is a 2-foot by 3-foot window on the north side with a metal frame. There are three windows on the east side of the building that are approximately 3-foot tall with varying width glass panes. There are windows at the roof elevation that have metal frames.</p> <p>Deficiencies noted included worn paint on the metal frame and missing or cracked grout between the glass and the metal frame; and the frame and the wall at the window on the north side of the building.</p>	4 - Good

1. Power-wash the brick where paint markings or stains are observed.
2. Replace damaged or chipped bricks.
3. Repair cracking near the air louver on the west side of the building and on the south side of the building and monitor for further degradation.
4. Replace the window on the north side of the building.

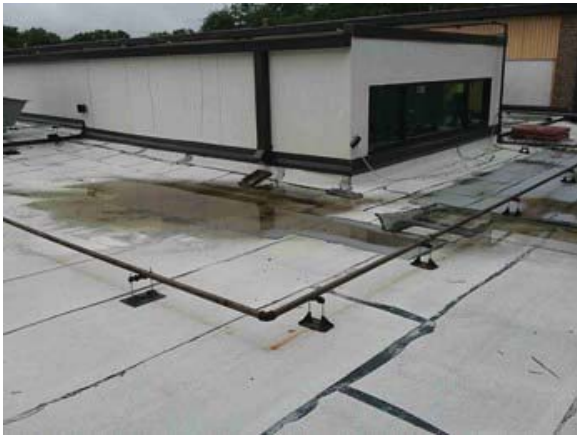
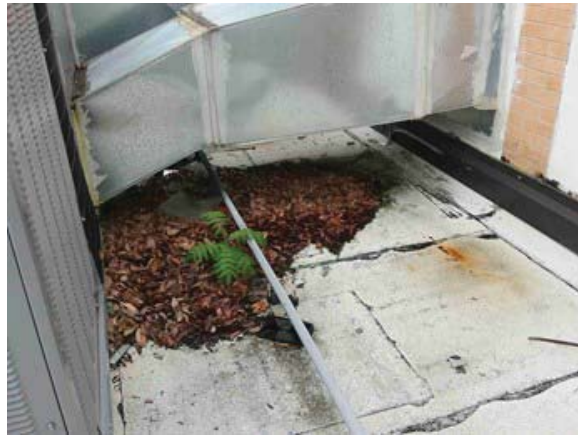
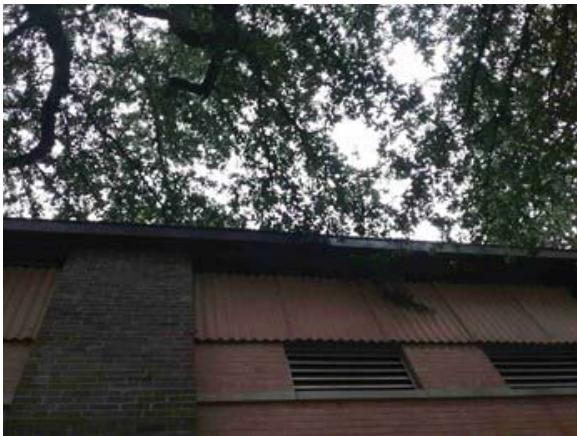
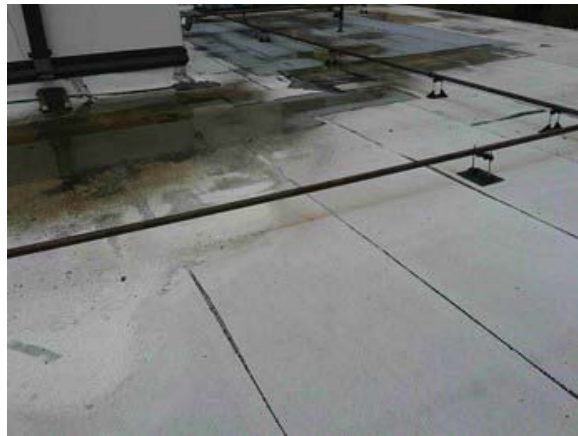
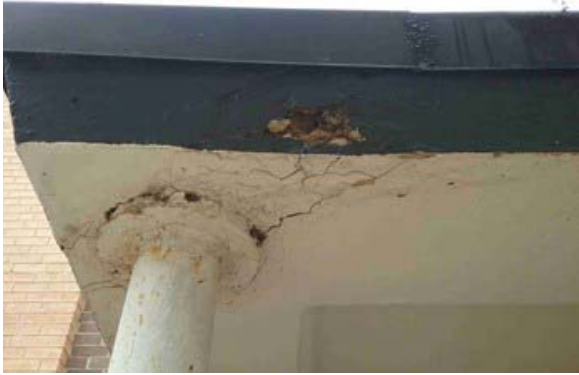
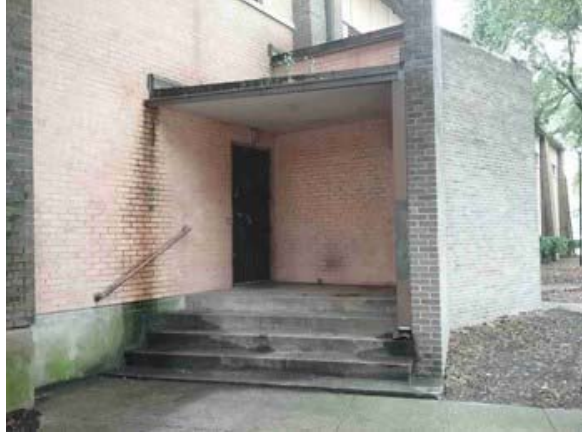
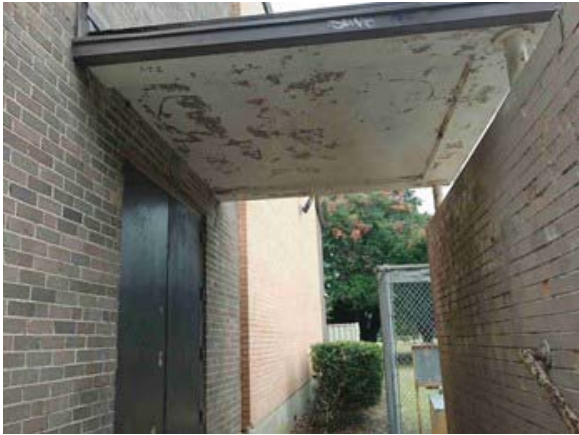
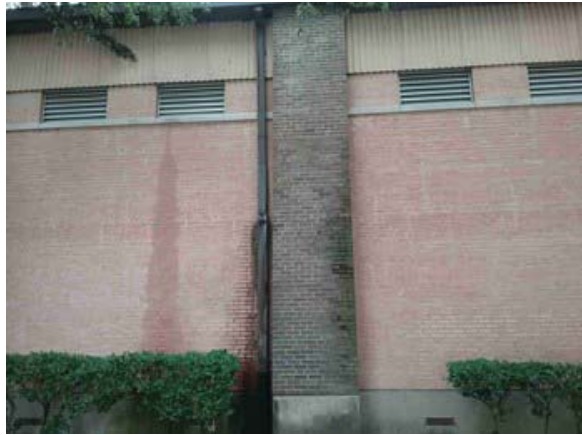
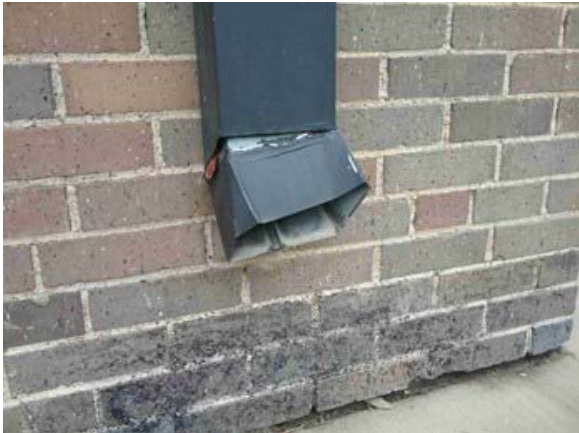
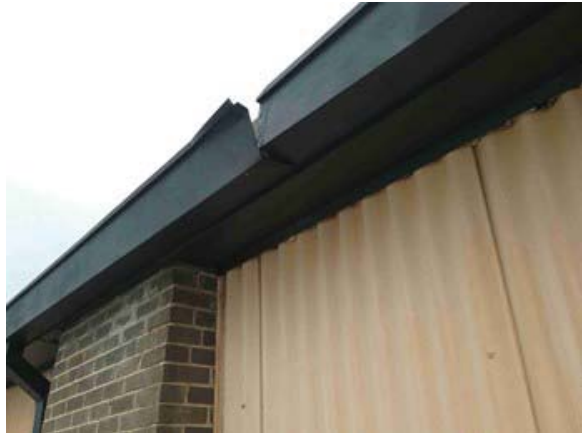
Exterior Doors	<p>There is one main public entryway located at the south side of the building, which consists of glass doors with a metal frame. The right public entry door is equipped with handicap accessible automatic door hardware. The remaining service doors are metal and located along north, west and south sides of the building.</p> <p>No deficiencies were observed or reported at the time of the assessment.</p>	4 - Good
B30 Roofing		
Roof	<p>The roof construction is a modified bitumen system occurring over multiple levels. The roof section over the gym was not accessible at the time of the assessment due to the high slope of the roof. The roof is assumed to be installed in 2013 based upon the date of the building expansion. There are four patio overhangs located on the north, west and south sides of the building each with a modified bitumen covering and supported by a brick wall.</p> <p>Other roofing features include: metal flashing, gutters and downspouts, painted concrete soffit under the patio overhangs, an access hatch and a chimney.</p> <p>Deficiencies noted included water ponding at the lower level of the roof. It was observed that the roof did not appear to be sloped towards the existing roof drains or there may not be sufficient roof drains installed to drain standing water on the roof. There were leaves accumulated in</p>	3 - Average

Subsystem	Condition and Deficiency Overview	System Condition Rating
	<p>multiple locations and tree branches were observed to be growing over the roof. Facility staff reported that water intrusion has been observed throughout the new addition of the building. Facility staff noted that repairs to the roof have been unsuccessful with regard to water intrusion observed in the building when it rains. Facility staff reported there were no leaks over the gym which is the roof over the original structure. At the patio on the south side of the building, there were cracks observed and deterioration of the concrete near the column supporting the roof. The gutters at the overhangs were clogged. The paint over the concrete fascia at the patio overhangs was chipping. There were stains observed around a downspout and it was assumed that the downspout was clogged.</p>	
C10 Interior Construction		
Interior Walls	<p>The building primarily consists of a combination of brick and gypsum board walls. The gym and custodial closet have concrete masonry unit (CMU) walls. The front desk has a store front supported by a counter and a stone countertop. There are store front windows above the interior entry doors, outside the gym office supported by a wall and around the check-in desk. There is a window with a mirrored film on the glass in the lobby. The multipurpose room has a storage closet constructed of gypsum board that does not extend the full height of the ceiling in the rest of the space. The gym has a retractable carpeted partition wall.</p> <p>Deficiencies noted included damage to the particle board wall above the partition in the gym, and cracks observed in the grout between multiple CMU blocks in the gym.</p>	4 - Good

1. Address various roof sloping issues to allow for proper drainage and continue to monitor for additional ponding.
2. Remove accumulated debris on the roof, such as leaves.
3. Trim the trees that have grown over the building to prevent further debris accumulation.
4. Determine the source of water intrusion into the new addition of the building and make necessary repairs.
5. Repair the cracked concrete at the patio overhang on the south side of the building.
6. Clean all of the gutters around the perimeter of the building.
7. Paint the soffit under the patio overhangs.
8. Clean the clogged downspouts.
9. Replace damaged downspouts.
10. Replace damaged gutters.

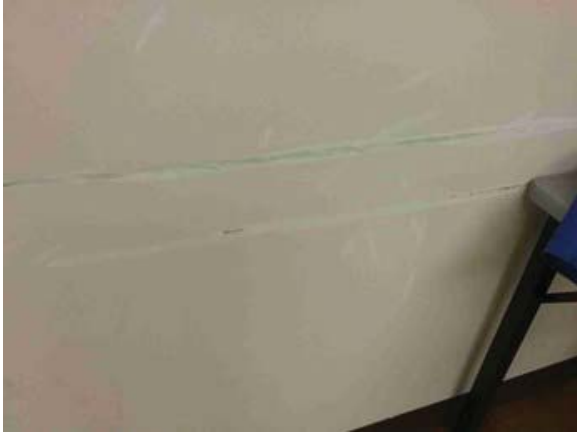
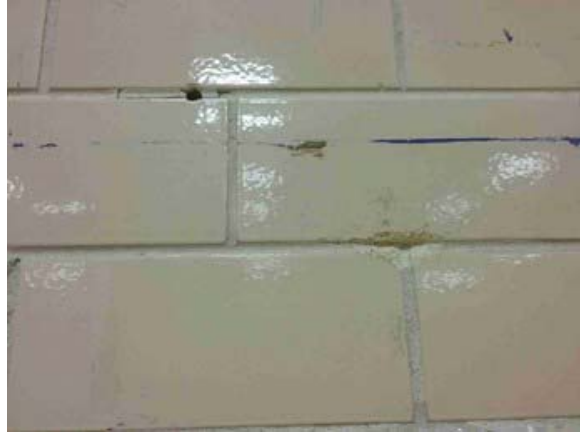
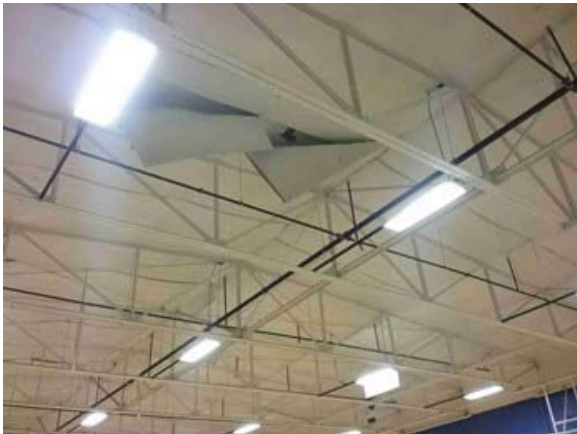
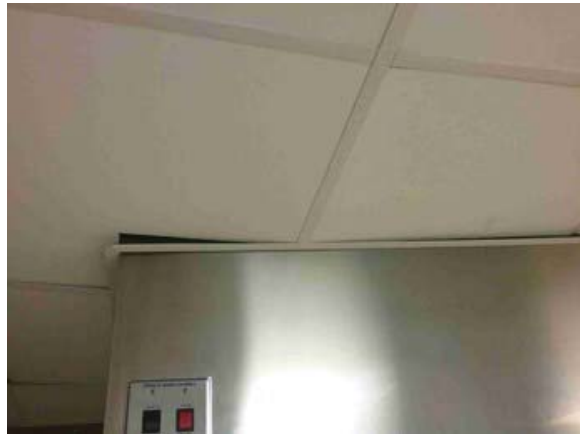
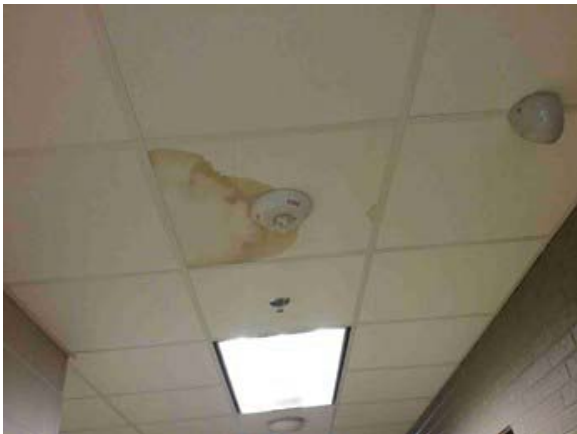
Subsystem	Condition and Deficiency Overview	System Condition Rating
C30 Interior Finishes		
Interior Wall Finishes	<p>The building contains a combination of painted brick, ceramic tile, painted concrete unit masonry (CMU) and painted gypsum board interior wall finishes. The restrooms and kitchen have 1-foot by 2-foot ceramic tiles. The gym has ceramic tiled walls approximately 7-foot high and the remainder of the walls are painted CMU. The storage area in the gym has fiberglass reinforced plastic (FRP) panels and painted gypsum board walls. The dance studio has mirrors installed around the perimeter of the room. The counter at the front desk has ceramic tile installed on the face of the counter.</p> <p>Deficiencies noted included minor damage to the paint in several locations. There was minor damage to multiple sections of the tiles in the gym.</p>	4 - Good
Interior Floor Finishes	<p>The building has primarily polished concrete floors. The fitness room has rubber floors. The restrooms have 1-foot square ceramic tiles. The multipurpose room has vinyl-composition tile (VCT) floors. The kitchen has 6-inch square ceramic tiles. The custodial closet has unfinished concrete floors. The gym and dance studio have sealed wood floors. No deficiencies were observed or reported at the time of the assessment.</p>	4 - Good

1. Repair damaged gypsum board and paint to match surrounding finishes.
2. Replace the damaged ceramic tiles in the gym.
3. Replace damaged insulation panels in the gym.
4. Repair the suspended acoustical ceiling tile (ACT) frame in the kitchen.
5. Determine the source of water intrusion into the building and replace stained ACT.

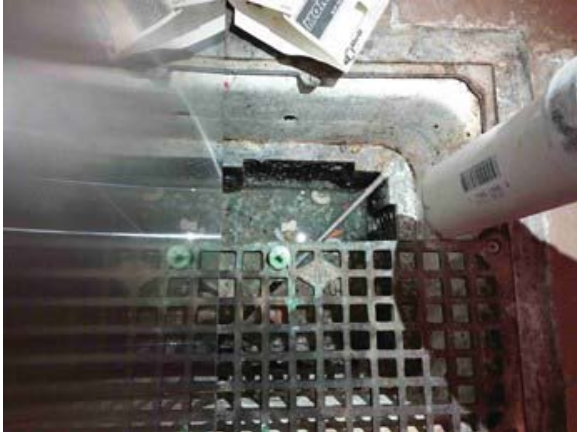
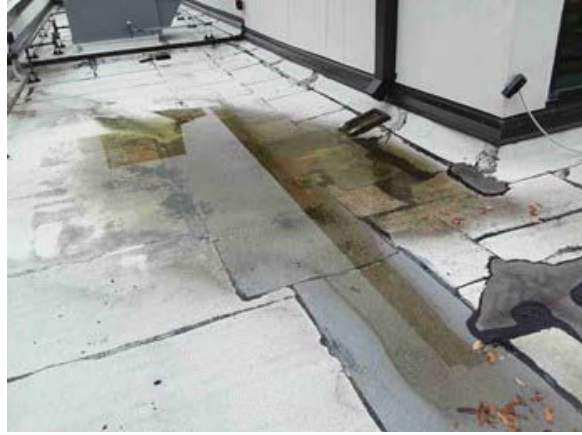
Subsystem	Condition and Deficiency Overview	System Condition Rating
	<p>kitchen.</p> <p>No deficiencies were observed or reported at the time of the assessment.</p>	
Domestic Water Distribution	<p>The plumbing system has a domestic water service feed to a 100-gallon AO Smith tank-type water heater with 199-MBH gas heating input located in the janitorial/storage room. The hot water distribution system is equipped with a circulation pump and master mixing valve which are also located in the custodial/storage room.</p> <p>No deficiencies were observed or reported at the time of the assessment.</p>	4 - Good
Other Plumbing	<p>Other plumbing assets include: Roof drains, floor drains and floor-sinks. Floor drains are located in the janitorial/storage room and all restrooms. Floor sinks are located in the kitchen.</p> <p>Deficiencies noted included significant water pooling on the rooftop and roof leakage reported by the facility staff. The roof drainage system was inadequate. Two floor-sinks serving as indirect waste receptacles (for the hand sink and kitchen sink) had water clogging, a pungent odor, and flies in their vicinities.</p>	2 - Poor

1. Unclog floor sinks located in the kitchen.
2. Reassess roof drain system. Additional roof drains are needed to properly drain the roof.

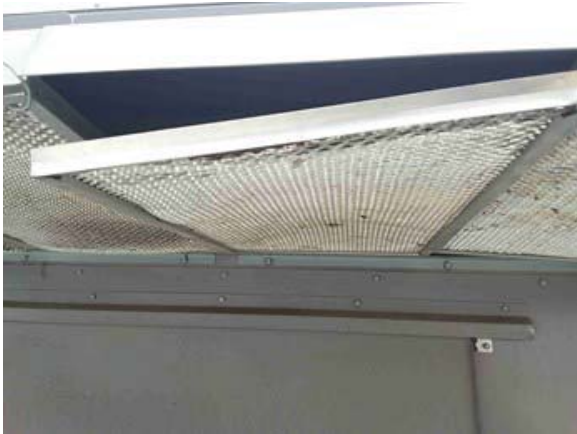
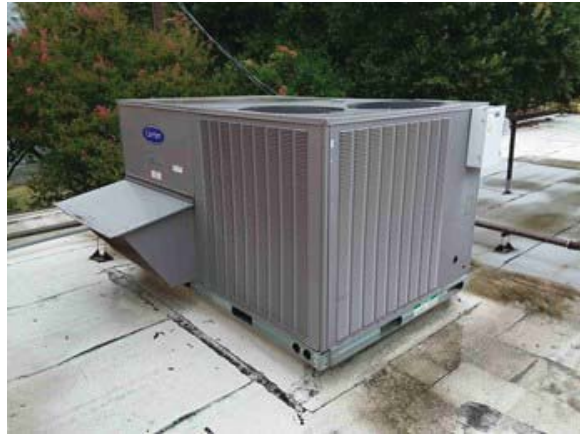
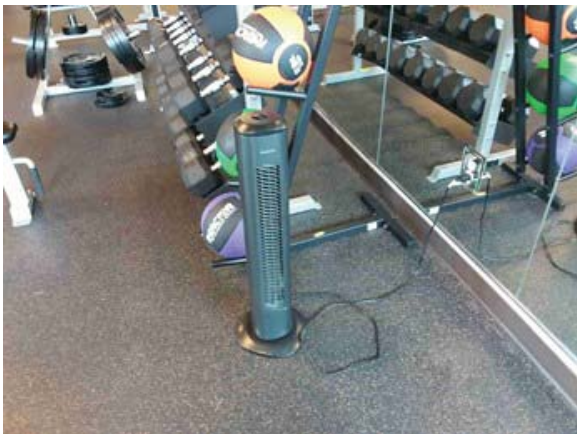
Mechanical/HVAC

D30 HVAC		
Mechanical / HVAC	<p>The major mechanical equipment consists of package units to service all of the heating, ventilating, and air conditioning (HVAC) system.</p> <p>The package units contain direct-expansion cooling and gas heating. There are seven units which were all manufactured in 2012 by Carrier. There are two 25-ton units with 310-MBH gas heating input, two 8.5-ton units with 125-MBH gas heating input, two 3-ton units with 72-MBH gas heating input and one 10-ton unit with 180-MBH gas heating input.</p> <p>Supplemental mechanical equipment for the HVAC system also includes three roof-mounted exhaust fans, a kitchen hood, a unit heater and two plug-in space coolers. Two exhaust fans serve the restrooms while the third serves the kitchen. The unit heater is used for freeze protection in the fire riser room. The plug-in space coolers are located in the manager's office and the weight room.</p> <p>Deficiencies noted included a misaligned/damaged economizer screen on one of the rooftop units. Air conditioning control issues were reported by the facility staff; an alarm had been triggered each morning and shut down the mechanical system. The plug-in space coolers are used as a result of subpar comfort in the manager's office and weight room.</p>	4 - Good

1. Replace the economizer screen for RTU 1.
2. Repair alarm controls issue.
3. Repair or replace cooling equipment servicing the manager's office and weight room. Make adjustments to the system as necessary.

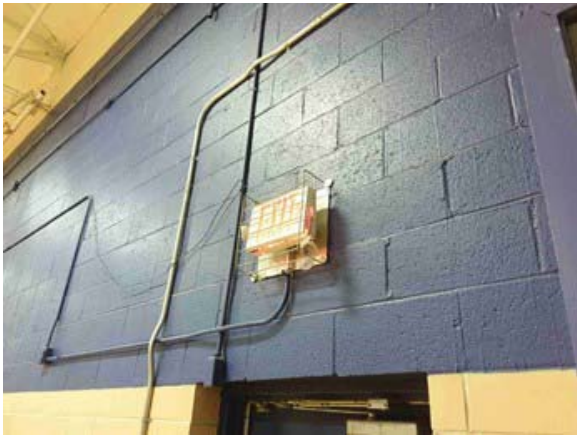
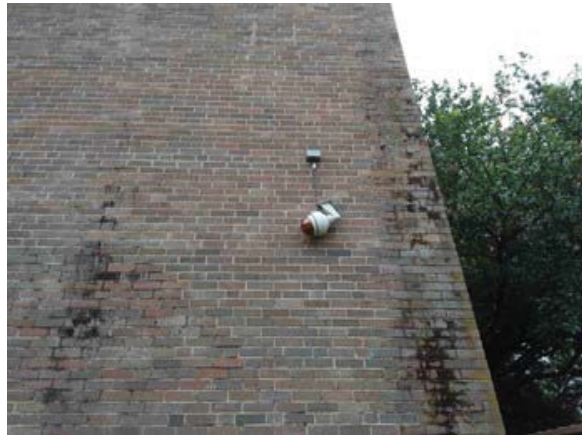
Electrical

Lighting	<p>The exterior lighting at the building consists of metal halide fixtures that are located along the entire perimeter.</p> <p>The interior lighting is made up of primarily T8 linear fluorescent fixtures with additional compact fluorescent fixtures observed along with T5HO high-bay linear fluorescents within the gym area.</p> <p>Additionally, exit lights and emergency light fixtures are seen throughout the facility in appropriate locations.</p> <p>Deficiencies noted included damaged emergency lighting and exit signs within the gym area, along with damaged exit sign lighting wire guards.</p>	4 - Good
Communications & Security	<p>The building has a communication system that consists of telephone, LAN, data points, and Wi-Fi.</p> <p>The building has a security system that consists of interior and exterior cameras and keypad access.</p> <p>Deficiencies noted included two damaged exterior cameras. The cameras are detached from the exterior wall.</p>	3 - Average

1. Repair or replace the damaged emergency lighting, exit sign and wire guards.
2. Replace the damaged exterior cameras.
