# Jaycee Zaragoza Recreation Center Summary

<b>Address</b>	3114 Clymer Street Dallas, TX 75211
<b>Building Purpose</b>	Recreation Center
<b>Original Year of Construction</b>	1962
<b>Building Area</b>	20,320 SF
<b>Inspection Date</b>	August 3, 2016
<b>Inspection Conditions</b>	90° F, Sunny and Hot

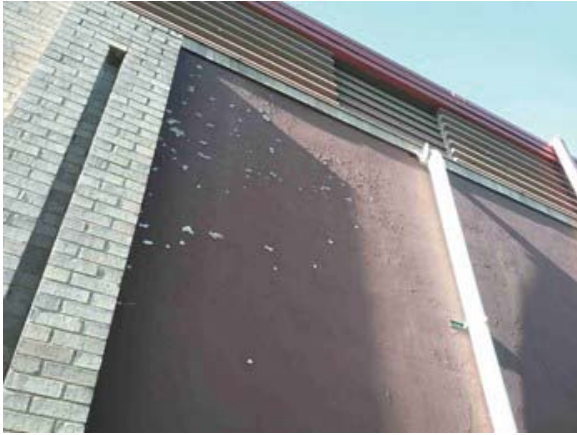
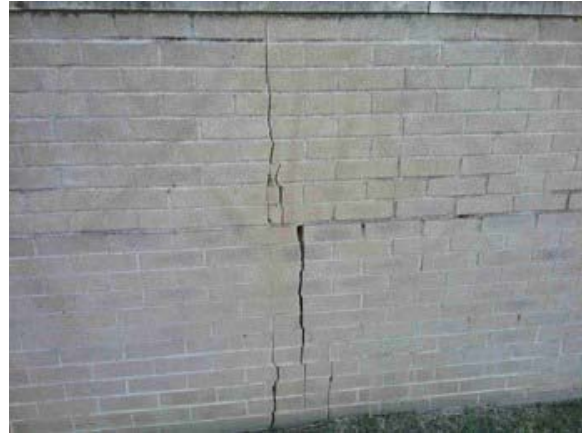
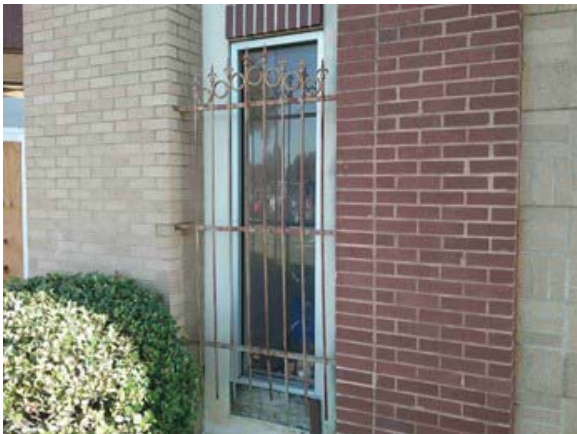
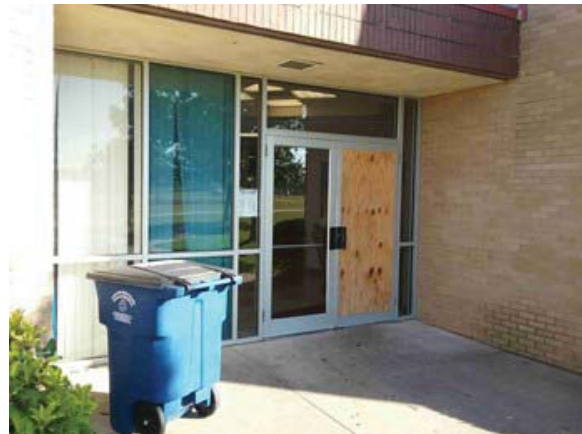
Subsystem	Condition and Deficiency Overview	System Condition Rating
<b>B20 Exterior Enclosure</b>		
<b>Exterior Walls</b>	<p>The exterior of the building consists primarily of a brick façade with decorative brick designs. The north exterior wall contains sections with a painted plaster finish.</p> <p>Deficiencies noted included chips in the paint on the plaster finish. There is also vertical cracking in the walls that surround the HVAC unit.</p>	4 - Good
<b>Exterior Windows</b>	<p>The exterior windows consist of double-paned glass windows with anodized aluminum frames, typically arranged in groups of three. There are also small square aluminum framed windows arranged together on the south side of the building. Several windows have metal bars installed in front of the windows.</p> <p>Deficiencies noted included rusted bars on one of the windows on the south side.</p>	4 - Good
<b>Exterior Doors</b>	<p>There is one main public entryway and secondary entrance located at the south side of the building; these doors are glass with anodized aluminum frames. The remaining doors of the facility are painted metal doors on the east and north side.</p> <p>Deficiencies noted included a broken glass door on the south side of the building that was temporarily covered with plywood.</p>	4 - Good

1. Paint the exterior plaster wall section observed with chipping paint.
2. Repair vertical cracking on walls surrounding HVAC unit.
3. Restore or replace rusted metal bars on window on the south side of building.
4. Replace broken glass door on south side of building.

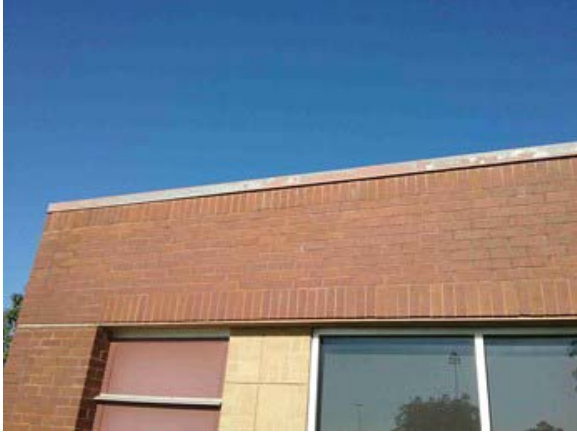
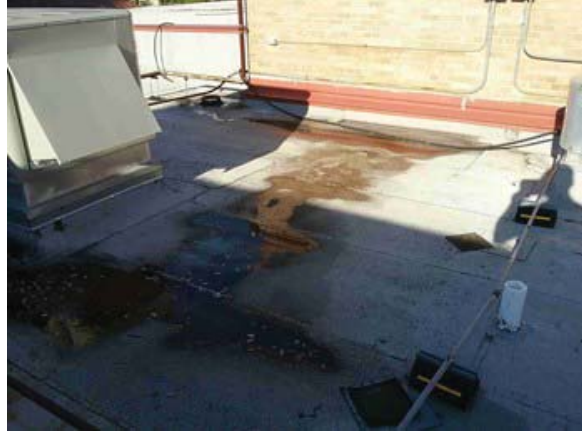
<b>B30 Roofing</b>		
<b>Roof</b>	<p>The roof construction consists primarily of a low-slope modified bitumen system encompassing approximately 90% of the building. There is also a section of the roof construction that is a steep-slope standing seam metal system, which appears to be constructed at a later date than the building's original construction. There is also a large wooden overhang over the main entrance with a decorative stone trim.</p> <p>Deficiencies noted included large areas of ponding on the modified bitumen portions of the roof. The metal flashing on the east side of the building had chipping paint.</p>	3 - Average
<b>C10 Interior Construction</b>		
<b>Interior Walls</b>	<p>The building contains primarily gypsum board interior walls. There is exposed brick on the walls between the gymnasium and adjacent rooms, and in the boxing room. Showers and the gymnasium contain concrete masonry unit (CMU) interior walls.</p> <p>Deficiencies noted included two holes in the east hallway gypsum board walls.</p>	4 - Good

1. Repaint or replace metal flashing on the east side of the building, as necessary.
2. Repair and level modified bitumen roofing to eliminate ponding issues.

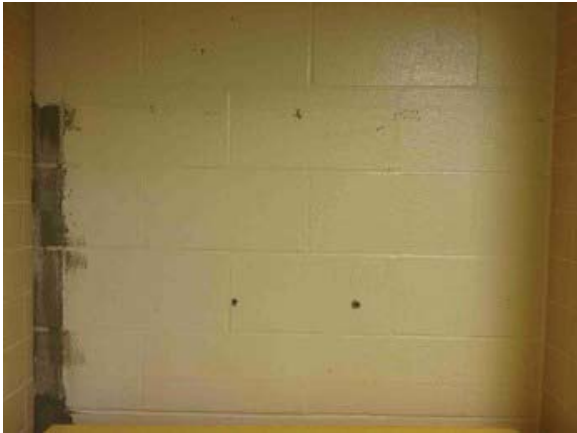
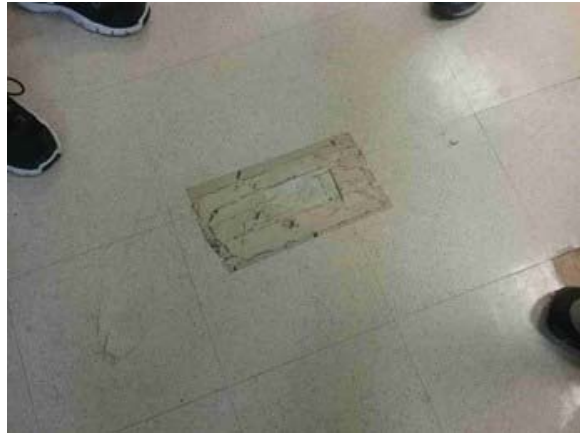
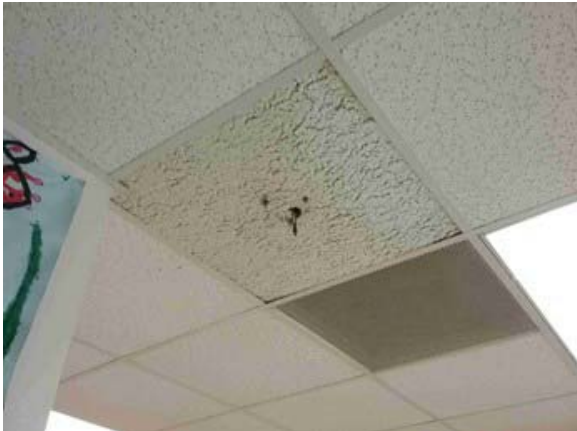
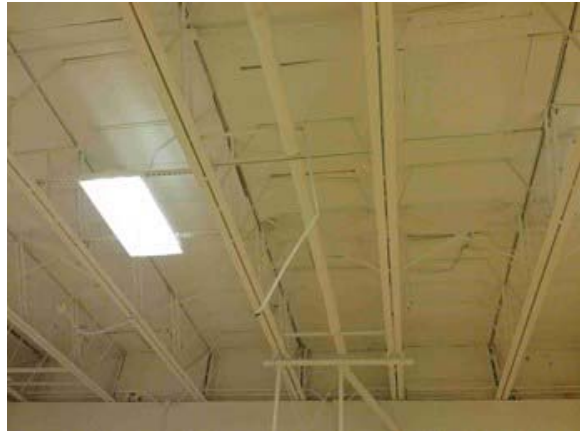
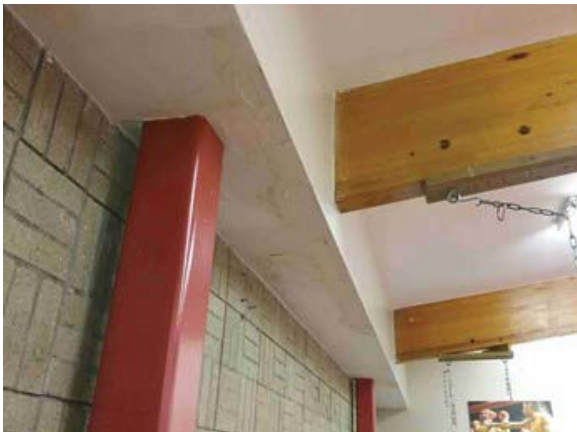
Subsystem	Condition and Deficiency Overview	System Condition Rating
<b>Interior Specialties</b>	A large kitchen is present with built in cabinetry. Partitions and lockers are located in the restrooms. The gymnasium contains collapsible bleachers.  No deficiencies were observed or reported at the time of the assessment.	4 - Good
<b>C20 Stairs</b>		
<b>Exterior Stairs</b>	System not present.	N/A
<b>Interior Stairs</b>	System not present.	N/A
<b>C30 Interior Finishes</b>		
<b>Interior Wall Finishes</b>	Wall finishes consist primarily of painted gypsum board interior wall finishes. The gymnasium and weight room have a painted CMU finish. The restrooms contain tiled interior wall finishes. Exposed brick is also present in small sections throughout the building.  Deficiencies noted included minor signs of scuffing to wall surfaces, and small areas with worn paint.	4 - Good
<b>Interior Floor Finishes</b>	Hallways and closets and office area contain vinyl composition tile (VCT) interior floor finishes. The gymnasium and activity rooms B and C contain wood flooring. The weight room and boxing room have a rubber mat finish.  Deficiencies noted included reports of sinking issues with the VCT in the office area.	4 - Good

<b>Interior Ceiling Finishes</b>	The building primarily contains acoustical ceiling tile (ACT) interior ceiling finishes. The gymnasium has an exposed metal ceiling, and the main activity room and boxing room have gypsum board ceilings with wood beams.  Deficiencies noted included water damage to the ACT in the hallways and janitorial closet. Several ceiling tiles and the metal framing were misaligned in the office area. There was a broken piece of metal framing that was hanging from the ceiling in the gymnasium. In the boxing room, there was apparent water damage to the gypsum board at the edge of the room	3 - Average
<b>D10 Conveying</b>		
<b>Elevators, Lifts, and Escalators</b>	System not present.	N/A
<b>D20 Plumbing</b>		
<b>Plumbing Fixtures</b>	The building has public restrooms for men and women. The restrooms have vitreous china fixtures throughout, consisting of floor-mounted water closets and wall-mounted urinals. The restrooms have counter-mounted vitreous china hand sinks. There is also a private restroom and shower for staff use. The staff water closet is wall-mounted. All fixtures are manually operated.  The building has wall-mounted water coolers located in the corridors of the facility.  Other plumbing fixtures include: A stainless steel three-compartment sink and two service sinks located in the kitchen.	3 - Average

1. Repaint gypsum board and CMU walls in building as necessary
2. Investigate sinking VCT in office area and make necessary repairs.
3. Replace broken and water damaged ACT throughout building.
4. Repair broken metal framing in gymnasium.
5. Investigate water damage in boxing room and janitorial closet, replace tile and repair gypsum board.

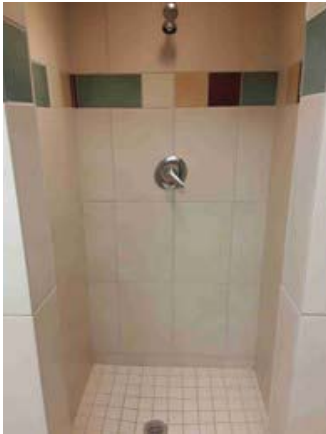
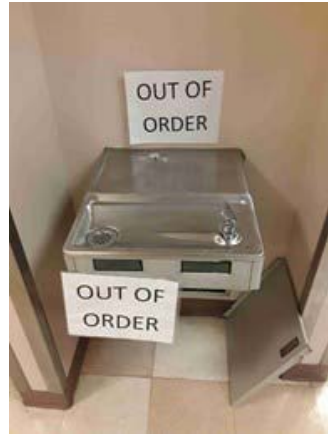
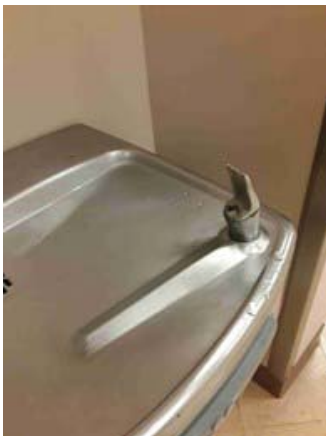
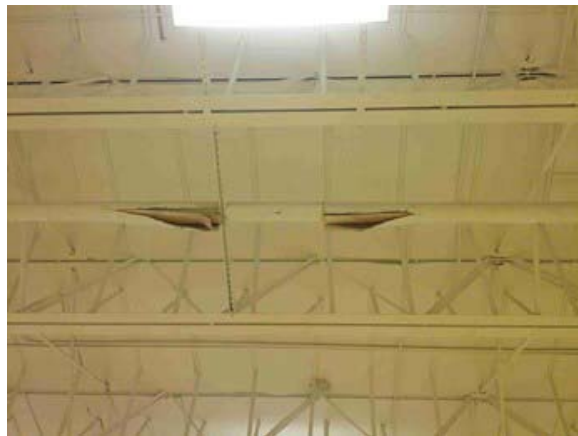
Subsystem	Condition and Deficiency Overview	System Condition Rating
	Deficiencies noted included the men's public shower does not have a complete head. One electric water cooler is out-of-order, and the other has excessive wear.	
<b>Domestic Water Distribution</b>	The plumbing system has a domestic water service feed from a 50-gallon, 4.5-kW water heater located in a laundry room. No deficiencies were observed or reported at the time of the assessment.	4 - Good
<b>Other Plumbing</b>	Other plumbing assets include floor drains for the water heaters, floor sinks, and roof drains. Deficiencies noted included deteriorated insulation on the interior portion of the roof drain piping above the gymnasium.	4 - Good
<b>D30 HVAC</b>		
<b>Mechanical / HVAC</b>	The major mechanical equipment consists of seven rooftop package air conditioning units and one ground mounted unit. The rooftop units are air-cooled with gas heat, range in size from 5-ton to 17.5-ton, and were installed between 2009 to 2013. The ground-mounted unit, serving the gym, is 50-ton. There is also a 3-ton air-cooled heat pump with a wall mounted indoor unit. Supplemental mechanical equipment for the HVAC system also includes roof mounted exhaust fans serving the restrooms and general exhaust. Deficiencies noted included backup in primary condensate causing the unit to leak. One condensate line had a gap in it. Two units had condensate discharging onto the roof. The 50-ton unit serving the gym is eight years old, but uses R-22, which is being phased out of manufacturing and construction use. Insulation was missing on the heat pump unit refrigerant lines.	4 - Good

1. Replace missing shower head.
2. Repair or replace electric water cooler that was out-of-order.
3. Replace electric water cooler that had shown excessive wear.
4. Repair roof drain piping insulation.

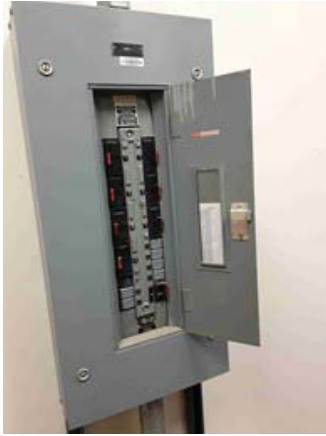
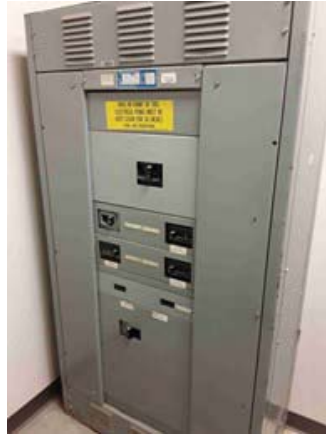
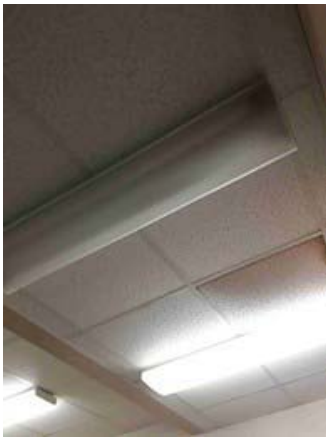
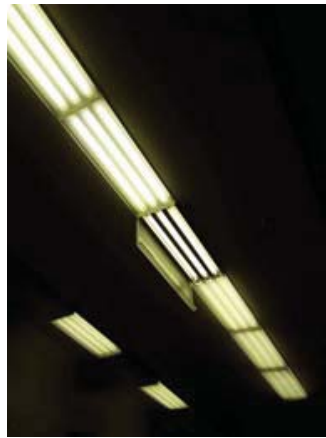
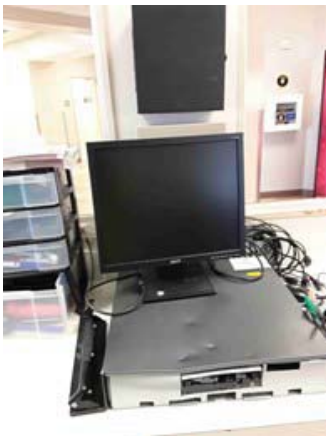
Subsystem	Condition and Deficiency Overview	System Condition Rating
	<p>branch panels throughout the building. Panel B and Panel A are manufactured by Federal Pacific.</p> <p>Deficiencies noted included Panels A and B were from the original installation (approx. 1963) and were Federal Pacific panels which are obsolete and potential life safety hazards. SB2 was approaching the end of its service life.</p>	
<b>Lighting</b>	<p>The exterior lighting at the building consists of compact fluorescent (CFL) wall pack fixtures that are mounted to the exterior façade, and 1-foot by 1-foot in-lay fixtures mounted underneath the canopy.</p> <p>The interior lighting is made up of fluorescent lamps that vary on size depending on the space; 2-foot by 4-foot, six-lamp, surface mounted fixtures are located in the high gym bays; 2-foot by 4-foot florescent, 1-foot by 4-foot florescent, 2-foot by 2-foot florescent and CFL can lights are located throughout the rest of the interior. Lighting controls consist of standard and secure switches located in each room.</p> <p>Additionally, exit lights and emergency light fixtures are seen throughout the facility in appropriate locations.</p> <p>Deficiencies noted included several fixture lenses that were cracked or broken. Several lamps were burnt out or broken. One of the shower light fixtures was missing its lens.</p>	4 - Good

<b>Communications &amp; Security</b>	<p>The building has a communication system that consists of telephone, LAN, Wi-Fi ports, and public address.</p> <p>The building also had a security system with security cameras located throughout the building. These security cameras can be monitored on a screen at the front desk. There were also motion detectors located in the main hallway and a security keypad located in the front office.</p> <p>Deficiencies noted included the security camera system was inoperable.</p>	2 - Poor

1. Replace distribution panelboards A and B which were manufactured by Federal Pacific.
2. Plan to replace aged panelboard SB2.
3. Replace lighting lamps as needed. Replace incandescent and florescent light fixtures with LED as needed.
4. Replace lighting fixture lenses that are missing or broken. Additionally, clean and maintain all lenses from staining and any residue build-up for efficient lighting output.
5. Replace security camera system.
