K.B. Polk Recreation Center Summary

| Address | 6801 Roper Street Dallas, TX 75209 |
| Inspection Date | July 20, 2016 |

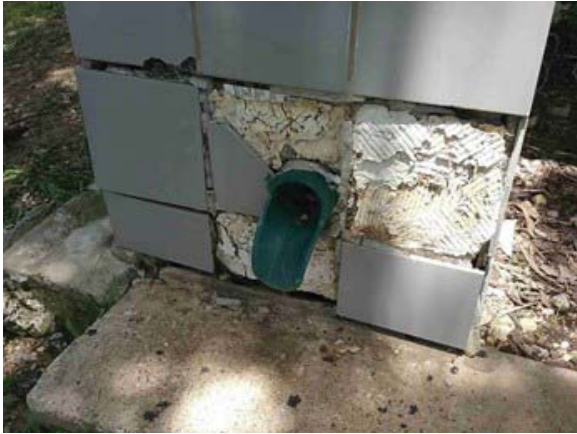
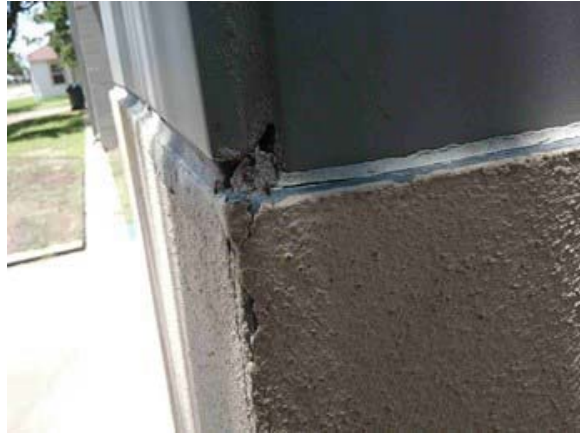
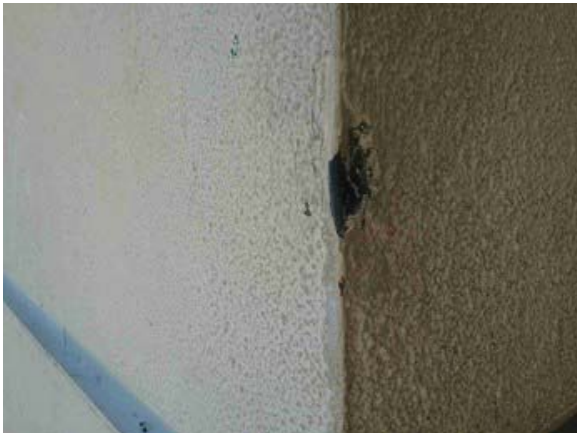
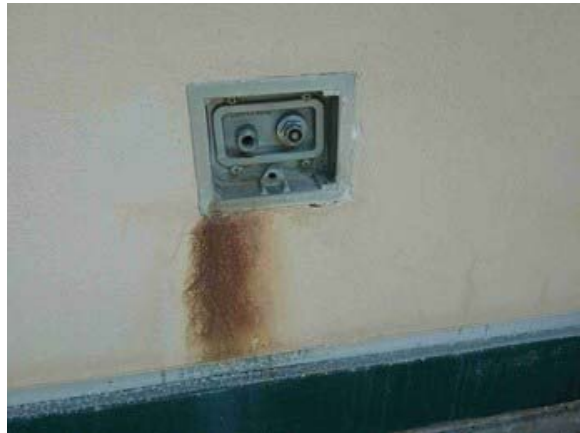
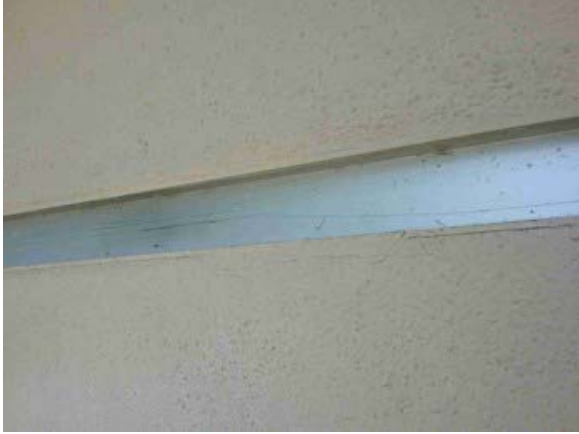
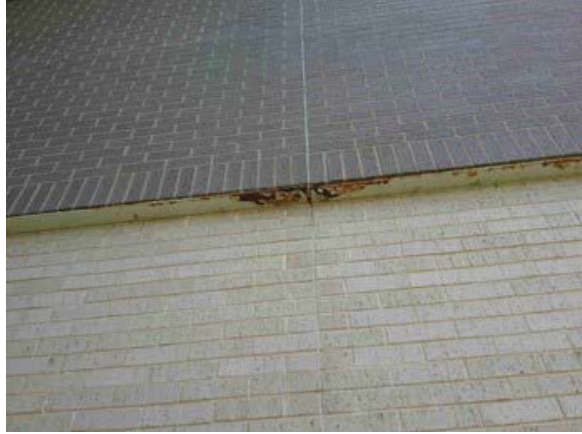
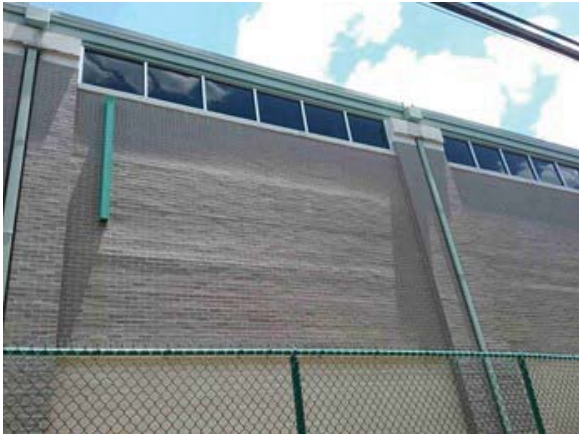
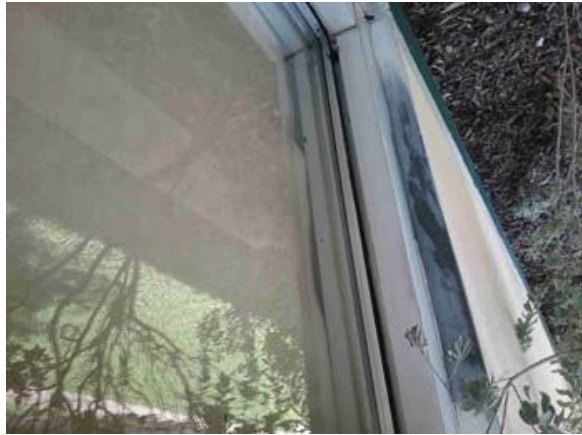
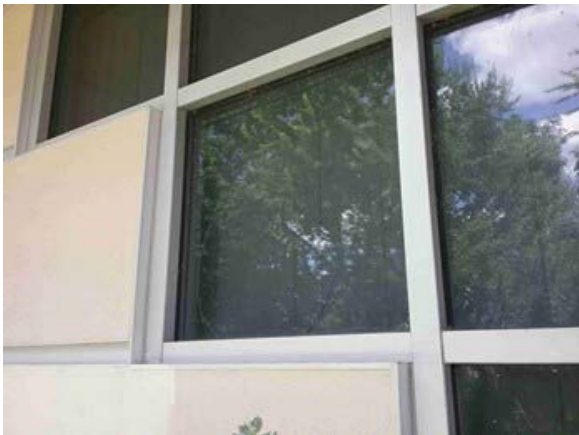
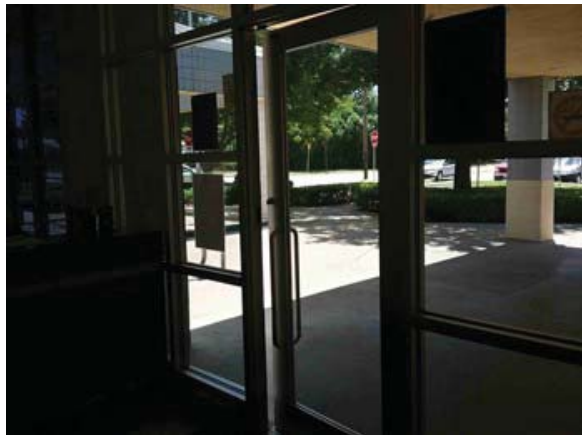
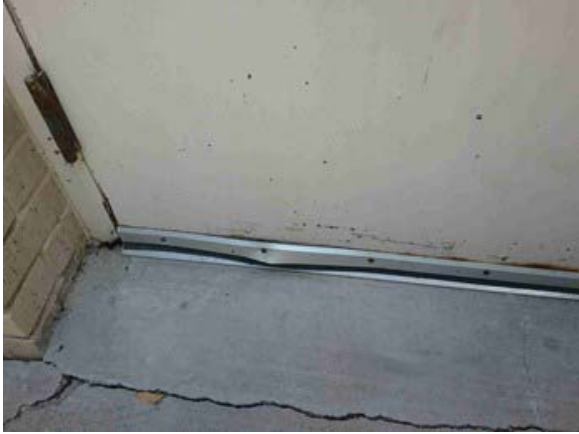
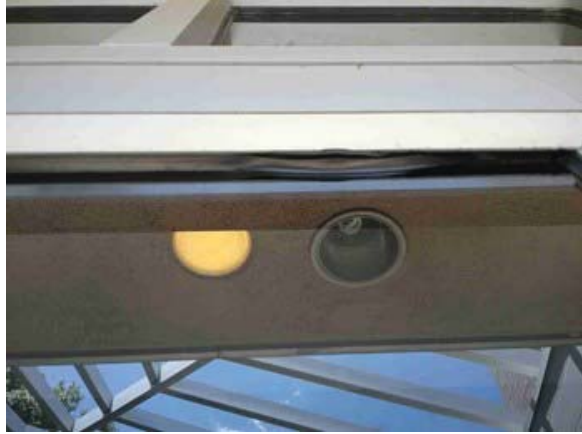
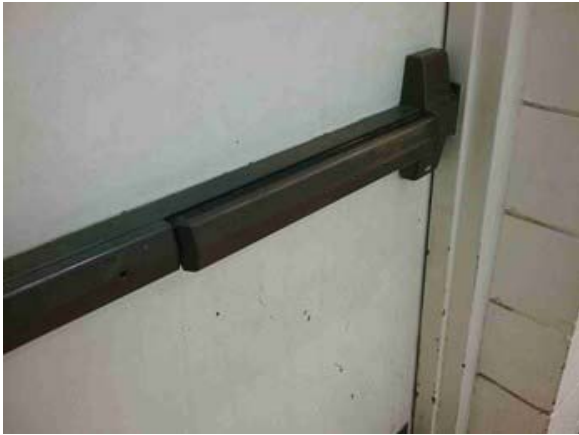
Exterior Enclosure

| Subsystem | Condition and Deficiency Overview | System Condition Rating |
|---|---|---|
| Exterior Walls | <p>The exterior walls at the south end of the building consist of plaster with metal embellishment strips at the bottom portion of the wall and tiles on the top portion of the wall and columns. The exterior walls at the gym on the north end of the building are brick.</p> <p>Deficiencies noted included chipped tiles around the perimeter of the building. Multiple tiles were missing on various columns around the building. There was grout missing sporadically on the tiles around the perimeter of the building. The main entrance columns appeared to have an ant infestation behind the tiles. There was some minor staining of the plaster and minor chips of the plaster on the corners of the building. The metal embellishment strips were scratched in some locations. The grout on the tiles under the trees was stained. There was some tile damage in the foyer area. The metal brick ledge was rusted in some locations. The surface of the brick appeared uneven.</p> | 4 - Good |
| Exterior Windows | <p>The exterior windows consist of 2-foot by 2-foot panes with aluminum frames. At the main entrance, the windows are floor to ceiling. There are additional windows around the perimeter of the building. The windows at the top of the gym wall are tinted with aluminum frames.</p> <p>Deficiencies noted included missing or loose seals around the windows. There were minor scratches on the metal window frames. The glass was cut or damaged on the east wall.</p> | 4 - Good |
| Exterior Doors | <p>There are two main public entryways located at the southeast side of the building, which are glass doors with metal frames. There are multiple additional public entrances around the perimeter of the building. The remaining service doors are primarily steel with a metal frame and located around the gym at the north end of the building.</p> <p>Deficiencies noted included rusted hardware and damage to the bottom seals on the steel doors. The south main entry door and public side entrance on the east side of the building did not close properly and had to be pulled closed. The seals around some of the glass doors were coming loose. The interior hardware on the steel doors was worn and the interior of the doors was scratched and scuffed.</p> | 3 - Average |

1. Replace chipped and missing tiles
2. Replace grout where it is missing.
3. Patch plaster where it is chipped.
4. Paint the plaster where it has been patched and where it has been stained.
5. Replace the metal embellishment strips that had scratches on them.
6. Remove existing paint and paint the brick ledge where it is rusted.
7. Monitor uneven brick on the side of the building.
8. Repair loose or missing seals on the windows.
9. Replace glass that is damaged or cut.
10. Replace and repair hardware on the public entry doors that do not close on their own.
11. Replace the hardware that is rusted or worn on the steel doors.
12. Replace loose seals on door windows where they were observed to be loose.
13. Paint the interior side of the steel doors.

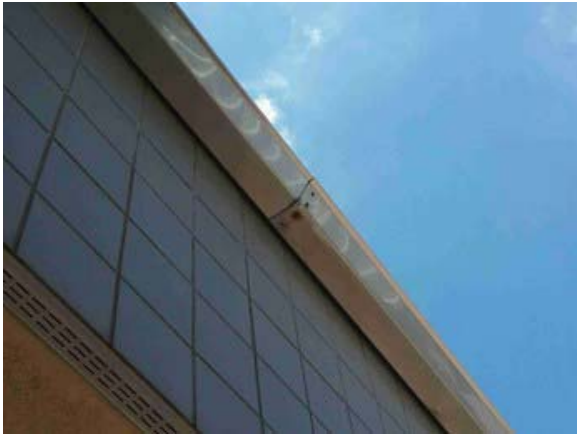
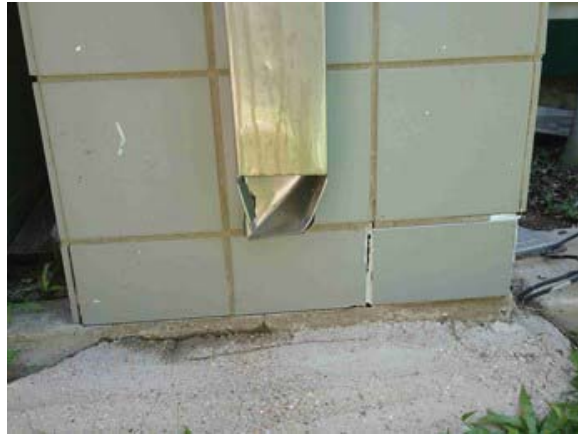
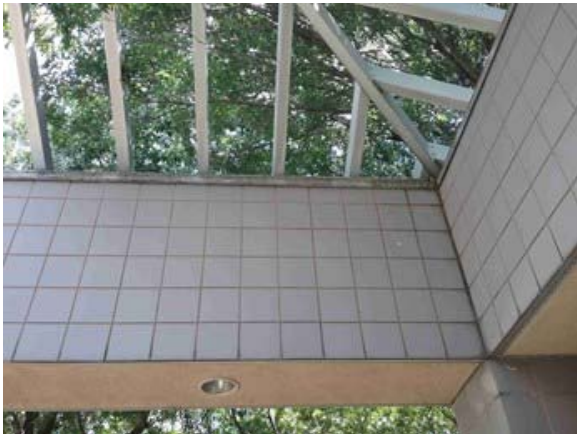
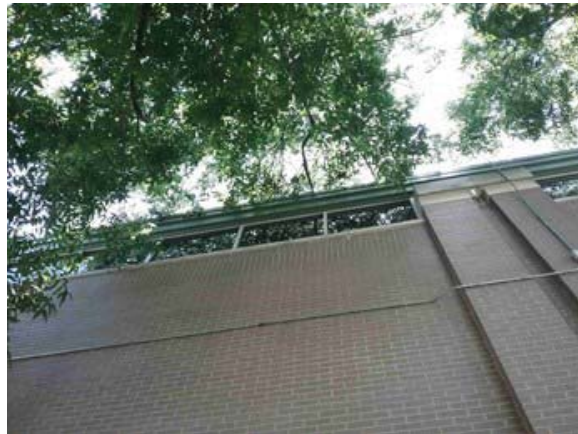
Roofing

| Subsystem | Condition and Deficiency Overview | System Condition Rating |
|---|---|---|
| Roof | <p>The roof was inaccessible at the time of the assessment. Based on previous reports provided by the client, the roof covering consists primarily of a built-up system. The roof sections on the south and east corners of the building consist of a steep-slope formed standing seam metal system. It is assumed that the roof was installed during the building renovation in 1998.</p> | 2 - Poor |

| Subsystem | Condition and Deficiency Overview | System Condition Rating |
|---|---|---|
| | <p>Other roofing features include: Metal gutters and downspouts at the south side of the building, and painted metal gutters and downspouts on the north side of the building, plaster fascia, and decorative metal pergolas on the southeast corner and east side of the building.</p> <p>Deficiencies noted included rust was observed on the metal gutters around the fasteners. One of the downspouts was damaged at the bottom of the downspout. The metal pergolas had some minor rust. The flashing above the tiles, especially under trees, was worn and stained. There were branches touching the gutters. Facility personnel noted that leaking above the gym appeared to have been fixed. Facility personnel noted multiple leaks within the main section of building during heavy rain events. It was reported by facility staff that the roof needs major repairs/replacement.</p> | |

1. Replace the fasteners in the gutter with stainless steel fasteners.
2. Replace the low slope modified bitumen roofing system.
3. Repair the damaged downspout.
4. Replace worn or stained flashing.
5. Trim trees away from the building to prevent further deterioration and debris.

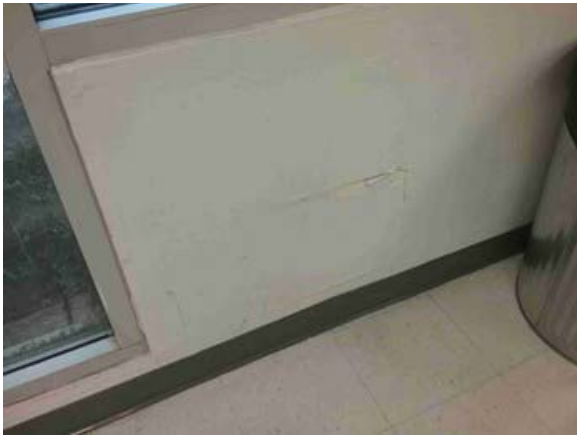
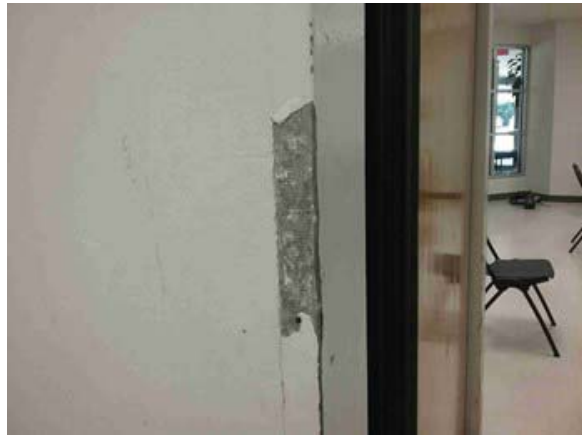
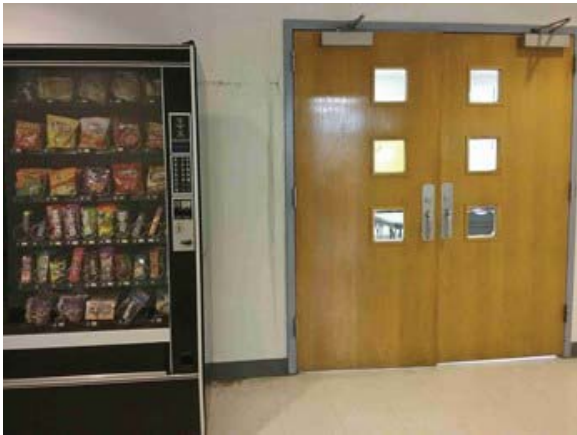
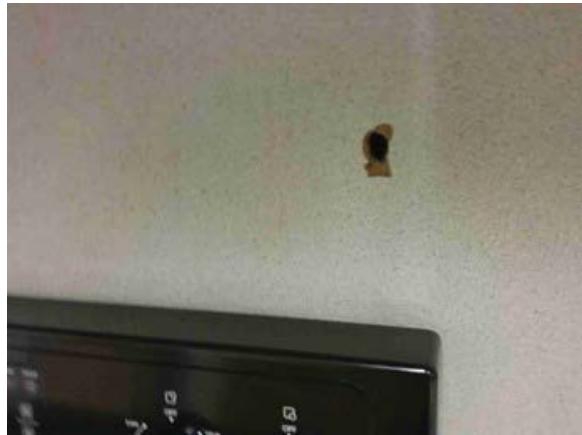
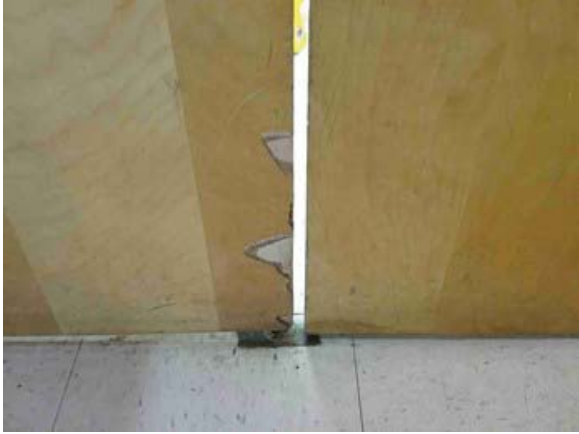
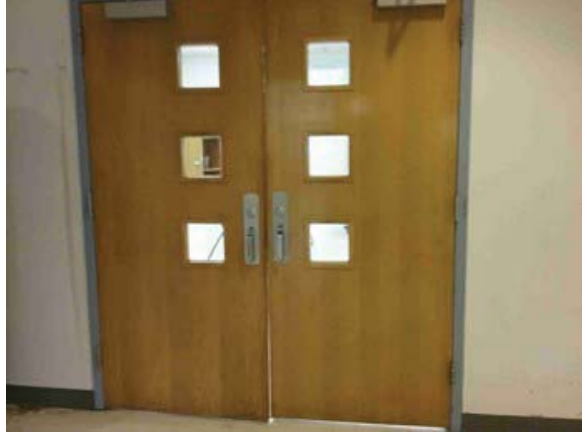
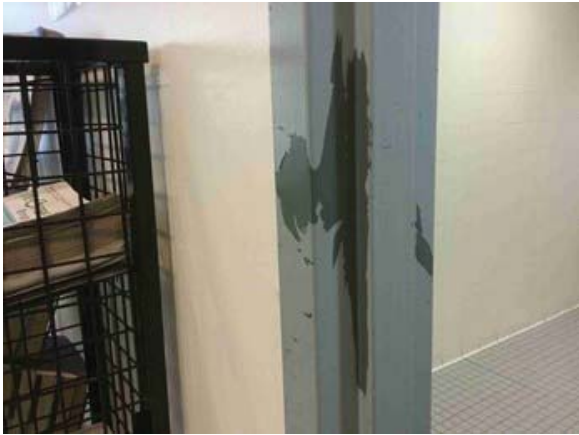
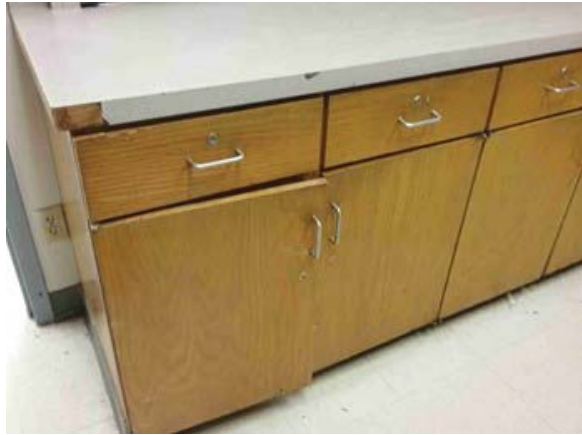
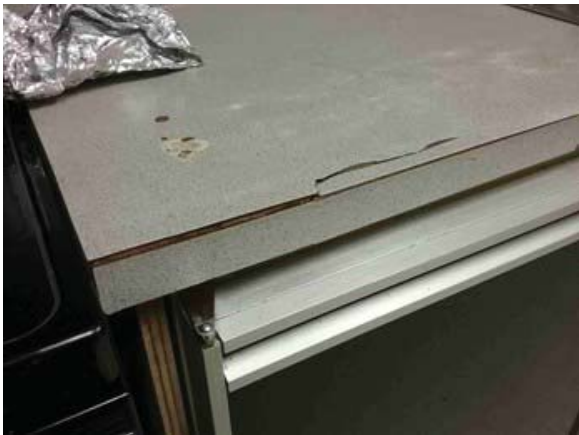
Interior Construction

| Subsystem | Condition and Deficiency Overview | System Condition Rating |
|---|---|---|
| Interior Walls | <p>The building generally consists of gypsum board interior walls. There are approximately 1-foot by 1-foot windows with aluminum frames between the hallway and the unity room. The gym walls are concrete with a tile pattern. There is a partition in the multipurpose room with wood veneer panels. The gym office has interior windows. The south office and computer room have door-height windows with metal mesh reinforced glass. The kitchen has a roll down window.</p> <p>Deficiencies noted included minor gypsum board damage throughout the building, including damage at the wall corners. There was damage to the gypsum board behind the vending machines. There was a hole in the press board wall behind the oven in the kitchen.</p> | 4 - Good |
| Interior Doors | <p>The majority of the interior doors are wood with a metal frame. Most wooden doors have approximately 7.5-inch square windows with metal mesh reinforced glass. The doors to the gym are metal with a small window and a metal frame. The doors to the HVAC room are metal with ventilation louvers. The doors to the storage closet in the gym are metal with a metal frame.</p> <p>Deficiencies noted included wooden doors were slightly worn with minor damage. The wood veneer on one door had chipped off. One multipurpose room door was unable to close all the way and was not square with the door frame. The paint on the metal frames had some minor chipping.</p> | 4 - Good |
| Interior Specialties | <p>The building has special interior construction such as cabinets in the kitchen and the unity room, stall partitions in the restrooms, and glass doors to the showers.</p> <p>Deficiencies noted included wear on the finish of the kitchen cabinets. Several kitchen cabinets were not able to be fully closed. The kitchen counter was delaminating. The cabinets in the unity room were worn and delaminating. The cabinets in the weight room were generally worn.</p> | 3 - Average |

1. Repair minor drywall damage throughout the building.
2. Patch wall corners where metal is exposed.
3. Replace drywall behind the vending machines.
4. Patch the hole in the press board behind the oven in the kitchen.
5. Replace the wooden door that has damaged veneer.
6. Repair the door or door hardware to the multipurpose room so that it is able to close properly.
7. Paint the metal door frames.
8. Replace the kitchen, unity room and weight room cabinet doors that are damaged. Replace the hardware on cabinet doors that do not close properly.
9. Replace the damaged veneer to match the existing on the countertops in the kitchen, unity room and weight room.

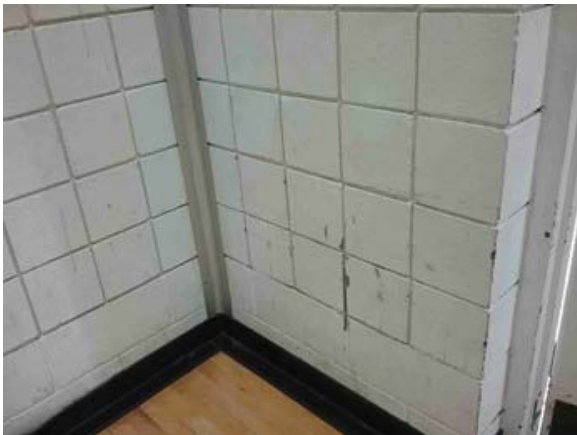
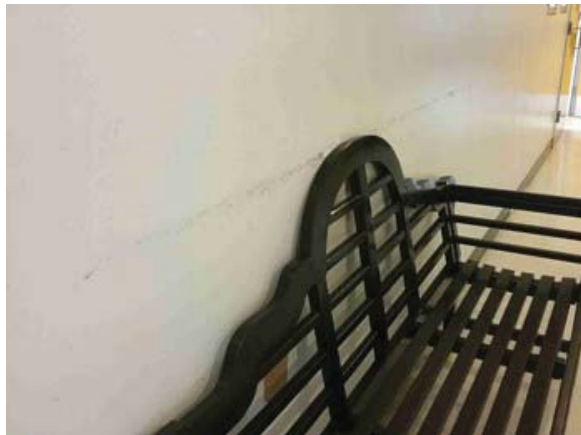
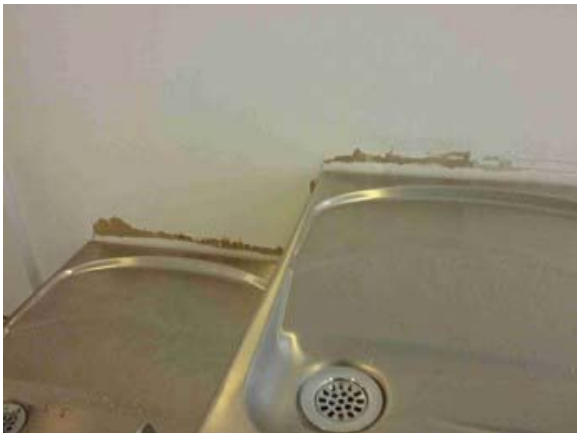
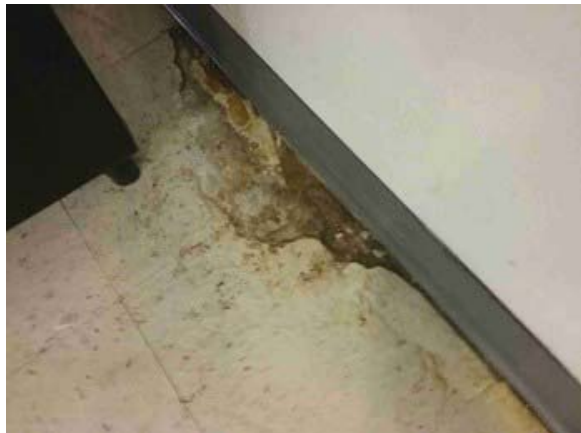
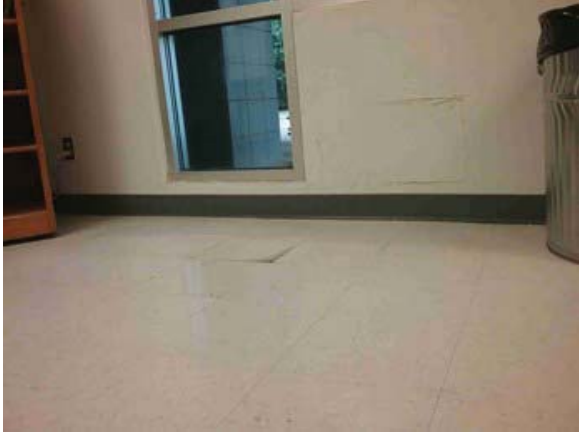
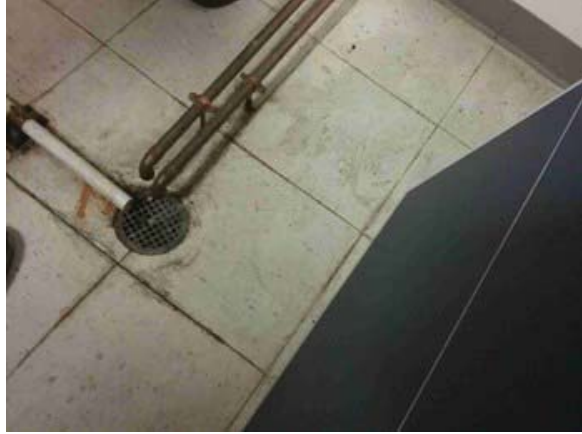
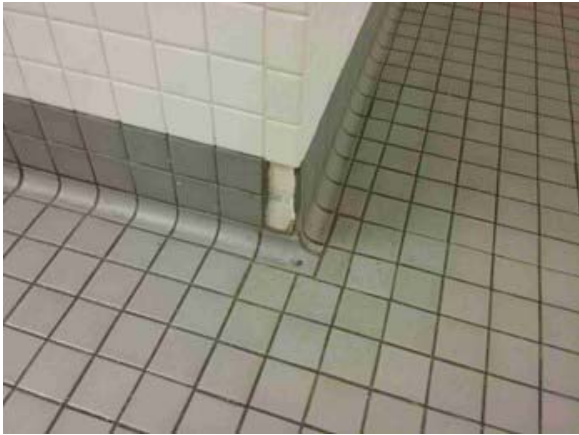
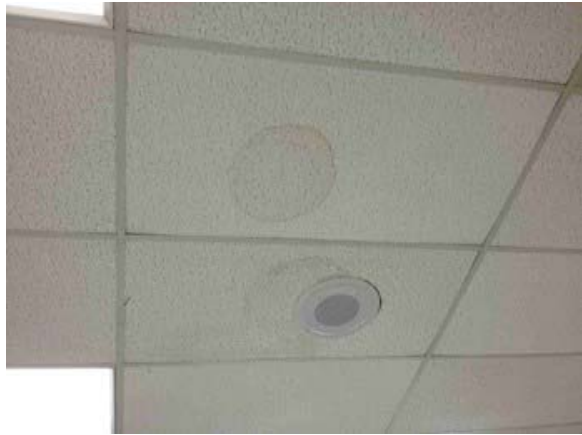
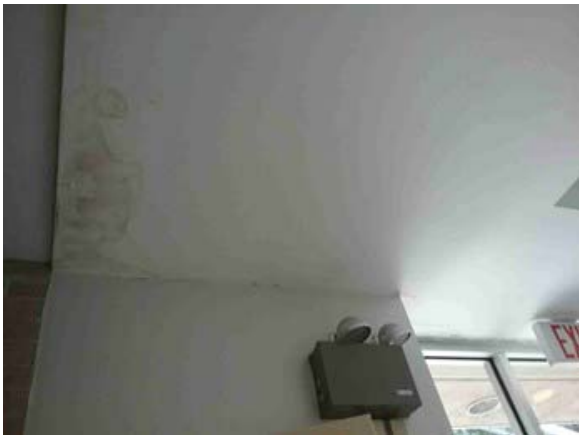
Interior Finishes

| Subsystem | Condition and Deficiency Overview | System Condition Rating |
|---|---|---|
| Interior Wall Finishes | <p>The building generally contains painted gypsum board interior wall finishes. The gym walls appear to be painted concrete. The restrooms have 2-inch square ceramic tile interior wall finishes.</p> <p>Deficiencies noted included some scuffing and minor chipping of the paint on the concrete gym walls. The paint on the gypsum board walls had some minor scuffs. The gypsum board paper was exposed behind the water fountains.</p> | 4 - Good |
| Interior Floor Finishes | <p>The building generally contains vinyl-composition tiles (VCT) interior floor finishes. The main lobby contains ceramic tiles floor finishes. The weight room has rubber flooring. The gym contains sealed wood flooring. The HVAC room and janitorial closets have unfinished concrete floors. The office contains carpet floor finishes. The bathrooms have 2-inch square ceramic tile.</p> <p>Deficiencies noted included chipped VCT behind the vending machine. The VCT in the multipurpose room was bulging by the east wall possibly due to water damage. The VCT was damaged at the condensate drain in the storage room by the gym. The restroom tiles had very minor damage, such as a few missing tiles.</p> | 4 - Good |
| Interior Ceiling Finishes | <p>The building generally contains suspended acoustical ceiling tiles (ACT) ceiling finishes. The lobby and hallways have finished gypsum board interior ceilings. The gym has exposed metal decking.</p> <p>Deficiencies noted included water stains present on ACT in multiple locations throughout the building. A few ceiling tiles were damaged. There was some water damage apparent on the gypsum board ceiling in the hallway outside the gym.</p> | 4 - Good |

1. Paint the concrete gym walls.
2. Paint the gypsum board walls throughout the building.
3. Repair and paint the gypsum board behind the water fountains.
4. Replace the vinyl-composition tiles (VCT) behind the vending machine and in the multipurpose room.
5. Determine if subflooring requires repair under the damaged VCT in the multipurpose room, and make necessary repairs.
6. Replace the VCT at the drain in the storage room by the gym.
7. Replace missing ceramic tiles in the restroom.
8. Replace water stained ACT.
9. Replace and paint gypsum board ceilings to match existing where water stains are present, after the source of water intrusion has been addressed.

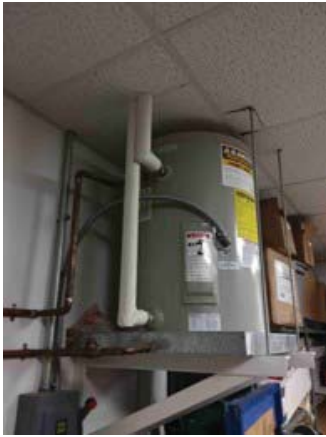
Plumbing

| Subsystem | Condition and Deficiency Overview | System Condition Rating |
|---|--|---|
| Domestic Water Distribution | The plumbing system has a domestic water service feed to three tank-type water heaters located throughout the building. All three water heaters have 30-gallon tanks. The water heater located in the gym storage room has 4.5-kW electric heating. The remaining water heaters are both Lochinvar gas-fired water heaters with 32-MBH gas-heating input. Deficiencies noted included the electric water heater located in the gym storage room was aged and had surpassed its typical design service life. | 3 - Average |

1. Plan for replacement of the 30-gallon electric water heater, which has surpassed its typical design service life.

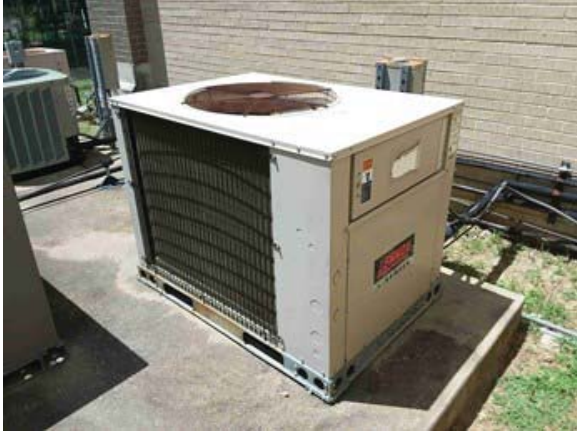
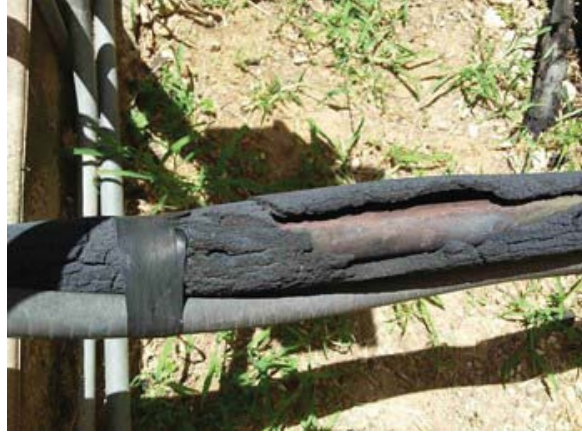
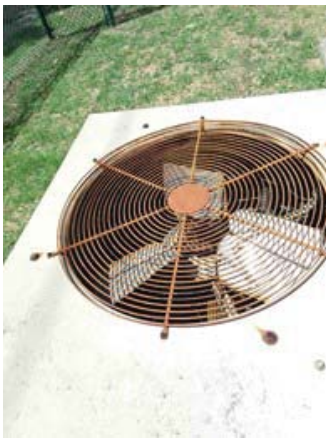
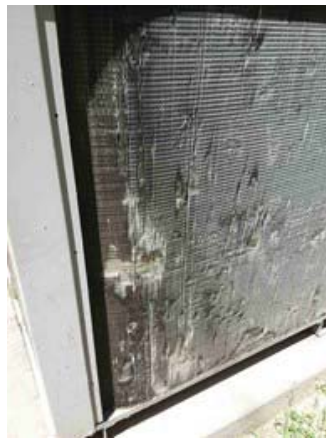
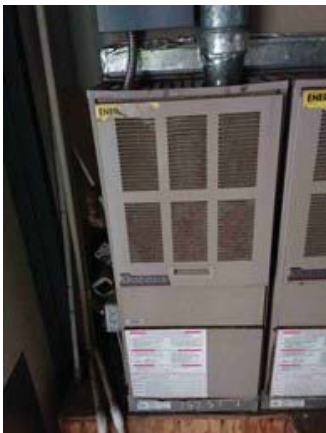
Mechanical/HVAC

| Subsystem | Condition and Deficiency Overview | System Condition Rating |
|---|--|---|
| Mechanical / HVAC | The major mechanical equipment consists of gas furnaces equipped with evaporative coils, condensing units and air handling units to service all of the heating, ventilating, and air conditioning (HVAC) system. The condensing units have direct-expansion cooling and are located on grade in two main mechanical areas. There are eight condensing units located near the gym and two units located in a locked cage. The locked units were inaccessible for assessment. The condensing units have cooling capacities ranging from 4-ton to 10-ton. The air handling units are located in the gym joist space and have electric heating. The gas furnace units equipped with evaporator coils are located in mechanical closets throughout the building. The gas furnace units have heating capacities ranging from 75-MBH to 160-MBH. Supplemental mechanical equipment for the HVAC system also includes a direct-expansion mini-split system serving the gym area. Deficiencies noted included the aged HVAC equipment that used R22 refrigerant which is being phased out of manufacturing and construction use. Several condensing units were observed with damaged refrigerant insulation, signs of corrosion, and had damaged condenser fins. Several gas furnace units and evaporator coils were past their typical design service life. | 3 - Average |

1. Plan for replacement on all HVAC using R-22 refrigerant which is being phased out of manufacturing and construction use.
2. Replace damaged refrigerant pipe insulation to properly insulate and protect the piping.
3. Repair and repaint the surface rust on the compressor covers of the condensing units.
4. Repair the damaged condensing unit fins.
5. Plan to replace aged gas furnace units equipped with aged evaporator coils that have extended past the end of their typical design service life.

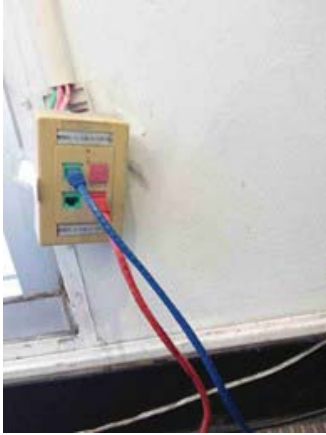
Electrical

| Subsystem | Condition and Deficiency Overview | System Condition Rating |
|---|---|---|
| Communications & Security | <p>The building has a communication system that consists of telephone, LAN, Wi-Fi, and a public address system.</p> <p>The building has a security system that consists of interior cameras, keypad access, and a central security control station.</p> <p>Deficiencies noted included damaged LAN outlets that were not properly secured into the wall.</p> | 4 - Good |

1. Replace damaged LAN outlets.
