Kiest Park Recreation Center Summary

Address	3080 South Hampton Road Dallas, TX 75224
Building Purpose	Recreation Center
Original Year of Construction	1998
Building Area	39,198 SF
Inspection Date	August 1, 2016
Inspection Conditions	100°F, Sunny

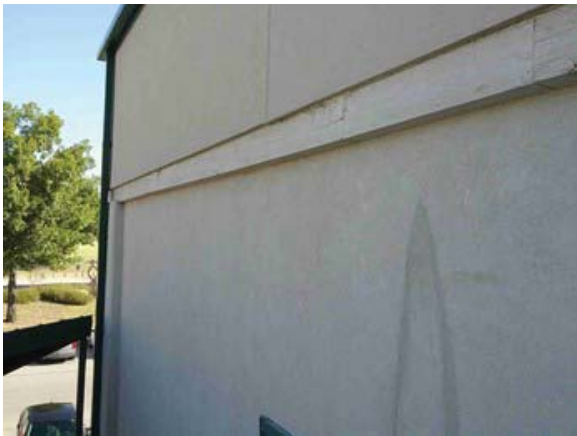
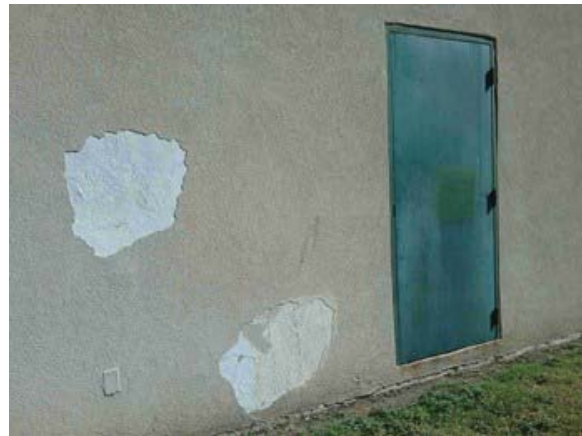
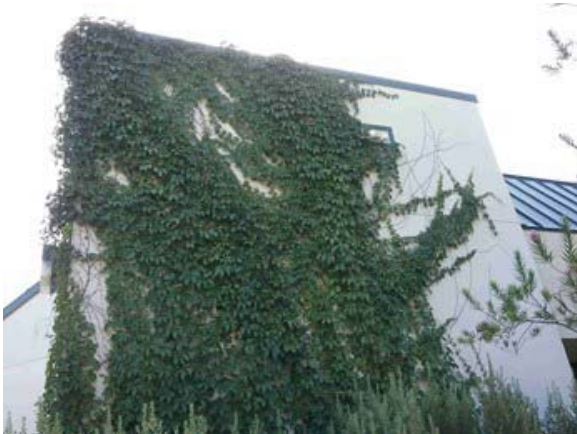
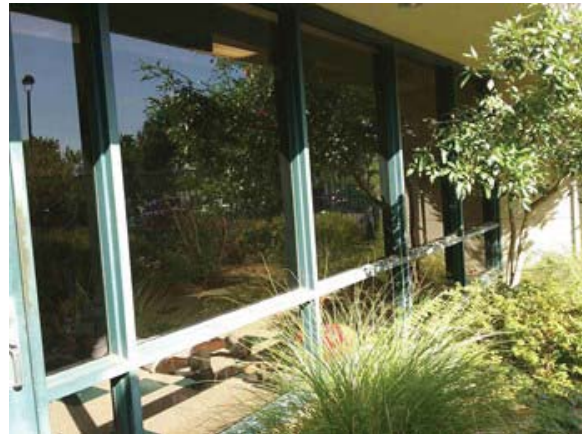
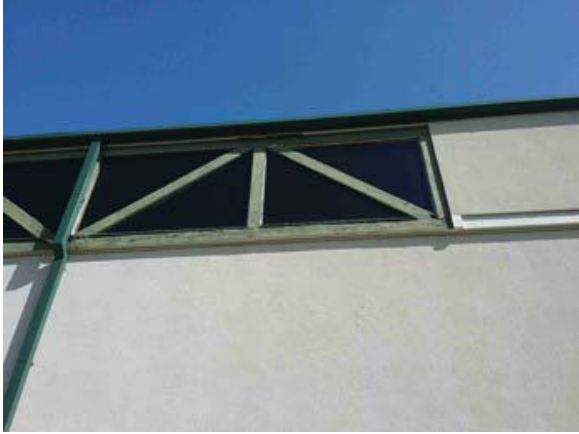
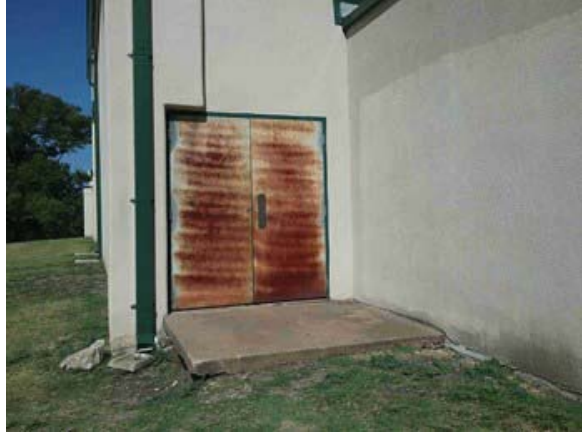
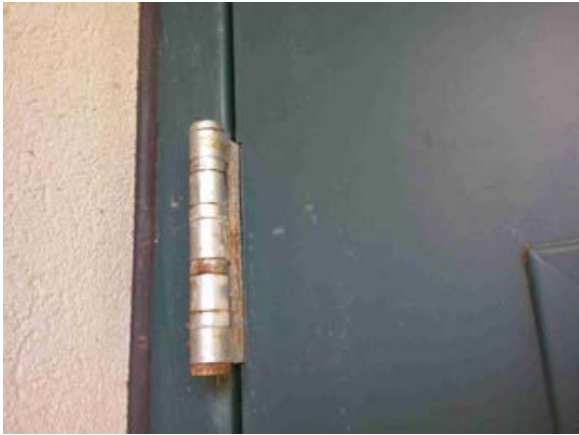
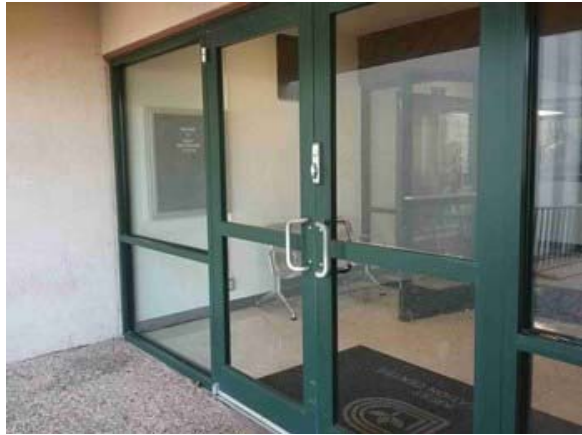
Subsystem	Condition and Deficiency Overview	System Condition Rating
B20 Exterior Enclosure		
Exterior Walls	<p>The exterior walls generally consist of painted plaster. Deficiencies noted included paint cracking and wear observed on the wood beam attached to the building. The plaster walls were stained in several locations and had mismatched paint. There were multiple chips in the plaster around the perimeter of the building; ranging from 2 inches to 2 foot in diameter. Ivy was growing on the northwest side of the building.</p>	3 - Average
Exterior Windows	<p>The exterior windows at the main entrance consist of floor to ceiling windows on either side of the main entry door. At the roof elevation, there are triangular window panes with metal frames and flashing over the windows. There are floor to ceiling windows with metal frames on the north and west sides of the building. There are store front windows around the south doors, on the west wall. There are four approximately 4-foot by 7-foot windows on the southwest wall. There are windows at the top of the gym walls with triangular glass panes and wood frames. Deficiencies noted included worn metal on the window frames. The wood frames near the roof level on the south side of the building appeared worn and had cracks between the beams. The frame above these windows was damaged.</p>	3 - Average

Exterior Doors	<p>There is one main public entryway located at the north side of the building, which consists of double glass doors with a metal frame. There is a glass door with metal frame and another set of Exit Only glass doors, used for public access on the west wall. The remaining service doors are primarily steel with metal frames and located along the north, south and east walls. Some exterior service doors have a metal mesh reinforced glass window and one door has two windows. Deficiencies noted included wear observed on the service doors and frames. The surface of the doors varied from slightly rusted to large areas of rust. The hinges on several of the doors were slightly rusted. The front entry doors were not equipped with automatic/handicap accessible door hardware.</p>	4 - Good
B30 Roofing		
Roof	<p>The roof covering is primarily modified bitumen. The roof is assumed to be original to construction. There are exposed wooden beams in the lobby and the gym. Several roof sections around the building consist of standing seam metal roofing. There are fixed metal ladders to access the multiple levels of the roof. Other roofing features include access hatches on the lower roof section and the west upper roof section, a parapet around the west section of the roof, flashing between the roof sections, and gutters around the west</p>	4 - Good

1. Seal wood beam around gym roof perimeter to prevent any further wear.
2. Repair chips in the plaster and paint the exterior of the building
3. Trim or remove ivy growing up the side of the building.
4. Paint the metal frames around the windows.
5. Patch the holes in the wood frames of the windows around the gym and reseal or paint the wood.
6. Paint the service doors and frames.
7. Replace rusted hinges on all exterior doors.
8. Replace the main entry door hardware with automatic/handicap accessible hardware.

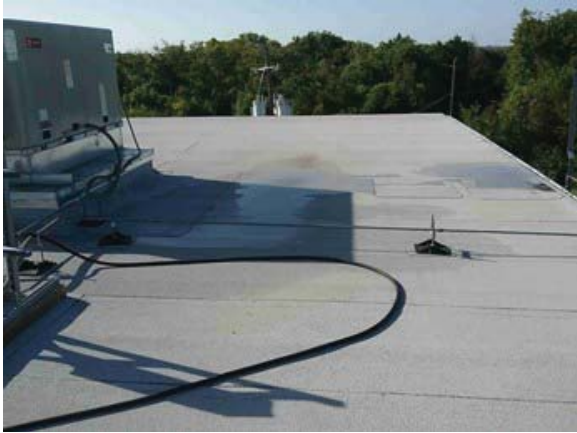
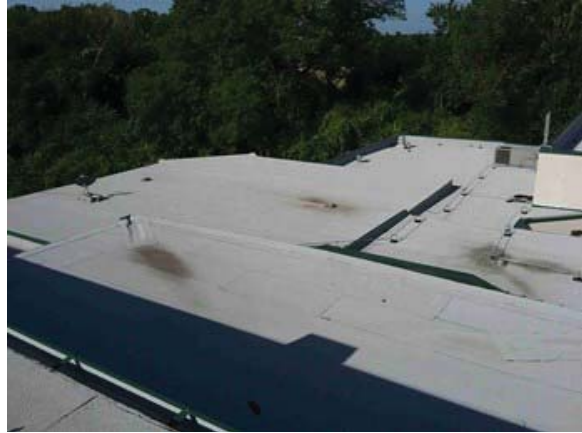
Subsystem	Condition and Deficiency Overview	System Condition Rating
	<p>upper section of the roof.</p> <p>Deficiencies noted included ponding observed on the upper roof level around the mechanical equipment. It was observed that the water originated from the condensate drains on the four air conditioning units. There was dirt accumulated around the roof drains. The facility personnel were not aware of any water intrusion from the roof. It was reported by facility staff that there was water intrusion in the gym, but it has since been repaired.</p>	
C10 Interior Construction		
Interior Walls	<p>Interior wall construction is primarily concrete or concrete unit masonry (CMU). There are windows from the lobby into the fitness center and the small room.</p> <p>The windows to the fitness center and small room have a decorative film over the glass. The office has a store front window surrounding the door. There are windows surrounding the office behind the check-in desk. The large activity room has a partition wall. The gym has a fabric partition wall. There is a retractable metal window between the kitchen and the gym.</p> <p>Deficiencies noted included minor corner damage that was observed at the walls at the entrance of the racquetball court.</p>	4 - Good

1. Confirm source of water from mechanical equipment and route water to a drain.
2. Confirm roof drains are able to freely drain. Clean out roof drains if they are clogged.

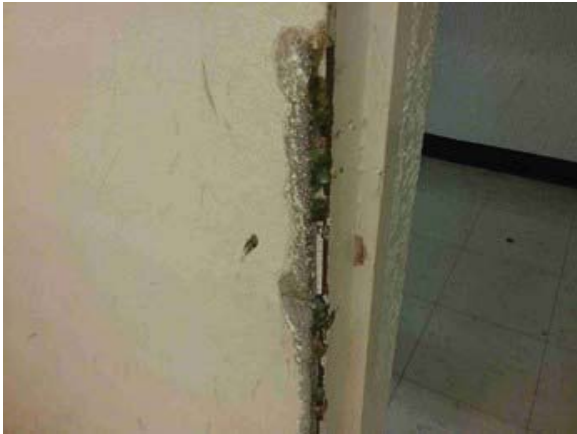
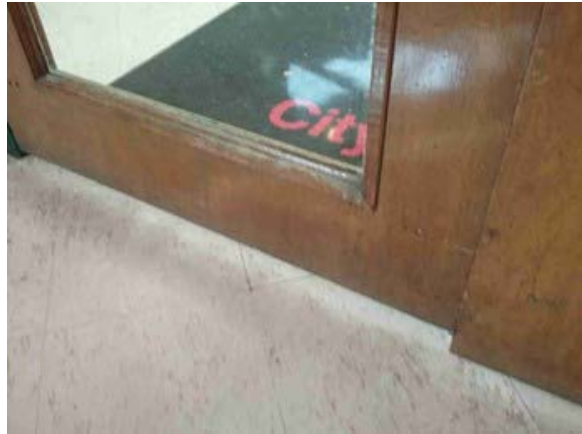
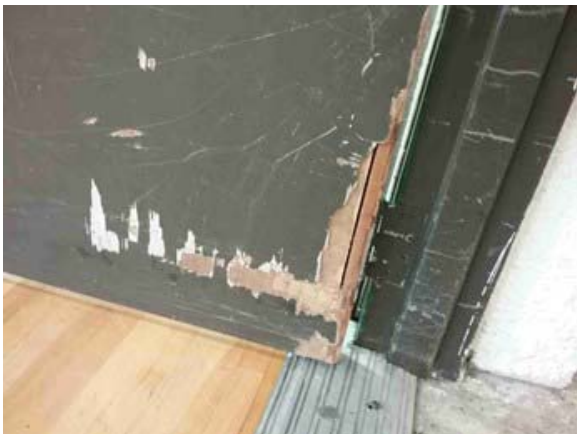
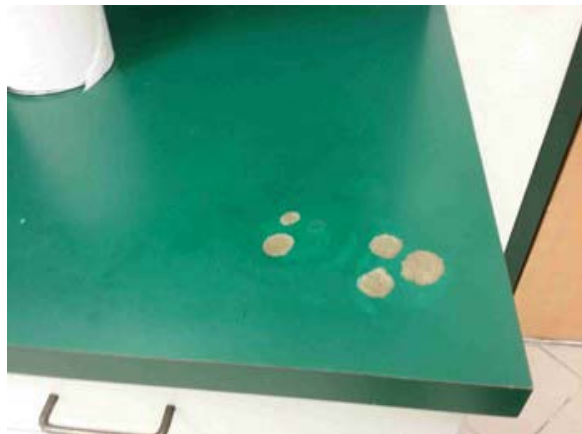
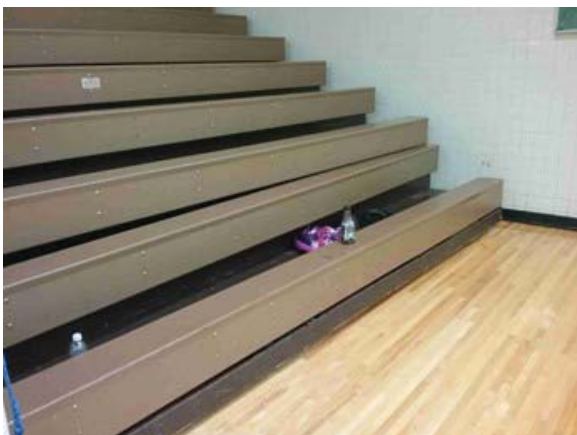
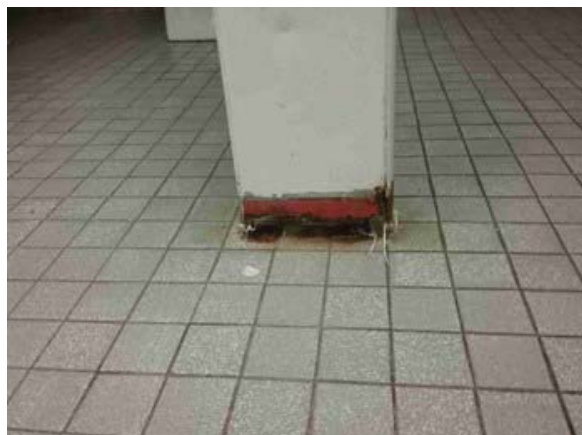
Interior Doors	<p>The interior doors are primarily wood with a metal frame. The doors for the fitness center and small room are wood with large windows and a metal frame. The doors to the gym are double wood doors with a window on each door that has frosted Plexiglas. The racquetball court door is wood and approximately 5-feet tall with a double glass window. There is an electric overhead door that separates the east wing from the rest of the building.</p> <p>Facility personnel reported that the overhead door is operable but a key was not available at the time of the assessment to verify operation.</p> <p>Deficiencies noted included wear observed on the wood doors. The veneer on the door to the storage room in the gym was damaged and the paint on the veneer was chipping at the bottom of the door.</p>	4 - Good
Interior Specialties	<p>The building has special interior construction such as cabinets and counters in the two kitchens, metal bleachers in the gym, partitions between the stalls in the restrooms, and a fire extinguisher cabinet in the kitchen.</p> <p>Deficiencies noted included wear observed on the laminate counter in the main kitchen. It appeared that one row of the bleachers in the gym was not able to extend fully. It was unclear if the other bleachers were fully operational. Rust was observed at the bottom of the vertical supports of the partitions in the restroom by the gym. It appeared that the hardware on the partitions in the restrooms near the gym were replaced since their original installation.</p>	3 - Average

1. Repair the corner damage to the concrete wall at the racquetball court entrance.
2. Monitor the wear observed on the wood doors.
3. Replace the damaged door to the storage room in the gym.
4. Replace the counter section that is damaged in the main kitchen.
5. Repair bleachers so that they are fully operational.
6. Replace the stall partitions in the restroom by the gym.

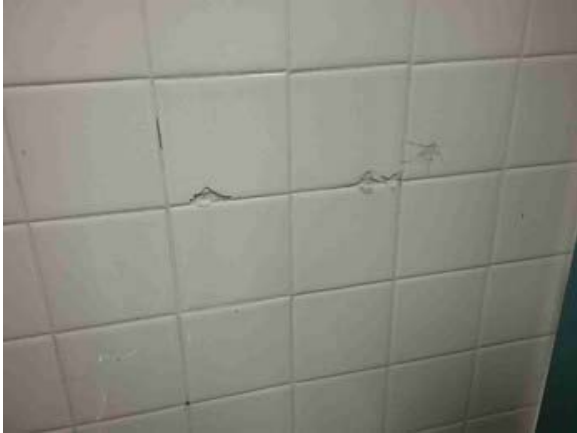
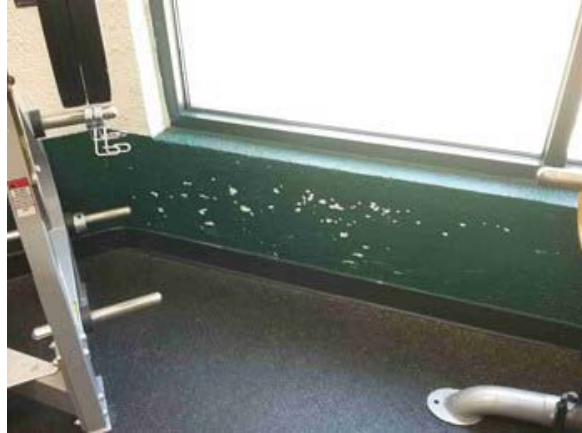
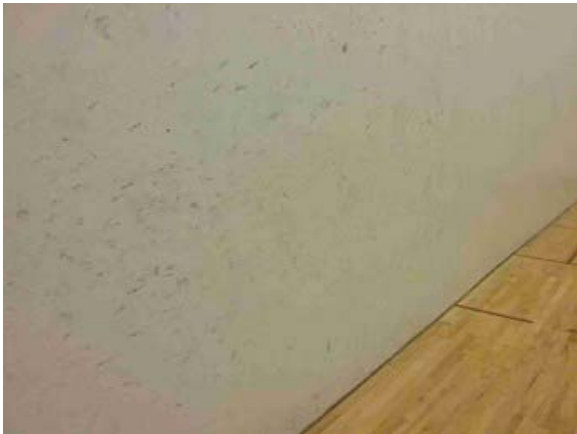
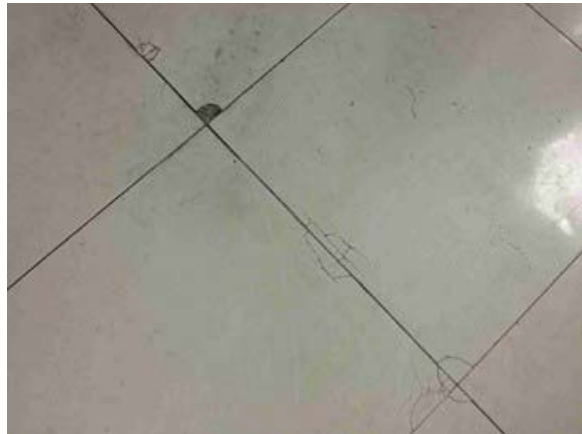
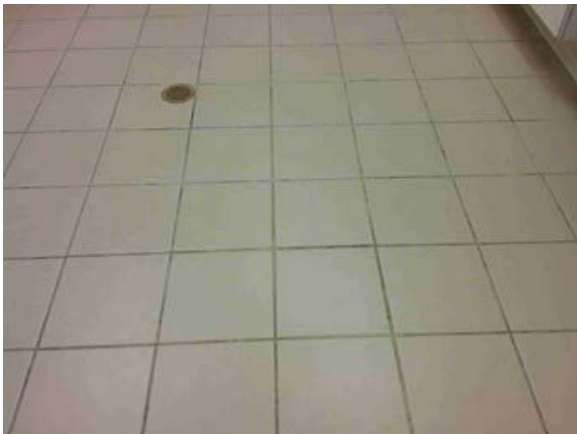
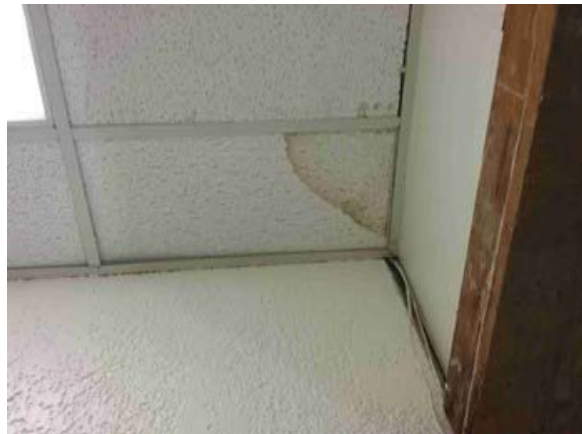
Subsystem	Condition and Deficiency Overview	System Condition Rating
Interior Stairs	System not present.	N/A
C30 Interior Finishes		
Interior Wall Finishes	<p>Interior wall finishes are primarily painted gypsum board or plaster. The main lobby has wood paneling beginning approximately 8-foot from the floor. The storage closet has painted concrete masonry unit (CMU) walls. The gym has 4-inch square ceramic tiles from the ground up approximately 8-foot. The walls above the tiles are painted plaster. There is wood paneling on the upper portion of the walls. The restrooms have 4-inch square ceramic tiles covering the walls. The racquetball court has a smooth finished plaster over the concrete walls. The kitchen in the fitness center has wallpaper.</p> <p>Deficiencies noted included chips observed on several of the 4-inch square tiles in the restrooms. The paint over the plaster in the fitness center had minor chipping. The walls in the racquetball court had scuffmarks on the paint.</p>	4 - Good

Interior Floor Finishes	<p>The building primarily contains vinyl composition tile (VCT) flooring. The kitchens and restrooms have ceramic tile flooring. The gym and racquetball court have finished wood floor. The fitness center has rubber gym flooring. The storage room behind the gym has unfinished concrete.</p> <p>Deficiencies noted included minor and limited damage observed to the VCT flooring throughout the building. The grout around the tiles in the kitchens and bathrooms was stained.</p>	4 - Good
Interior Ceiling Finishes	<p>The interior ceiling finishes are primarily suspended acoustical ceiling tiles (ACT) ceilings. The ceiling in the main lobby is finished with wood paneling. The ceilings in the bathrooms are painted gypsum board. The gym has wood paneling on the ceilings with exposed wood beams.</p> <p>Deficiencies noted included several instances of isolated staining to ceiling tiles throughout the building. Stains appear to have been caused by water damage in the hallway near the fitness center, and in the office by the small room. Several ceiling tiles appeared worn or did not match the coloring of the other tiles.</p>	4 - Good

1. Replace the damaged tiles in the restrooms.
2. Paint the fitness center walls.
3. Clean or repaint the scuffed racquetball court walls.
4. Replace damaged VCT.
5. Clean the grout in the kitchens and the restrooms.
6. Replace stained or worn ceiling tiles.

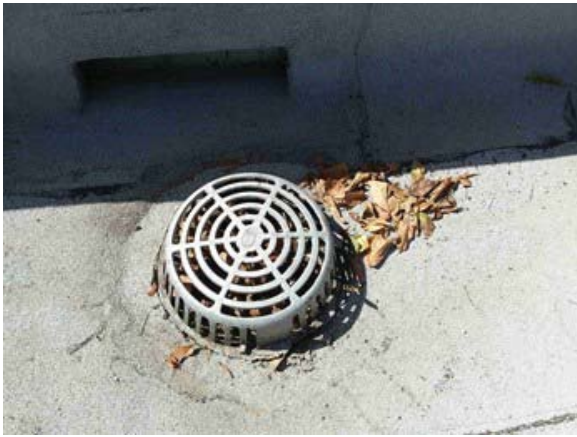
Other Plumbing	<p>Other plumbing assets include roof drains, floor drains, and a waste pump for the ice maker. Floor drains are located in the public restrooms.</p> <p>Deficiencies noted included a clogged roof drain.</p>	4 - Good
D30 HVAC		
Mechanical / HVAC	<p>The major mechanical equipment consists of electric furnaces, condensing units, air handling units and package units to service all of the heating, ventilating, and air conditioning (HVAC) system.</p> <p>The direct-expansion package units have cooling capacities ranging from 4-ton to 10-ton with heating capacities ranging from 15.9-KW to 27-KW. All eight package units are located on the roof and have electric heating. Both direct-expansion condensing units have 10-ton cooling capacities and are located on the roof. Both air handling units have corresponding condensing units and are located in dedicated closets. Each air handling unit is equipped with 26.2-KW supplemental electric furnaces for heating. Supplemental mechanical equipment for the HVAC system also includes two roof-mounted exhaust fans serving the restrooms.</p> <p>Deficiencies noted included the majority of package units with condensate leakage issues. Several package units also had hail damage to the condenser fins. One package unit had a damaged economizer screen while another unit had its economizer hood completely detached. Both condensing units had refrigerant insulation issues. Along with lacking insulation, one condensing unit did not have its refrigerant piping properly supported. Both air handling units were observed aged and out-of-date. Several pieces of mechanical equipment use R-22 refrigerant, which is being phased out of manufacturing and construction use.</p>	3 - Average

1. Remove leaves and debris from the clogged roof drain.

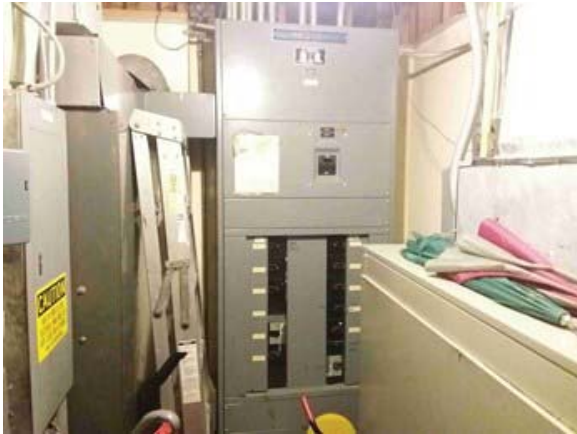
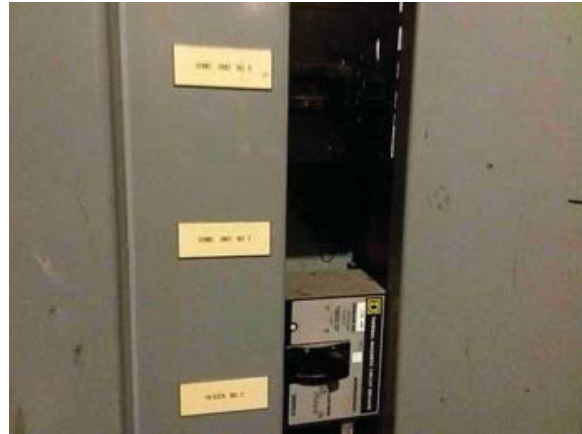
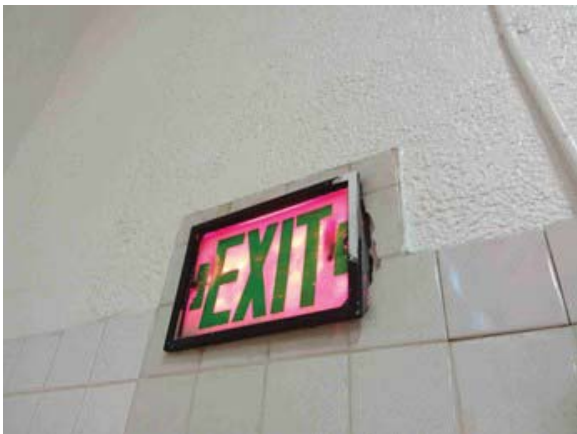
Subsystem	Condition and Deficiency Overview	System Condition Rating
	<p>devices such as horns, annunciators, strobes, horn/strobe combos, pull stations, and detectors.</p> <p>The fire alarm system control equipment includes an addressable single zone Fire Lite fire alarm control panel.</p> <p>No deficiencies were observed or reported at the time of the assessment.</p>	
Fire Protection/Suppression	<p>The building does not have a fire suppression system. The building has portable fire extinguishers for fire protection.</p> <p>No deficiencies were observed or reported at the time of the assessment.</p>	N/A
D50 Electrical		
Electrical Distribution	<p>The electrical service enters the building from overhead service on the exterior feeding the 1000A 120/208V main switchgear which is in the main electrical closet and delivers power to sub panelboards throughout the building. Additionally, the building has an emergency UPS located in the control center that provides back-up power to a small IT rack.</p> <p>Deficiencies noted included the aged main switchgear. A missing breaker within the main switchgear exposed live parts and presented a life safety hazard.</p>	3 - Average

1. Replace the dated switchgear, as it appears past the end of its typical design service life.
2. Install proper breaker covers in the main switchgear to eliminate safety hazards due to exposing live bussing.
3. Service the exit and emergency lighting to ensure all fixtures work in case of emergency.
