Lake Highlands North Recreation Center Summary

Address	9940 White Rock Trail Dallas, TX 75238
Building Purpose	Recreation Center
Original Year of Construction	1971
Building Area	33,036 SF
Inspection Date	June 14, 2016
Inspection Conditions	91°F, Cloudy

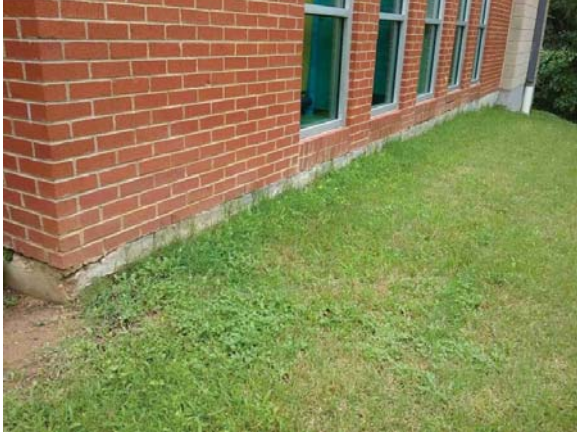
Subsystem	Condition and Deficiency Overview	System Condition Rating
B20 Exterior Enclosure		
Exterior Walls	The exterior walls consist of CMU walls with a brick veneer. Deficiencies noted included instances of spalling on the foundation around the perimeter of the building.	4 - Good
Exterior Windows	The exterior windows on the east and north east facades of the building have metal frames. The gym portion of the building has no windows and the entrance has small glass block windows. Deficiencies noted included minor environmental wear based upon the age of the building. It was reported that the windows had other degradations that could not be confirmed at the time of assessment.	3 - Average
Exterior Doors	There are two main public entryways located at the north-east and south-west side of the building, which are metal framed, glass doors. The remaining service doors are primarily metal and located along the entire perimeter. Deficiencies noted included minor wear and tear based upon frequent use.	4 - Good

1. Repair exposed foundation on the exterior of the building to prevent further spalling.

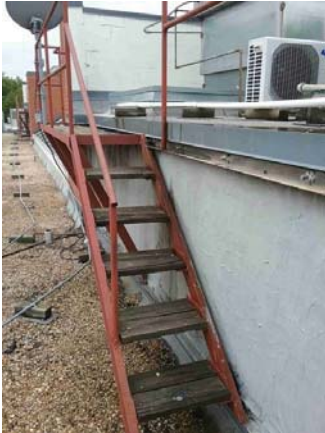
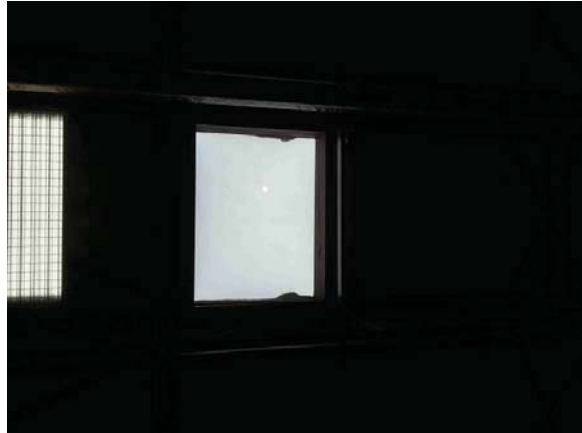
B30 Roofing		
Roof	Approximately three quarters of the roof construction is a built-up tar and gravel system. The other approximately one quarter of the roof is a single-ply membrane material. There is one large skylight and several smaller skylights, which are a part of the roof over the gym. A corrugated metal canopy covers the main entrance. There are two small sets of rooftop stairs, which lead to HVAC units. Deficiencies noted included standing water on the single-ply membrane roof covering. There are also several cracks on various parts of the skylights above the gym, which allow for water intrusion. The roof stairs are corroded.	3 - Average
C10 Interior Construction		
Interior Walls	The building consists of brick and painted CMU interior walls. There appears to be an addition where the interior walls are gypsum board. No deficiencies were observed or reported at the time of the assessment.	4 - Good

1. Repair or replace the broken stairs that lead to the HVAC units.
2. Repair the cracked skylights above the gym.

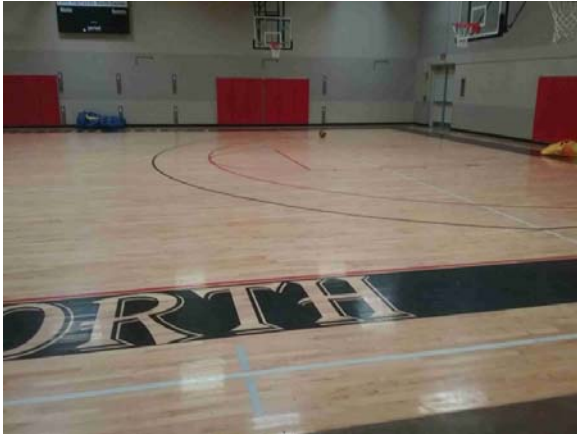
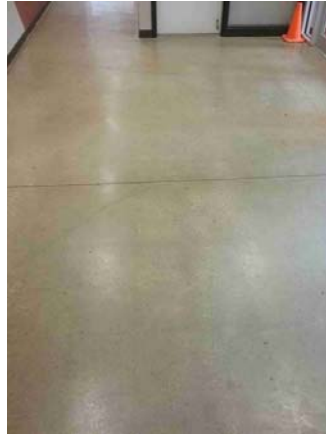
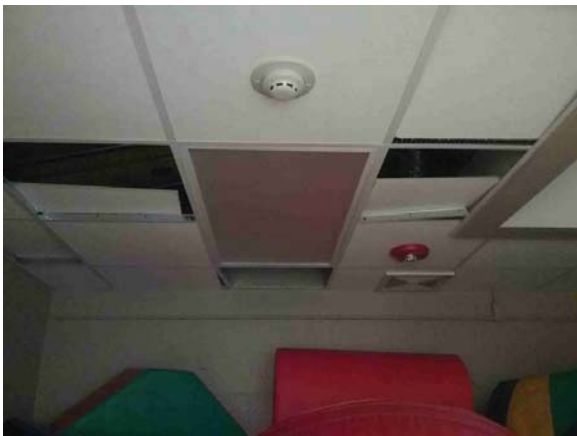
Subsystem	Condition and Deficiency Overview	System Condition Rating
Interior Stairs	System not present.	N/A
C30 Interior Finishes		
Interior Wall Finishes	Wall finishes include exposed brick and painted CMU. There are painted gypsum board walls in the office and kids area. The gym area is entirely painted CMU block finish. Deficiencies noted included minor discoloration at joints.	4 - Good
Interior Floor Finishes	The main hallway contains finished concrete flooring with linoleum tile. The gym has a wood finish, the fitness center has rubber matting, and the dance room has a wood tile floor. Deficiencies noted included cracking on the finished concrete floor in the main hallway and an uneven floor in the gym with dead spots. It was reported that the gym had suffered flooding and repair was performed insufficiently causing these issues.	3 - Average
Interior Ceiling Finishes	The majority of the building contains acoustical ceiling tile (ACT) with instances of gypsum board. The gym and weight room contain exposed metal ceilings. Deficiencies noted included damaged ceiling tiles in the gym storage areas and missing ceiling tiles in the craft room.	4 - Good

1. Seal the crack in the finished concrete in the main hallway.
2. Investigate the wood floor and sub-floor of the gym to remove and repair any warped wood that resulted from an earlier flood.
3. Replace the broken and missing acoustic ceiling tiles in the gym storage room and craft room.

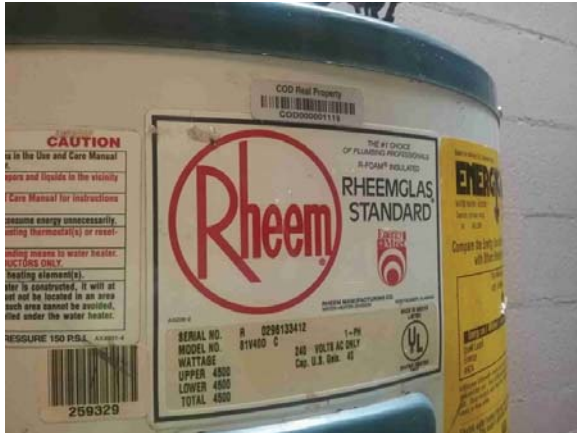
Domestic Water Distribution	The plumbing system has a domestic water service feed from two 40-gallon electric water heaters located in the janitorial closet. Deficiencies noted included a water heater WH-1119 that has surpassed the end of its typical design service life.	3 - Average
Other Plumbing	Other plumbing assets include 2-inch diameter floor drains in the restrooms and janitorial closet. The roof has 2 1/2-inch single inlet roof drains for rainwater drainage. No deficiencies were observed or reported at the time of the assessment.	4 - Good

1. Replace the electric hot water heater that has surpassed its typical design service life.

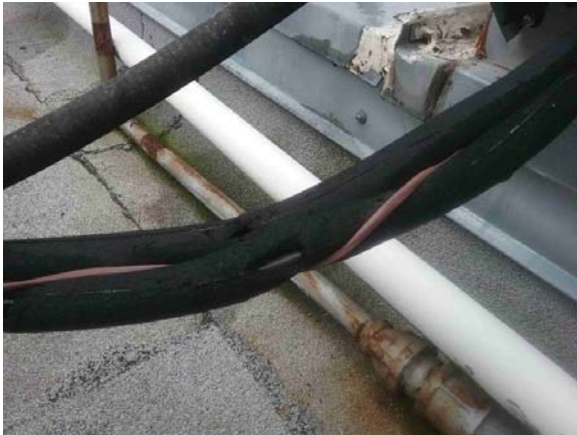
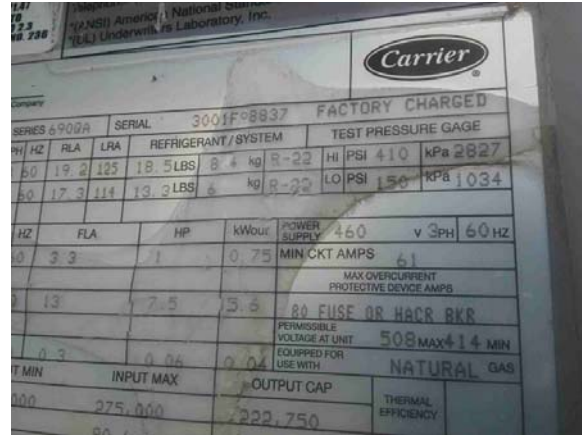
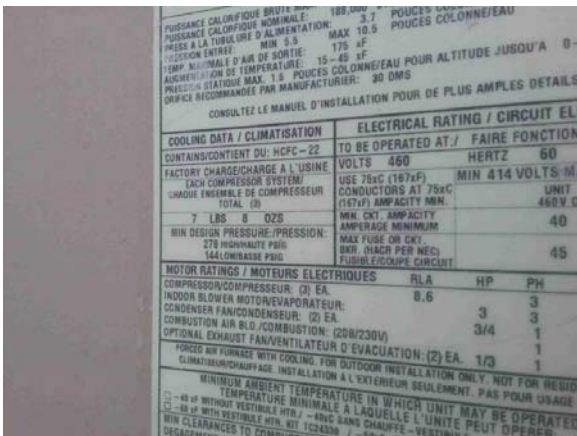
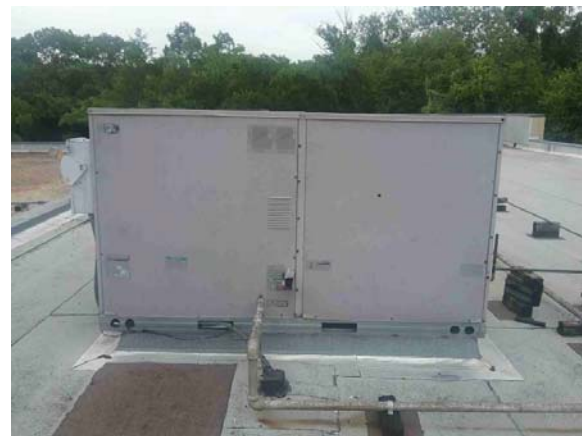
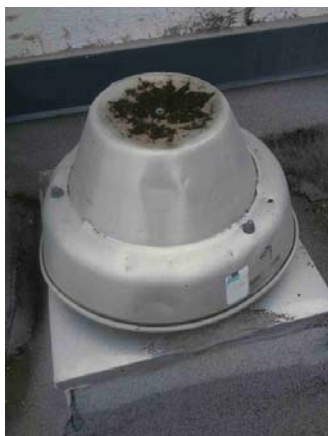
Mechanical/HVAC

Subsystem	Condition and Deficiency Overview	System Condition Rating
D30 HVAC		
Mechanical / HVAC	<p>The major mechanical equipment consists of seven rooftop package air conditioning units and a mini-split system air conditioning unit. The gymnasium is conditioned by two 15 nominal ton air cooled and gas heat RTU's and two 20 nominal ton air cooled and gas heat RTU's. The rest of the building is serviced by one 12.5 nominal ton, one 8.3 nominal ton, and one 6 nominal ton air cooled and gas heat RTU's. An additional 1 nominal ton mini-split system provides cooling for the guest check in area. The bulk of the rooftop package units are reaching the end of their typical design service life. The AC unit in the office, entrance, restrooms, and playroom was replaced in 2015.</p> <p>Supplemental mechanical equipment for the HVAC system also includes four rooftop mounted exhaust fans.</p> <p>Deficiencies noted included sun damaged and cracking refrigerant insulation on the mini-split system. The RTUs were typically charged with R-22 refrigerant and nearing the end of their typical design service lives. The exhaust fans have all been replaced; however, they appear to be reaching the end of their typical design service life and should be planned for replacement. TEF-1 has a significant vibration in the housing when in operation. It was reported that the gym AC has cooling problems.</p>	3 - Average

1. Replace the damaged sections of insulation on the refrigerant lines for the 1 nominal ton mini-split system, which is sun damaged and cracking.
2. Plan to remove and replace all aged rooftop package units that are nearing the end of their typical design service life. They are charged with R-22 refrigerant, which is being phased out of production. Schedule for replacement the four roof mounted exhaust fans. All show signs of typical wear and tear and appear to be reaching the end of their typical design service life.
3. Ensure that the recommended solutions address the reported gym cooling issue.

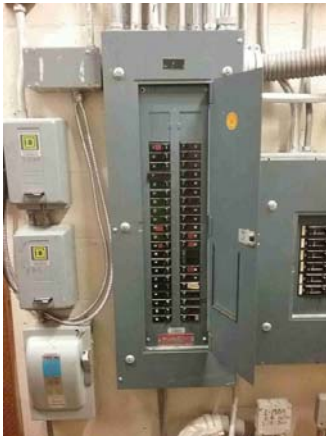
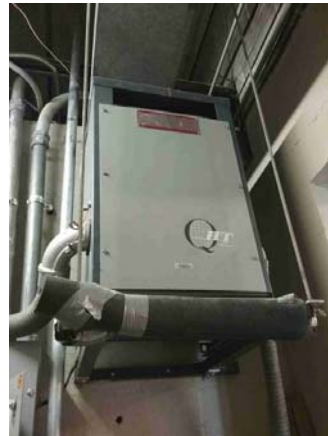
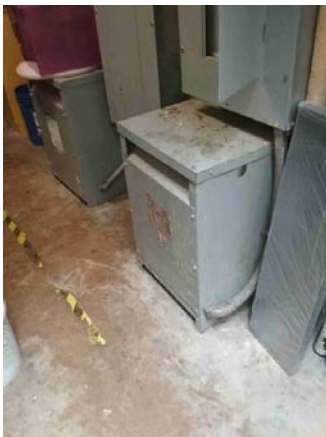
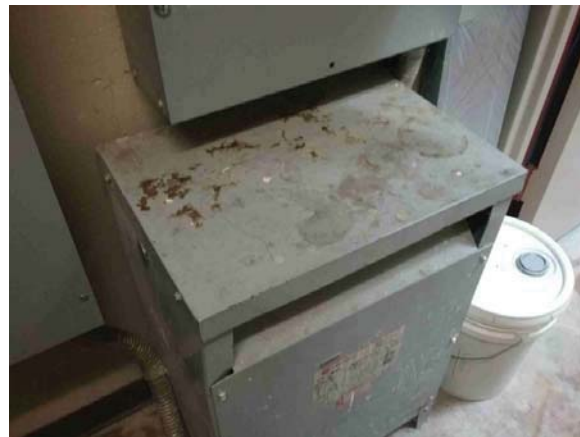
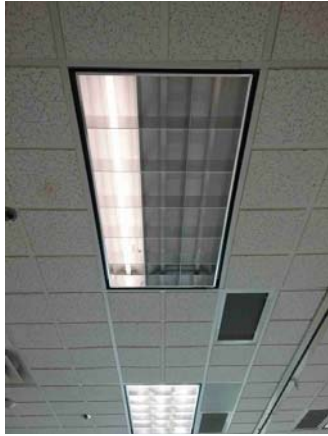
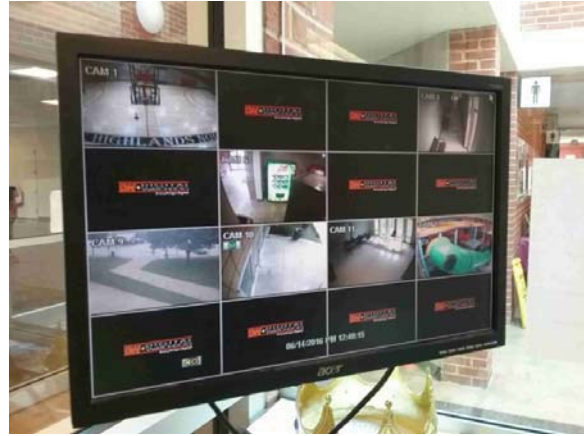
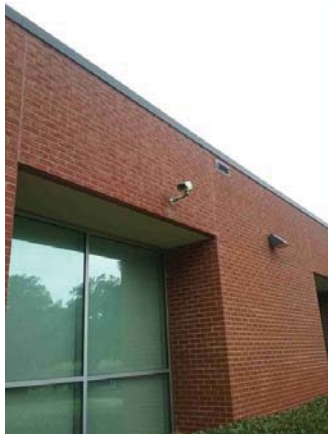
Electrical

Subsystem	Condition and Deficiency Overview	System Condition Rating
	<p>The building has no emergency, back-up power.</p> <p>Deficiencies noted included panel L and the 45-KVA transformer located in the FACP room appear to be original to the building's construction and are approaching the end of their typical design service life. One of the 45-KVA transformers located in the janitorial closet has corrosion and debris on its enclosure. Facility occupants reported persistent phone line and power line issues.</p>	
Lighting	<p>The exterior lighting at the building consists of recessed compact fluorescent fixtures in the soffits and metal halide wall packs located along the perimeter. The interior lighting is made up of primarily recessed and surface mounted 2-lamp T8 fluorescent fixtures throughout the building. The craft wing uses 3-lamp T8 fluorescent fixtures, while the gymnasium uses 4-lamp T8 fluorescent fixtures. Single lamp compact fluorescent fixtures are also used throughout the building. A majority of the interior lighting is controlled by wall switches with occupancy sensors. Exit lights are seen throughout the facility in appropriate locations. Emergency lighting is supplied through standard light fixtures equipped with battery backups.</p> <p>Deficiencies noted included two blown T8 bulbs in the craft wing.</p>	4 - Good

Communications & Security	<p>The building has a communication system that consists of telephone, LAN, Wi-Fi, and public address. The building has a security system that consists of security cameras throughout the building.</p> <p>Deficiencies noted included building staff reported only seven of the thirteen security cameras are currently functional.</p>	3 - Average

1. Replace the aged and outdated electrical distribution panelboard as it is approaching the end of its typical design service life.
2. Replace the aged and outdated electrical distribution transformer as it is approaching the end of its typical design service life.
3. Determine the cause of corrosion on the electrical distribution transformer to eliminate future corrosion. Monitor current corrosion on the enclosure to ensure it does not affect the asset's functionality in the future.
4. Replace blown T8 bulbs in the craft wing and continue to service lighting fixtures throughout the facility as needed.
5. Repair or replace the non-functional security cameras.
