Reverchon Recreation Center Summary

Address	3505 Maple Avenue Dallas, TX 75219
Building Purpose	Recreation Center
Original Year of Construction	1975
Building Area	14,357 SF
Inspection Date	July 19, 2016
Inspection Conditions	97° F, Sunny

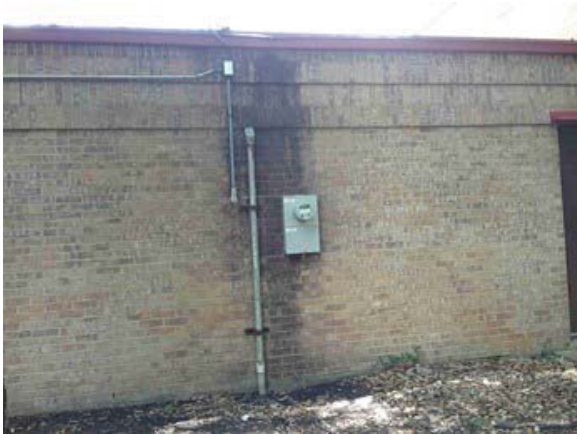
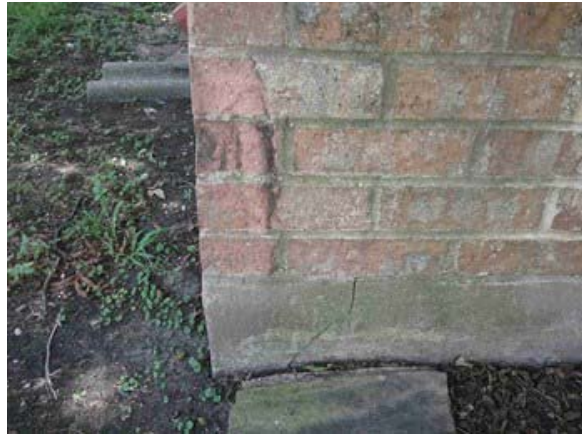
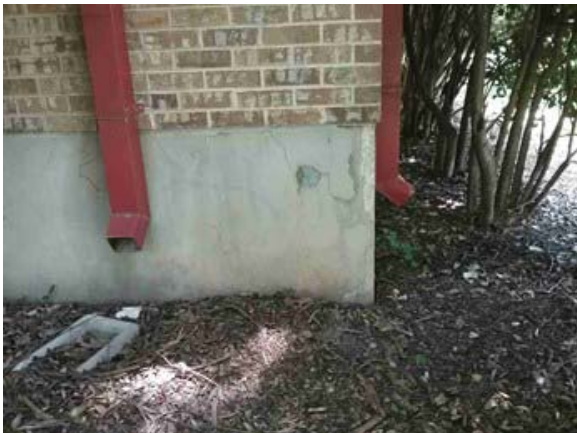
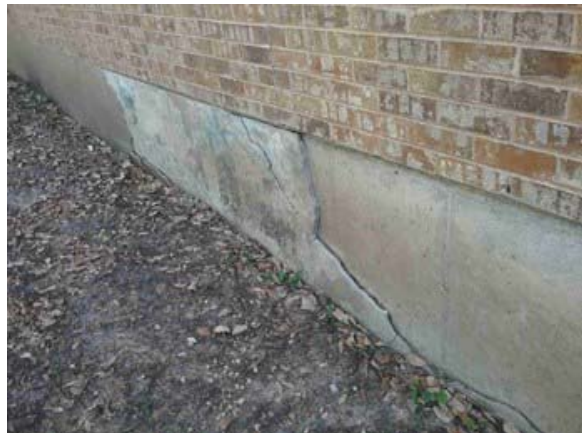
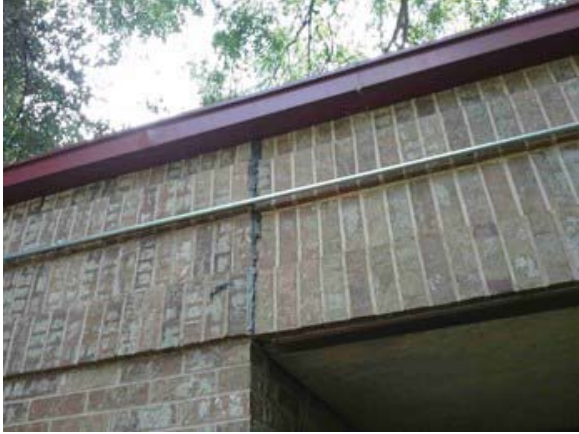
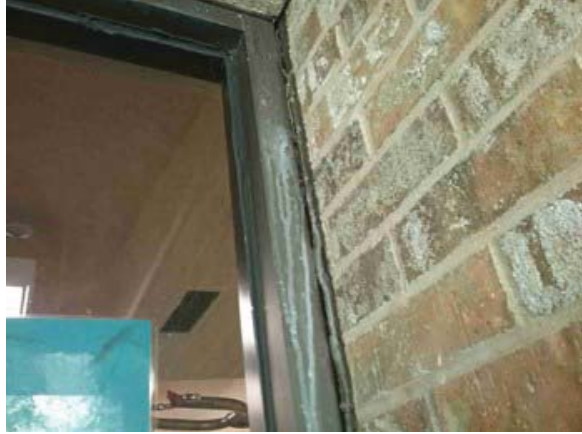
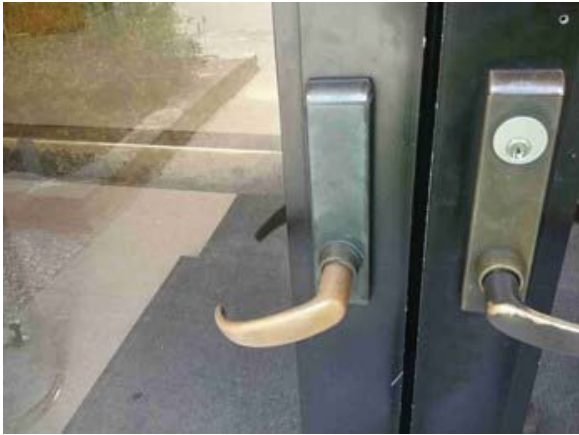
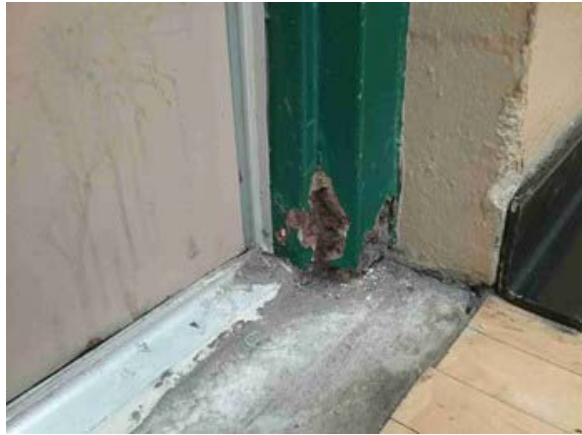
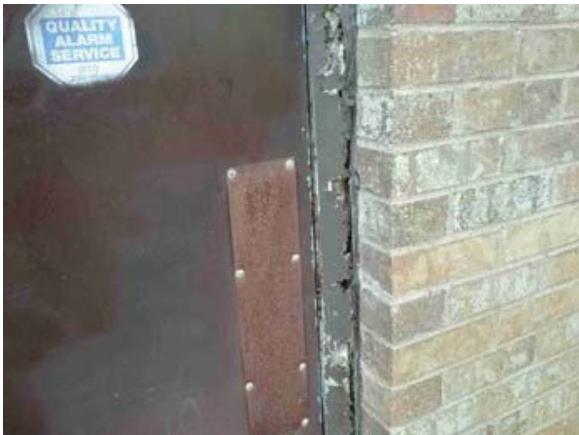
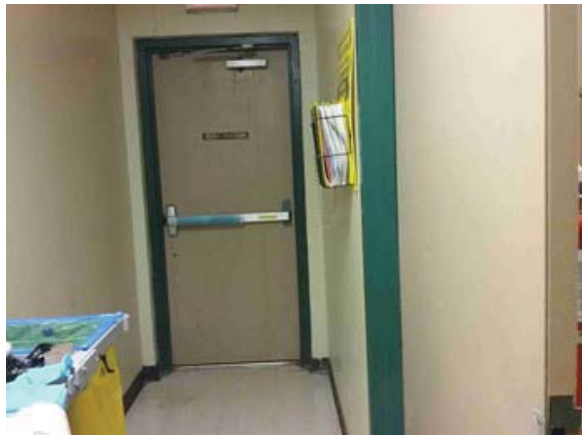
Subsystem	Condition and Deficiency Overview	System Condition Rating
B20 Exterior Enclosure		
Exterior Walls	<p>The exterior walls consist of a brick masonry veneer and a concrete foundation around the entire perimeter of the building.</p> <p>Deficiencies noted included minor discoloration of the bricks in several locations. The bricks at the northeast corner of the building were chipped. The mortar around several bricks was worn or separating from the brick and sealant had been installed in these locations. There was minor cracking at the west corner of the foundation. The concrete facade on the building foundation was delaminating.</p>	4 - Good
Exterior Windows	<p>The exterior windows consist of floor to ceiling windows with metal frames.</p> <p>Deficiencies noted included limited locations where caulking was missing around the windows.</p>	4 - Good
Exterior Doors	<p>There is one main public entryway located at the north side of the building, which consists of glass doors with a metal frame. The remaining service doors are primarily steel with a metal frame and located along the entire perimeter of the building.</p> <p>Deficiencies noted included discoloration of the main door hardware. The frame for the service door on the west wall was severely damaged and corroded. The paint and the hardware on the service doors were generally worn. The emergency exit door on the west wall was difficult to open.</p>	4 - Good

1. Pressure-wash discolored bricks.
2. Patch chipped bricks.
3. Repair concrete foundation corners.
4. Repair delaminating concrete on foundation.
5. Remove sealant and repair grout where grout has separated from the bricks.
6. Caulk around windows where caulk is missing or worn.
7. Replace hardware on main entry door.
8. Replace door frame for the service door on the west wall.
9. Paint the service doors and replace the hardware on these doors.
10. Replace the emergency exit door on the west side of the building or correct deficiency causing door to be difficult to open.

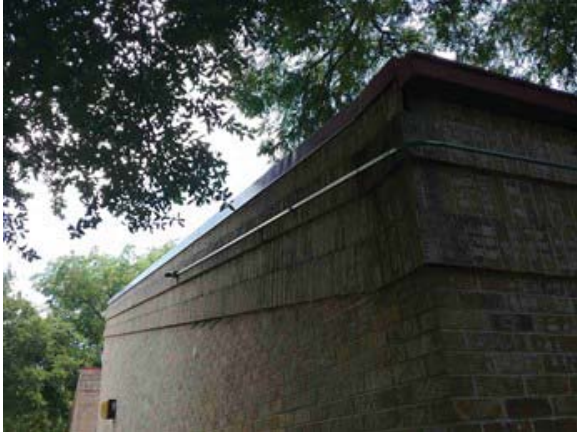
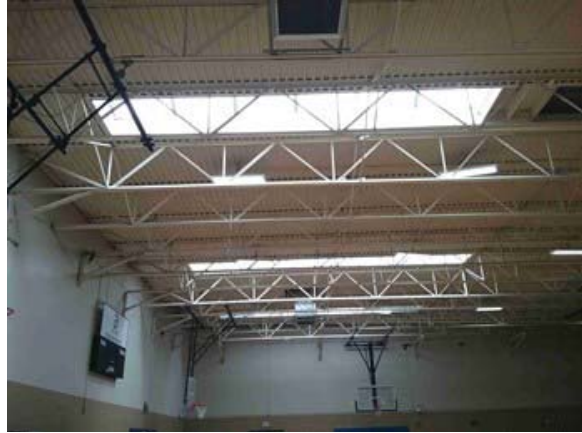
B30 Roofing		
Roof	<p>The roof construction is metal decking with a single-ply membrane system. The roof covering is assumed as the roof was inaccessible at the time of the assessment. The roof is assumed to be installed in 2000 based upon the condition at the time of the assessment, and the typical design service life of the roofing material.</p> <p>Other roofing features include skylights over the gym and the lobby, painted metal flashing, gutters, and downspouts.</p> <p>Deficiencies noted included minor damage to the flashing around the perimeter of the building. Water intrusion from the skylights in the gym and the lobby was reported by facility staff. Facility staff noted that the skylight in the lobby was replaced approximately three months prior to the assessment date. Facility staff noted that the gym skylight was replaced but water intrusion is still occurring.</p>	3 - Average
C10 Interior Construction

1. Repair or replace damaged sections of flashing.
2. Determine cause of water intrusion at skylights and make necessary repairs.

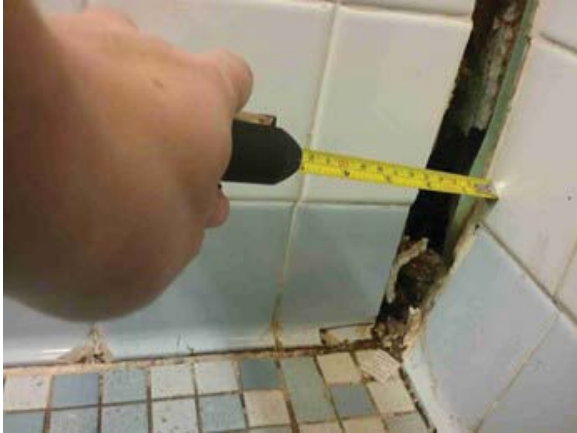
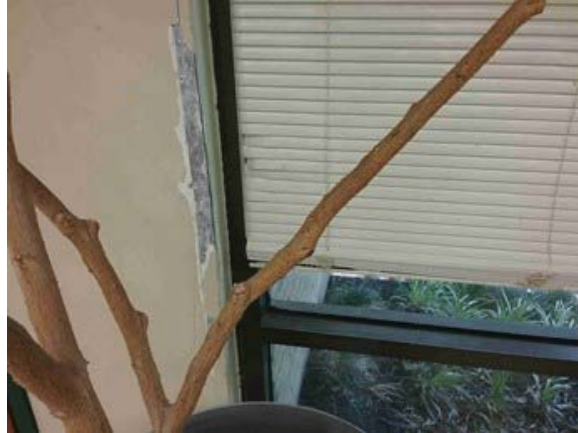
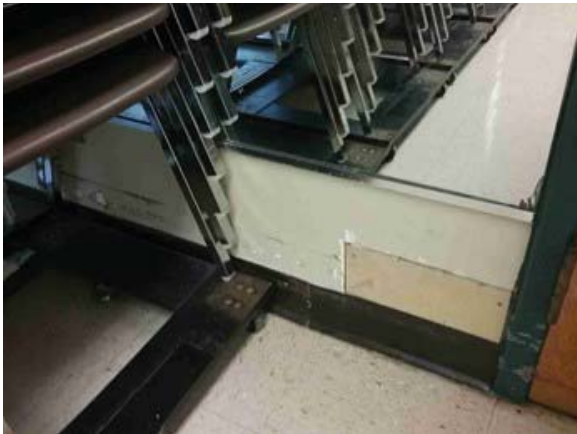
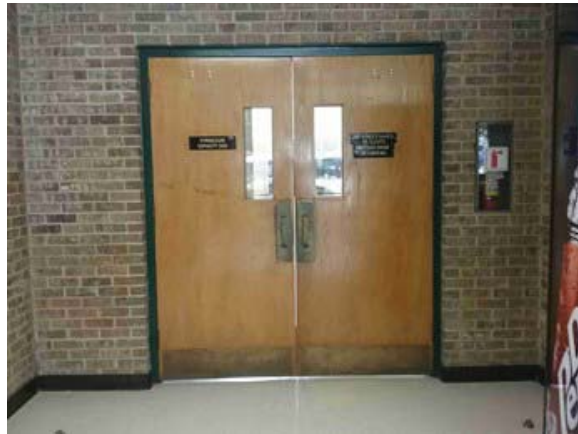
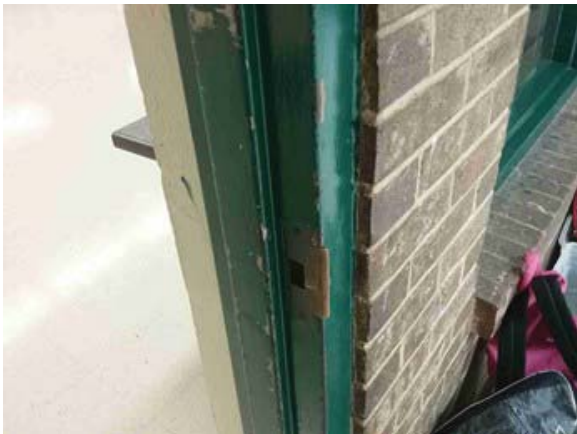
Interior Construction

Interior Walls	<p>The building contains concrete masonry unit (CMU) interior walls, with the exception of the lobby which consists of brick interior walls. There are metal wire reinforced windows between the main lobby and the assembly room, weight room and game rooms. There are windows with a metal</p>	2 - Poor

Subsystem	Condition and Deficiency Overview	System Condition Rating
	<p>frames around the check-in desk.</p> <p>Deficiencies noted included substantial cracks that were observed in the CMU blocks in the north wall of the gym, in the men's shower wall, and in the south wall of the office. Instances of patched gypsum board and corner damage were observed in the game room.</p>	
Interior Doors	<p>The majority of the interior doors are wood doors with metal frames. The doors to the gym are double wood doors with a metal frame. The doors to the weight room are glass with a metal frame.</p> <p>Deficiencies noted included wear and scuffs on the wooden doors. The metal hardware on the double wood doors to the gym was worn and aged. The paint on the metal door frames was generally chipped.</p>	4 - Good
Interior Specialties	<p>The building has special interior construction such as bleachers in the gym and partitions between the stalls in the restrooms.</p> <p>No deficiencies were observed or reported at the time of the assessment.</p>	4 - Good

1. Conduct a structural investigation of the building foundation to determine the cause of the large cracks in the walls, and make necessary repairs.
2. Repair the corners of the walls where the metal is exposed in the game room.
3. Repair damaged gypsum board in the game room.
4. Replace the hardware on the double wood doors leading to the gym.
5. Paint metal door frames throughout the building.

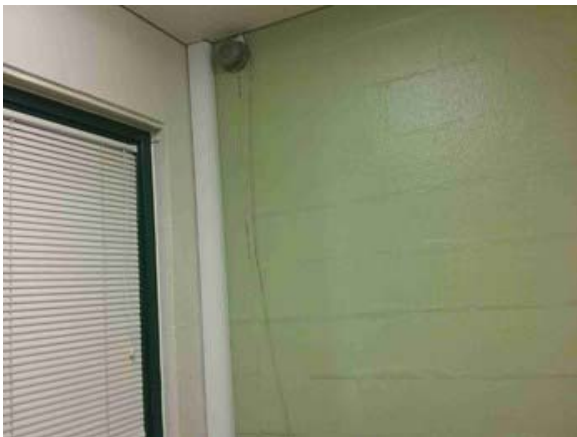
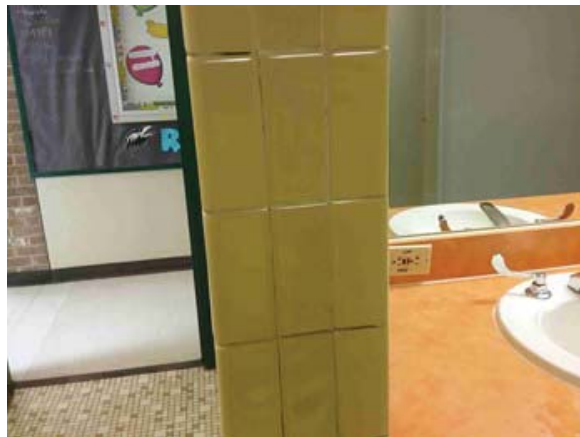
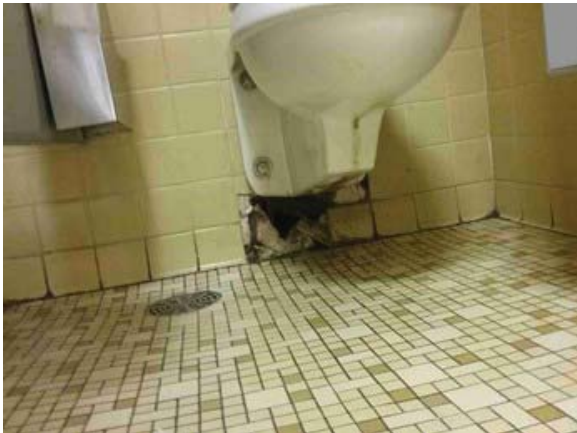
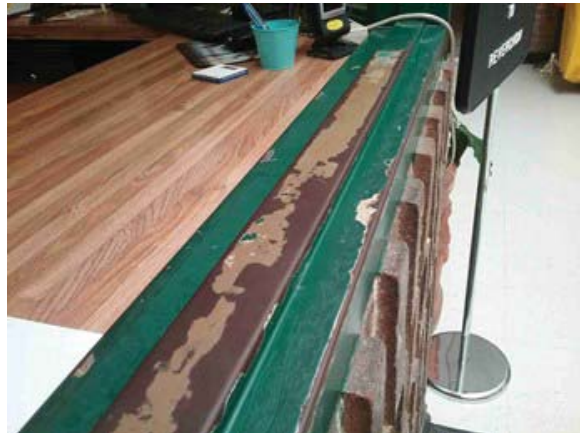
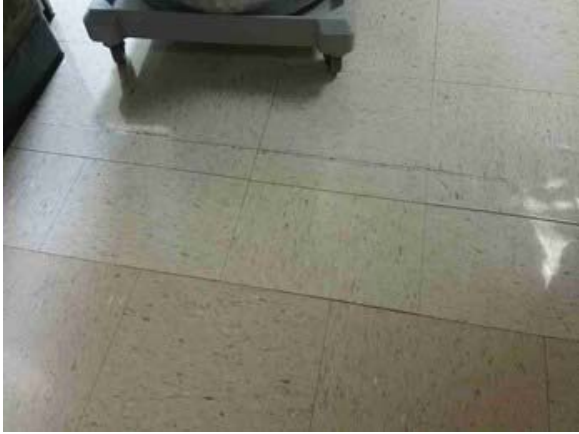
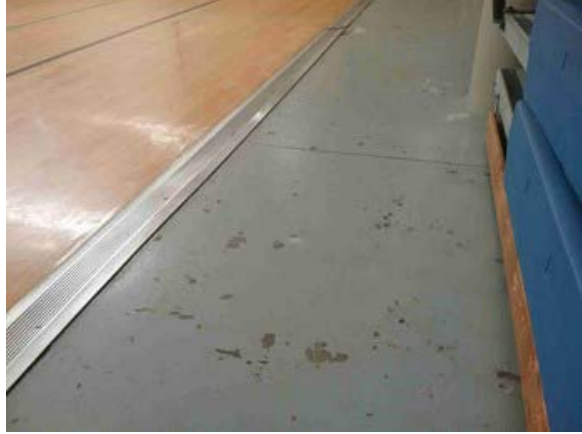
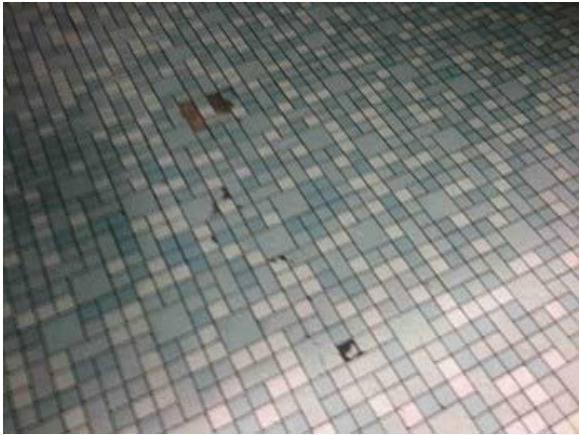
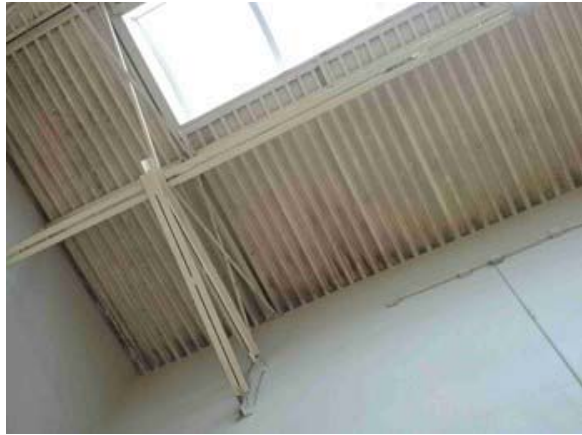
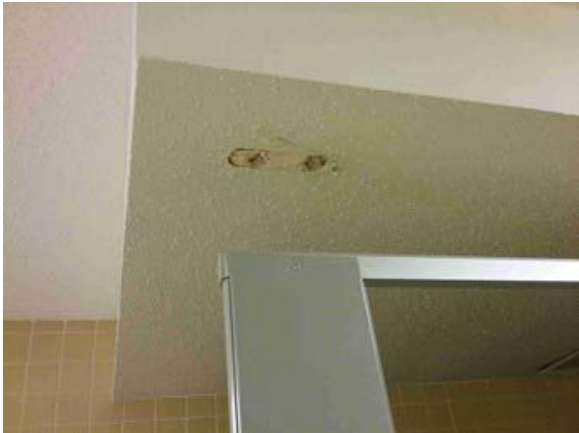
C20 Stairs		
Exterior Stairs	System not present.	N/A
Interior Stairs	System not present.	N/A
C30 Interior Finishes		
Interior Wall Finishes	<p>The building primarily contains painted interior wall finishes. The activity and game rooms have carpet installed on the walls from approximately 6-foot from the ground up to the ceiling. The walls in the main entry are unfinished brick. The walls in the restrooms have ceramic tile interior wall finishes.</p> <p>Deficiencies noted included scuffs and chipping paint on the gypsum board in limited locations throughout the building. Several of the ceramic tiles in the restroom were observed to be damaged, cracked, missing grout, or missing entirely. The paint on the frame around the lobby check-in desk exhibited moderate wear.</p>	4 - Good
Interior Floor Finishes	<p>The building generally contains vinyl composition tile (VCT) interior floor finishes. The gym contains a finished wood floor and has painted concrete under the bleachers. The bathrooms contain ceramic tile interior floor finishes. The mechanical rooms have unfinished concrete floors. The weight room has a rubber floor. The office has carpeted flooring.</p> <p>Deficiencies noted included generally worn and cracking VCT tile throughout the building. The paint on the concrete under the bleachers in the gym was worn and chipped. The bathroom tile had cracks or missing tiles.</p>	3 - Average

Interior Ceiling Finishes	<p>The building primarily contains acoustical ceiling tiles (ACT). Interior ceiling finishes The ceilings near lobby skylights, in the activity room, the game room, the restroom, and weight room have a popcorn texture applied over the gypsum board. The ceiling in the gym is painted but exposed to the structure above.</p> <p>Deficiencies noted included the metal decking at the west wall in gym was</p>	4 - Good

Subsystem	Condition and Deficiency Overview	System Condition Rating
	discolored. There was minor damage to the ceiling in the restroom where it appears the previous bathroom stall partitions were installed.	
D10 Conveying		
Elevators, Lifts, and Escalators	System not present.	N/A
D20 Plumbing		
Plumbing Fixtures	<p>The building has public restrooms for male and female as well as a single occupant restroom; all restrooms are located along a main corridor near the lobby. The male and female restrooms have counter-mounted hand sinks with manually-operated faucets; along with wall-hung toilets with manual flushing mechanisms. There are also wall-hung urinals in the male restroom with manual flushing mechanisms. The single occupant restroom has a wall-mounted hand sink with a manually-operated faucet, along with wall-hung toilet with manual flushing mechanisms. The building also has janitorial closet which has a floor-mounted mop sink. There is also a water cooler located in the main restroom corridor</p> <p>Other plumbing fixtures include a two bowl kitchen sink with a manually-operated faucet and sprayer attachment located in the break room</p> <p>Deficiencies noted included aged plumbing fixtures that are approaching their typical design service life.</p>	3 - Average

1. Paint walls to cover markings and locations where the gypsum board has been patched.
2. Repair or replace missing grout between wall tiles in the restroom.
3. Determine source of damage to tiles under the toilet and then replace all damaged or missing tiles on the walls in the restroom.
4. Paint the frame around the lobby check-in desk.
5. Monitor VCT for further deterioration and plan for replacement.
6. Paint the concrete under the bleachers in the gym.
7. Replace damaged or missing floor tiles in the restroom.
8. Clean metal decking in the gym.
9. Repair damaged ceiling in the restroom.

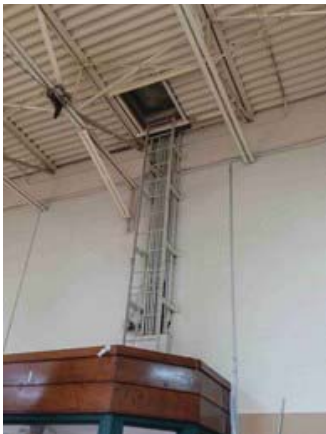
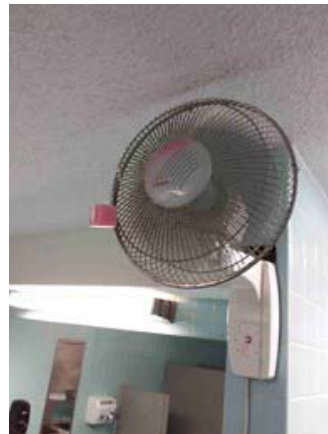
Mechanical/HVAC

Domestic Water Distribution	<p>The plumbing system has a domestic water service feed to an 82-gallon Lochinvar tank-type water heater with 12-kW electric heating, located in a closet in the electrical room.</p> <p>No deficiencies were observed or reported at the time of the assessment.</p>	4 - Good
Other Plumbing	<p>Other plumbing assets include floor drains. Floor drains are located in the restrooms and in the water heater closet.</p> <p>Deficiencies noted included the floor drain accompanying the water heater was observed with corrosion and was clogged with dirt and grime.</p>	3 - Average
D30 HVAC		
Mechanical / HVAC	<p>The major mechanical equipment consists of furnaces, condensing units, air handling units and package units to service all of the heating, ventilating, and air conditioning (HVAC) system.</p> <p>The package units are all located on the roof and have direct-expansion cooling and gas heating. The package units were inaccessible due to safety concerns in reaching the roof hatch. The package units have approximate cooling and heating capacities of 10-ton and 150-MBH. The direct-expansion condensing units are also located on the roof and have cooling capacities ranging from 5-ton to 7-1/2-ton. The accompanying air handling units are located above the ceiling throughout the building.</p> <p>There was no supplemental mechanical equipment observed or reported at the time of the assessment.</p> <p>Deficiencies noted included that the rooftop was reported to generally be accessed using a non-fixed ladder on the side of the building; making it</p>	3 - Average

Subsystem	Condition and Deficiency Overview	System Condition Rating
	difficult for maintenance and access of equipment. The facility staff reported that there was no exhaust system serving the restrooms.	
D40 Fire Protection		
Fire Alarm	<p>The building has a fire alarm system that consists of alarm and signaling devices such as horn/strobe combos and detectors.</p> <p>The fire alarm system control equipment includes a single zone fire alarm control panel.</p> <p>Deficiencies noted included the gypsum board wall surrounding the fire alarm annunciator panel was severely damaged, causing damage to the annunciator. A pull station located below the annunciator was damaged.</p>	3 - Average
Fire Protection/Suppression	<p>System not present.</p> <p>The building has portable fire extinguishers for fire suppression.</p>	N/A
D50 Electrical		
Electrical Distribution	<p>The electrical service enters the building at the 800-amp 208/120-volt main switchgear which is located in the electrical room and delivers power throughout the building. There are also two 225-amp distribution panelboards serving the facility.</p> <p>Deficiencies noted included the main switchgear and panelboards were estimated to be installed in 1971-1976; around the time of building construction. All of these assets were aged past their typical design service life.</p>	2 - Poor

1. Install a permanent fixed ladder either on the exterior of the building or near the roof hatch.
2. Install ceiling-mounted exhaust fans in each restroom.
