## Thurgood Marshall Recreation Center Summary

Address	5150 Mark Trail Way Dallas, TX 75232
Building Purpose	Recreation Center
Original Year of Construction	1970
Building Area	21,300 SF
Inspection Date	August 17, 2016
Inspection Conditions	77° F, Overcast

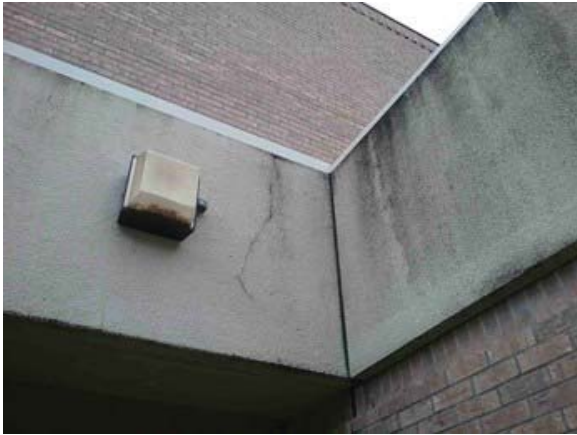
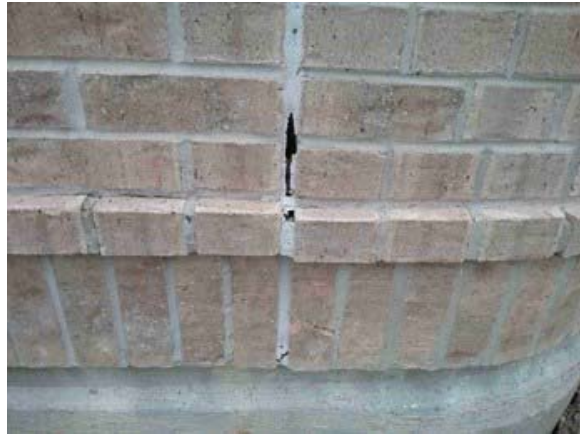
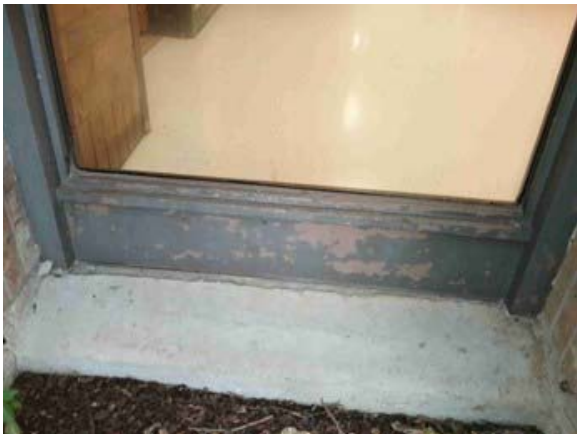
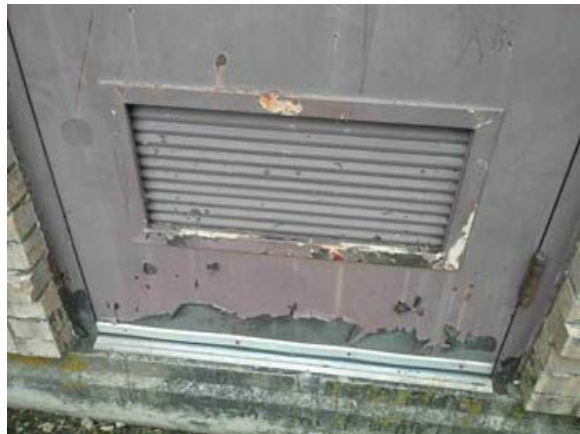
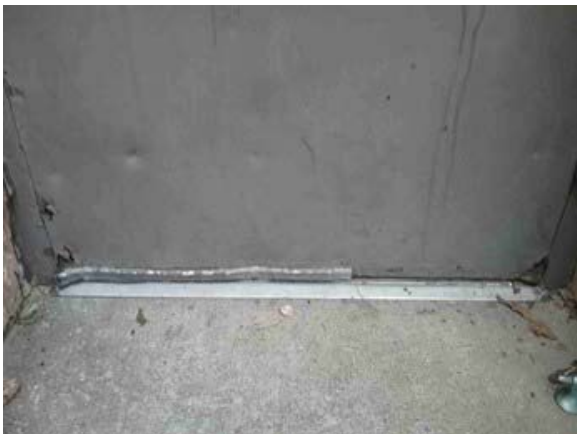
Subsystem	Condition and Deficiency Overview	System Condition Rating
<b>B20 Exterior Enclosure</b>		
<b>Exterior Walls</b>	<p>The exterior of the building consists of a brick façade with sections of plaster toward the upper wall.</p> <p>Deficiencies noted included isolated areas of cracking in the plaster finish, and deterioration of existing joints at various locations around the perimeter of the building.</p>	4 - Good
<b>Exterior Windows</b>	<p>The exterior windows consist of full length, double paned glass with metal frames. The windows are located on the east and south sides of the building.</p> <p>Deficiencies noted included noticeably worn window frames, with chipped paint.</p>	3 - Average
<b>Exterior Doors</b>	<p>There is one main public entryway located at the east side of the building, which consists of metal framed glass doors. There are additional metal framed glass door entrances at the southwest corner of the building. The remaining service doors are primarily metal and located along the east and north sides of the building.</p> <p>Deficiencies noted included noticeable dents and paint deterioration observed on exterior doors. The weather stripping on several of the doors was torn or corroded.</p>	3 - Average

1. Repair cracking plaster on exterior walls.
2. Repair the deteriorated wall joint sealant around the perimeter of the building.
3. Paint window frames where paint is chipped.
4. Repair or replace dented and corroded exterior doors.
5. Replace deteriorated or missing weather stripping on bottom of doors.

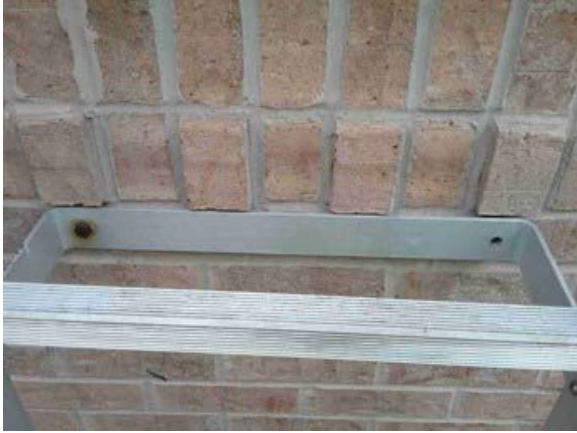
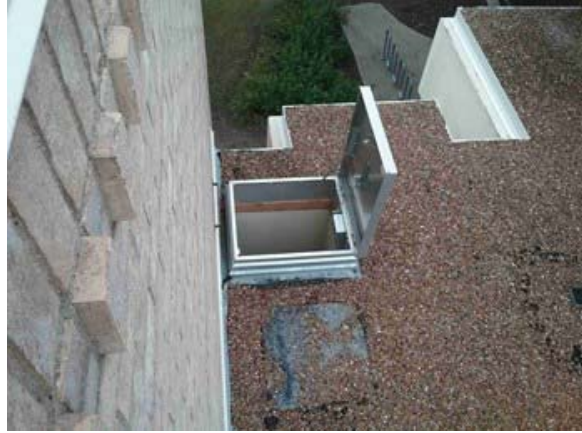
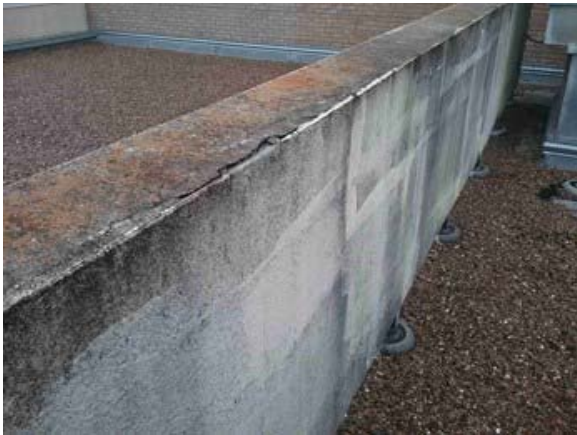
<b>B30 Roofing</b>		
<b>Roof</b>	<p>The roof construction is a low-slope built-up tar and gravel system occurring over two levels. The roof is assumed to be installed at a later date than the original roof based the condition at the time assessment.</p> <p>Other roofing features include: roof access hatch, metal ladder from the lower level to the upper level of the roof, and metal flashing that surrounds the exterior of the building. Skylights are present in two rows of four on the upper level. There is also a wall on the lower roof level that surrounds the HVAC equipment.</p> <p>Deficiencies noted included safety issues regarding the roof access. The hatch opened into a wall and was located very close to the roof edge. In addition, the ladder that provided access to the second roof level had missing bolts, and was loose and not secured to the structure. The concrete wall that surrounded the HVAC equipment had corrosion.</p>	4 - Good

1. Re-orient the roof access hatch to provide safer roof access.
2. Ensure all bolts are in place and that roof ladders are secure.
3. Repair the roof wall surrounding the HVAC equipment.

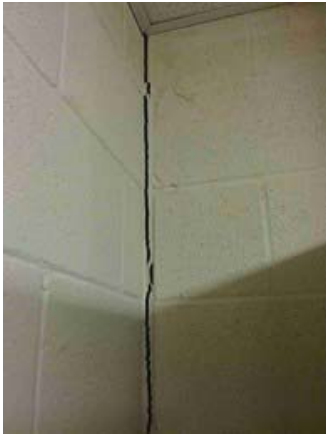
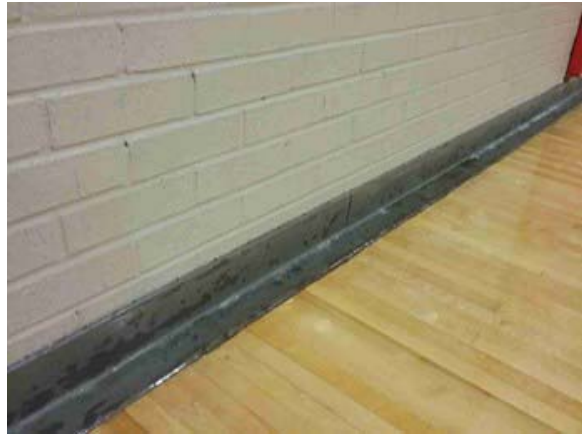
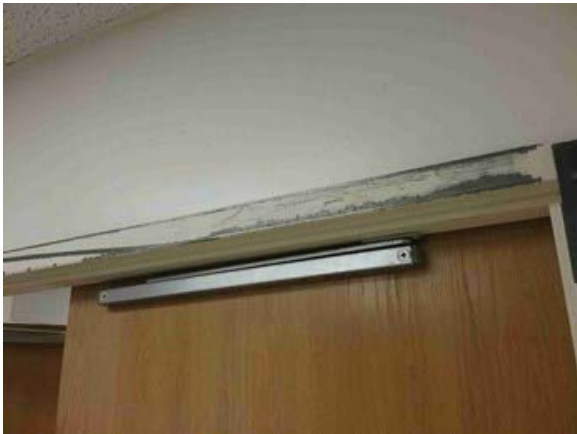
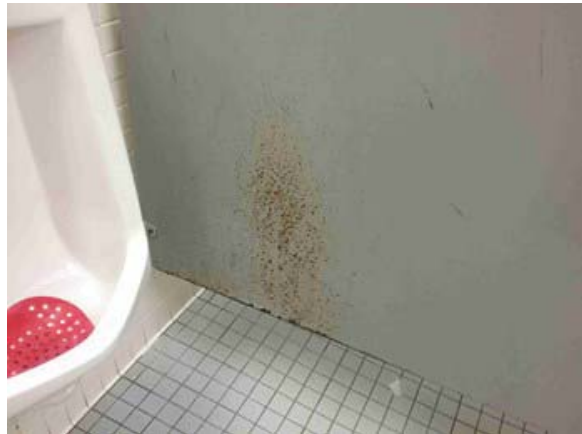
<b>C10 Interior Construction</b>		
<b>Interior Walls</b>	<p>The main hallways and computer lab contain brick interior walls. The gymnasium has brick and concrete masonry unit (CMU) walls. The activity room, kitchen and weight room have gypsum board walls. The storage closets are predominantly CMU walls.</p> <p>Deficiencies noted included a large crack in the main storage closet CMU wall. There was also chipped paint and scratches on the baseboards in</p>	3 - Average

Subsystem	Condition and Deficiency Overview	System Condition Rating
	the gymnasium.	
<b>Interior Doors</b>	The majority of the interior doors are wood with metal frames. Several doors have glass viewing windows and metal kick plates. Deficiencies noted included damage to the paint of several of the interior door frames.	4 - Good
<b>Interior Specialties</b>	The building has special interior construction such as bleachers in the gymnasium, partitions in the restrooms, cabinets in the kitchen, and room dividers located in the new addition. Deficiencies noted included moderate rust and corrosion on the restroom partitions.	3 - Average
<b>C20 Stairs</b>		
<b>Exterior Stairs</b>	System not present.	N/A
<b>Interior Stairs</b>	System not present.	N/A
<b>C30 Interior Finishes</b>		
<b>Interior Wall Finishes</b>	The building contains primarily painted interior wall finishes. The restrooms contain ceramic tile interior wall finishes. The gymnasium contains plywood paneling and the new addition contains acoustical and laminate panel interior wall finishes. Deficiencies noted included graffiti on the interior walls of the storage closet.	4 - Good

1. Repair cracking in CMU walls in gymnasium and monitor for future damage.
2. Paint the baseboards in the gymnasium or replace if necessary.
3. Paint door frames where paint is chipping or scraped off.
4. Replace restroom partitions where corrosion is present.

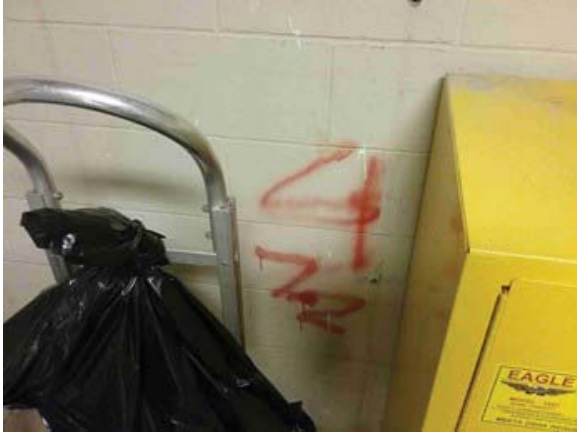
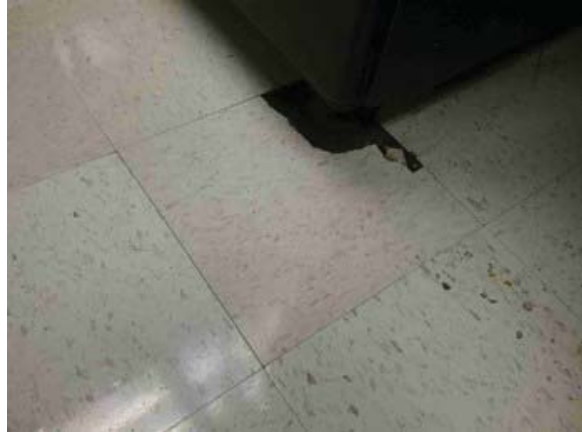
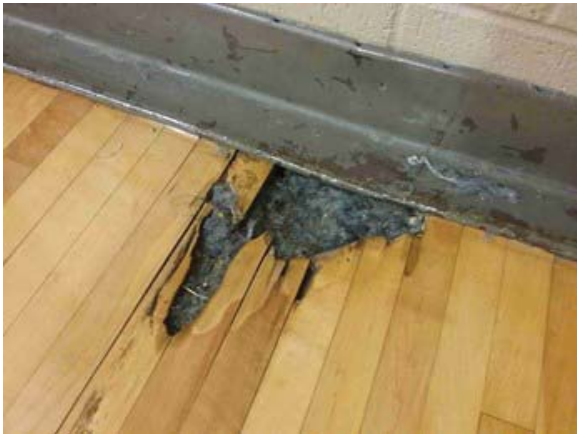
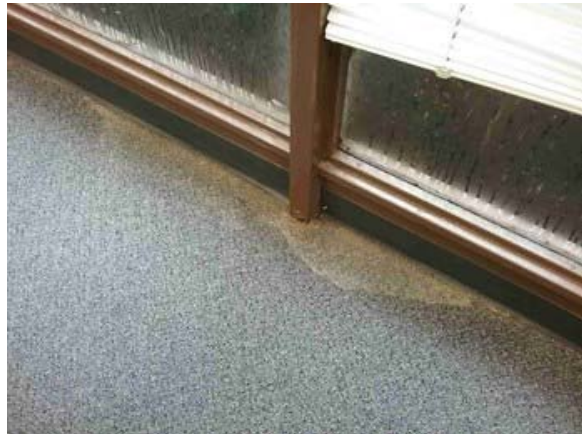
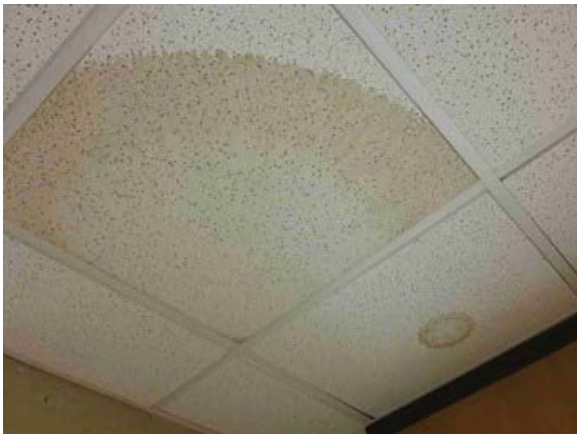
<b>Interior Floor Finishes</b>	The entryway, main hallway and the new addition contain vinyl composition tile (VCT) interior floor finishes. The weight room contains rubber flooring, and closets and storage rooms contain finished concrete flooring. . The gymnasium is predominantly wood with sections of finished concrete. The large room and office areas contain carpeting, and restrooms contain ceramic tile floor finishes. Deficiencies noted included cracking and staining on the VCT in the hallways. The gymnasium had deteriorating wood around the perimeter of the space. There was evidence of water intrusion in the office areas along the walls, with a report from facility personnel that there was a musty odor coming from under the cabinets at the front desk, presumably from the water damaged carpet flooring.	3 - Average
<b>Interior Ceiling Finishes</b>	The building contains primarily acoustical ceiling tile (ACT) interior ceiling finishes. The ceiling in the gymnasium is exposed to the structure above. The restrooms contain gypsum board interior ceiling finish. Deficiencies noted included isolated areas of water damaged or broken ceiling tiles.	4 - Good

1. Paint concrete masonry unit (CMU) walls in storage closets where graffiti was observed.
2. Replace damaged and stained VCT flooring.
3. Repair or replace broken and deteriorated sections of wood flooring in gymnasium.
4. Investigate source of water intrusion and replace water damaged carpeting in the office area.
5. Investigate the source of water intrusion and replace missing and water damaged acoustical ceiling tiles (ACT).

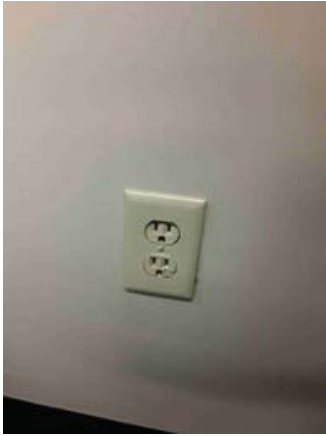
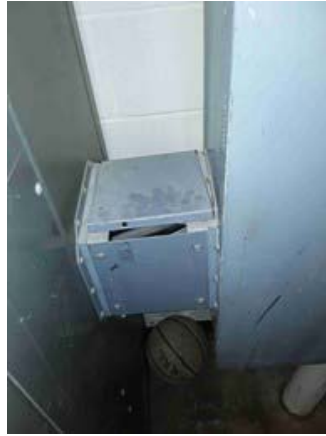
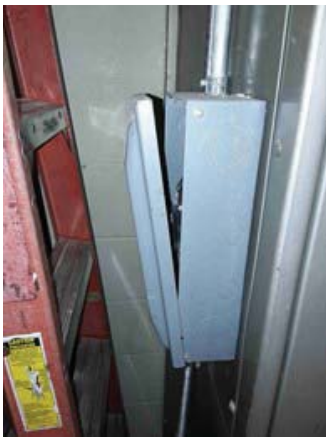
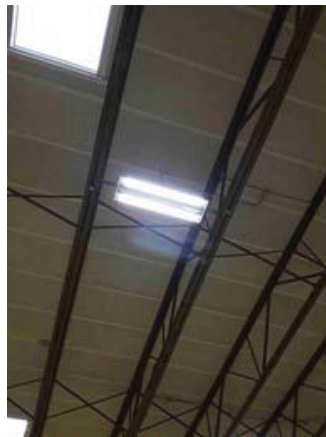
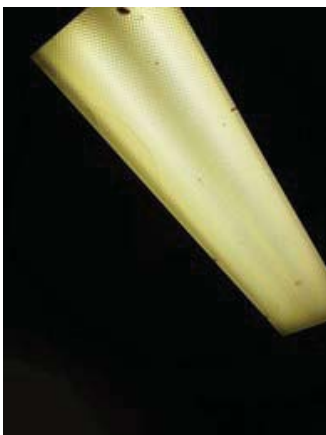
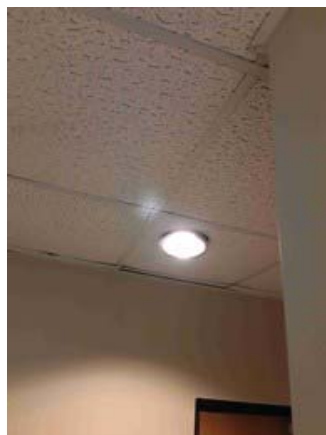
Subsystem	Condition and Deficiency Overview	System Condition Rating
	No deficiencies were observed or reported at the time of the assessment.	
<b>Fire Protection/ Suppression</b>	<p>The building does not have a system for fire protection.</p> <p>The building has portable fire extinguishers for fire suppression that have inspection tags dated within the last year as required.</p> <p>No deficiencies were observed or reported at the time of the assessment.</p>	N/A
<b>D50 Electrical</b>		
<b>Electrical Distribution</b>	<p>The electrical service enters the building at two different locations. The first service enters the building to the main switchgear/board (MP1) – 240/120-volts 600 amps. The main switchgear/board has a second section rated at 240/120-volts 1200 amps. Both sections are located in electrical room 1 and deliver power to portions of the building. The second service enters the building in electrical room 2, which was inaccessible at the time of the assessment due to a blockage caused items that were being stored in that room. The distribution and branch panelboards are primarily located in electrical room 1, electrical room 2 and throughout the interior of the building.</p> <p>This building does not have a backup power system.</p> <p>Deficiencies noted included damaged cover plates on several receptacles. There were several panel covers and junction box covers that were not secured properly. Several pieces of distribution equipment were approaching its typical design service life.</p>	3 - Average

1. Replace damaged receptacles.
2. Secure all panel and junction box covers.
3. Replace aging switchgear and distribution panels.
4. Replace lighting lamps as required. Replace incandescent and florescent light fixtures with LED as needed.
5. Replace lighting fixture lenses that are missing or broken. Clean and maintain all lenses from staining and any residue build-up for efficient lighting output.
6. Remount all lighting fixtures that are not flush with ceiling tile or surface.
