Timberglen Recreation Center Summary

Address	3810 Timberglen Road Dallas, TX 75287
Building Purpose	Recreation Center
Original Year of Construction	2003
Building Area	15,000 SF
Inspection Date	August 2, 2016
Inspection Conditions	100° F, Sunny

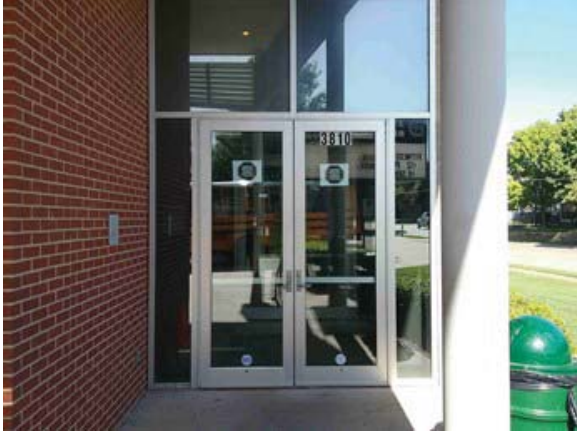
Subsystem	Condition and Deficiency Overview	System Condition Rating
B20 Exterior Enclosure		
Exterior Walls	<p>The exterior walls consist primarily of red and white brick with decorative concrete masonry unit (CMU) blocks.</p> <p>No deficiencies were observed or reported at the time of the assessment.</p>	4 - Good
Exterior Windows	<p>The exterior windows on the north side of the building consist of 4-foot by 5-foot aluminum framed windows, multi paned floor-to-ceiling windows, and 2-foot clerestory windows along the perimeter of the north wall. The exterior windows on the southeast side of the building consist of approximately 3-foot by 4-foot metal framed windows.</p> <p>No deficiencies were observed or reported at the time of the assessment.</p>	4 - Good
Exterior Doors	<p>There is one main public entrance located at the northeast side of the building, which consists of glass doors with a metal frame. There is an exit door located on the northwest side of the building, which is a metal framed glass door. The remaining service doors are primarily steel with a metal frame and located along the southeast and west sides of the building.</p> <p>Deficiencies noted included reports from facility staff that the aluminum front door frames, jambs, thresholds, and locking mechanism are not durable enough to withstand the amount of traffic and are in regular need of repairs.</p>	4 - Good

1. Replace front entry door hardware with a more durable option.

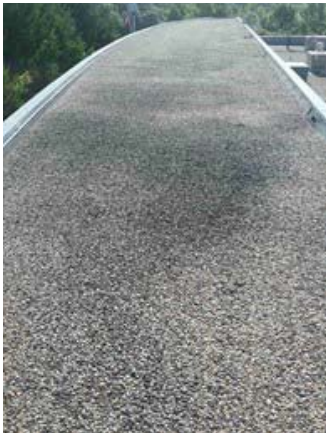
B30 Roofing		
Roof	<p>Roof construction consists of a built-up with tar and gravel system occurring over three levels. The roof is assumed to be installed in 2003 based upon the original year of building construction.</p> <p>Other roofing features include flashing around the perimeter of the roof, an access hatch at the middle level, ladders to access the lower and upper levels, gutters at the top level, and a parapet at the upper and lower roof levels.</p> <p>Deficiencies noted included thinning gravel on some areas of the roof.</p>	4 - Good
C10 Interior Construction		
Interior Walls	<p>The building consists primarily of gypsum board interior walls. The gymnasium has concrete masonry unit (CMU) interior walls. The entry way contains textured concrete walls. There is a retractable partition wall between the classrooms. There are metal framed windows in the office and fitness room.</p> <p>No deficiencies were observed or reported at the time of the assessment.</p>	4 - Good

1. Place additional gravel in locations where gravel layer appears thin.

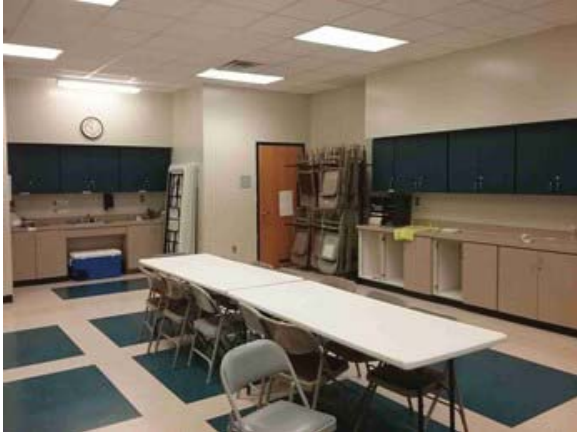
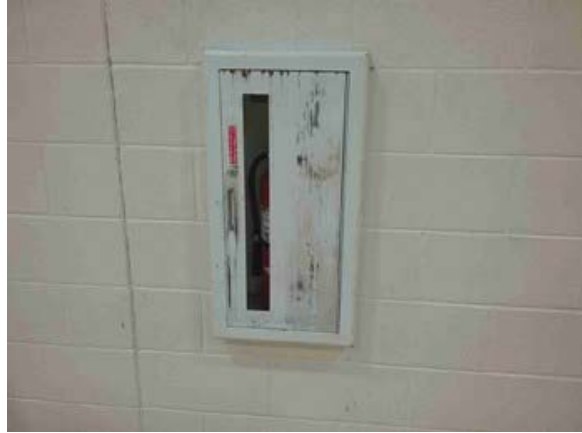
Subsystem	Condition and Deficiency Overview	System Condition Rating
	retractable door in the kitchen. No deficiencies were observed or reported at the time of the assessment.	
Interior Specialties	The building has special interior construction such as cabinets and countertops in the crafts room and kitchen, fire extinguisher cabinets, an information desk in the main lobby, lockers in the restrooms, and partitions between the stalls in the restrooms. Deficiencies noted included several missing doors on the crafts room cabinets, and worn paint on the fire extinguisher cabinets.	4 - Good
C20 Stairs		
Exterior Stairs	System not present.	N/A
Interior Stairs	System not present.	N/A
C30 Interior Finishes		
Interior Wall Finishes	The building primarily consists of painted gypsum board or painted (CMU) block interior wall finishes. The restrooms contain 4-inch square ceramic tile interior walls finishes. Deficiencies noted included minor damage to the paint on the gypsum board walls in the classrooms.	4 - Good

1. Replace missing and damaged cabinet doors in the crafts room.
2. Paint worn fire extinguisher cabinets.

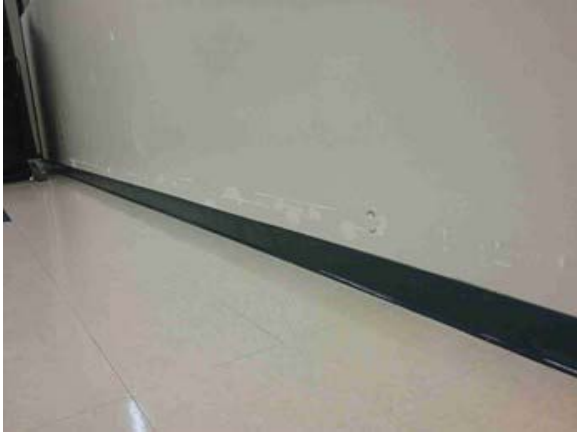
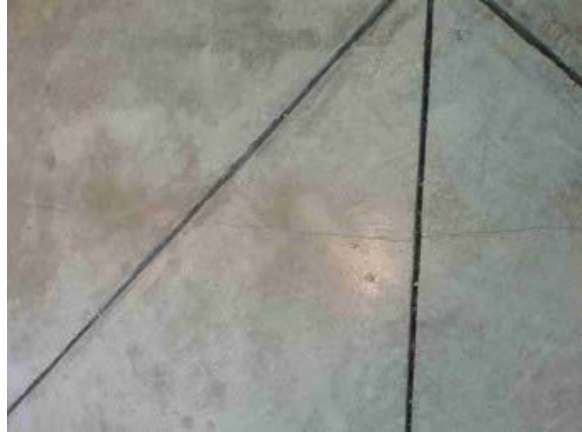
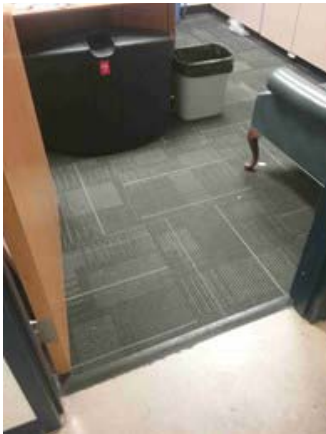
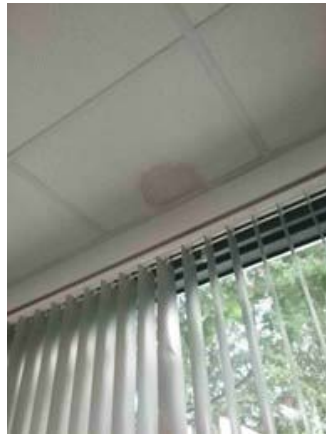
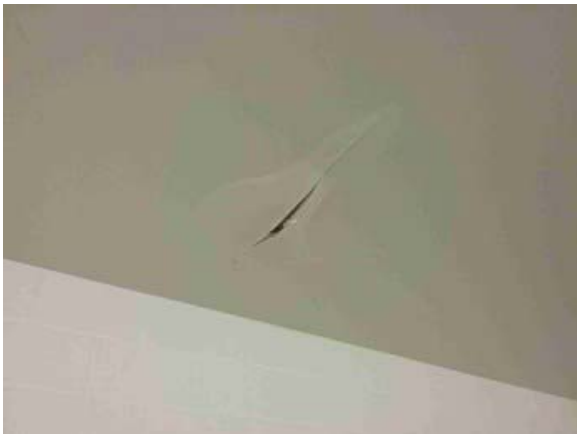
Interior Floor Finishes	The main entry area, a small area near the exit doors in the gym, the storage room in the crafts room, and the restrooms contain polished concrete flooring. The crafts room, classrooms, and kitchen contain vinyl composite tile (VCT) flooring. The fitness room contains rubber flooring. The office contains carpet. The gymnasium contains finished wood flooring. The polished concrete at the main entry had minor cracking. It was reported by facility staff that the carpeting was in need of replacement; however, the carpet appeared to be in good condition at the time of the assessment.	4 - Good
Interior Ceiling Finishes	The building primarily contains suspended acoustical ceiling tile (ACT) interior finishes. The storage room and the classroom are exposed to the metal decking structure above. The gym has painted metal joists and decking. The restrooms contain painted gypsum board ceilings. Deficiencies noted included minor staining to several ceiling tiles. The gypsum board ceiling in the restroom had a sag in the seam, which appeared to be from water intrusion.	4 - Good

1. Repair and paint gypsum board walls in classrooms.
2. Monitor size and length of cracks in the concrete at the main entry, and repair with sealant.
3. Monitor carpeted flooring and plan for future replacement.
4. Replace stained ceiling tiles.
5. Repair and paint damaged gypsum board ceiling in the restroom.

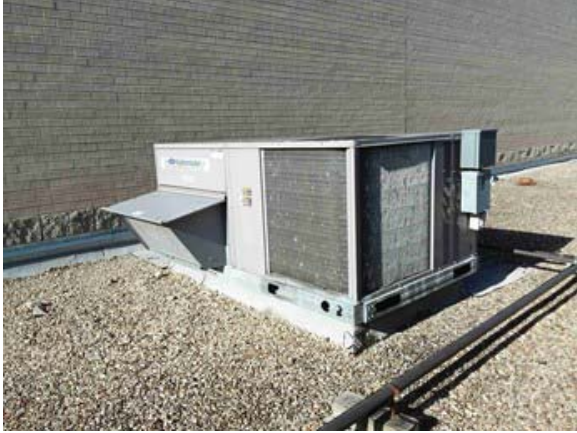
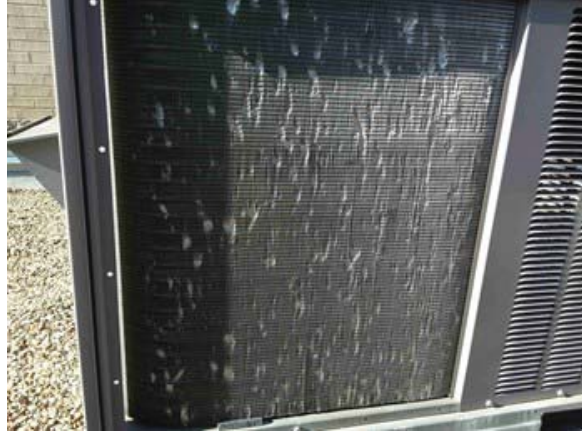
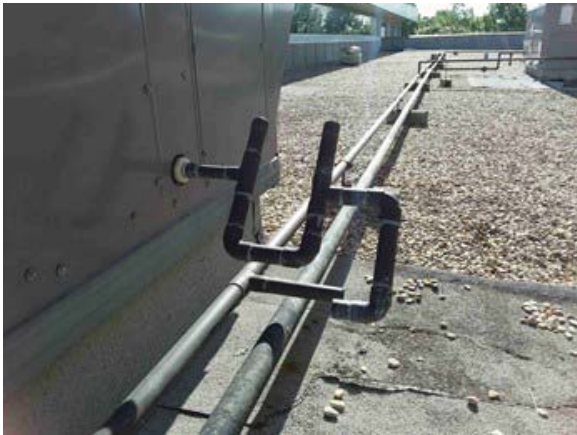
Other Plumbing	<p>Other plumbing assets include roof drains, one floor sink, floor drains in the restrooms and water heater room, and a grease trap located in a vault in a storage room.</p> <p>No deficiencies were observed or reported at the time of the assessment.</p>	4 - Good
D30 HVAC		
Mechanical / HVAC	<p>The major mechanical equipment consists of package units to service all of the heating, ventilating, and air conditioning (HVAC) system.</p> <p>There are eight package units are located on the roof which serve the entire building. The package units have direct-expansion cooling and gas heating. The package units have cooling capacities which range from 3-ton to 12.5-ton and heating capacities which range from 72-MBH to 250-MBH.</p> <p>Supplemental mechanical equipment for the HVAC system also includes three roof-mounted exhaust fans and one roof-mounted gravity ventilator.</p> <p>Deficiencies noted included the aged package units that utilized R22 refrigerant, which is being phased out of production and construction use. These package units were observed with corrosion and moderate to severe condenser fin damage. One of the aged package units was observed with a damaged economizer screen. The newer package unit, which was installed in 2013, was observed with a disconnected condensate pipe.</p>	3 - Average

1. Plan for replacement on all HVAC using R-22 refrigerant, which is being phased out of production.
2. Repair the damaged condenser cooling fins.
3. Complete installation of the disconnected condensate pipe.

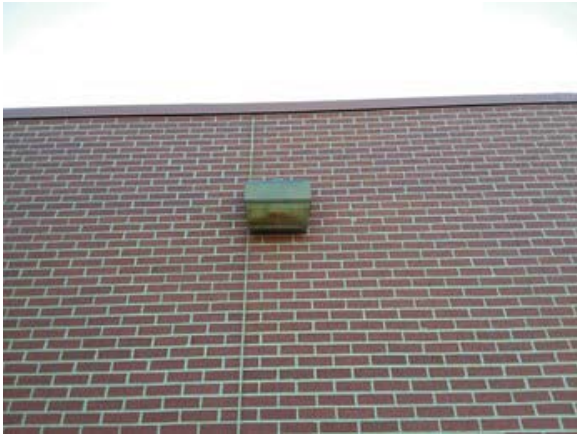
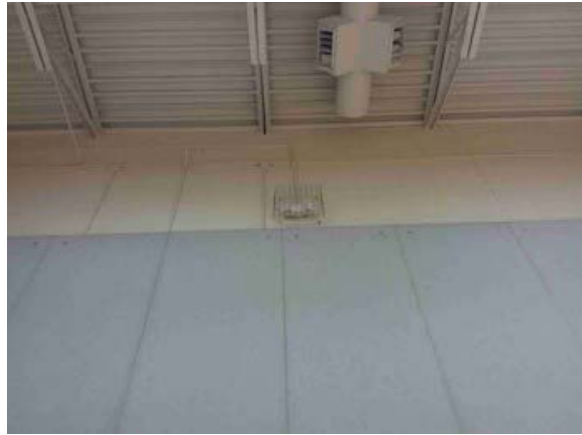
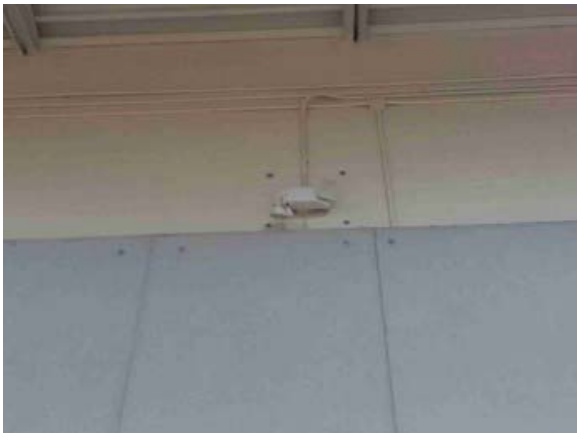
Subsystem	Condition and Deficiency Overview	System Condition Rating
Suppression	<p>extinguishing system for the kitchen-hood. This fire protection system has inspection tags dated within the last year as required.</p> <p>The building also has supplemental, portable fire extinguishers for fire suppression.</p> <p>No deficiencies were observed or reported at the time of the assessment.</p>	
D50 Electrical		
Electrical Distribution	<p>The electrical service enters the building at the 800-amp, 120/208-volt main switchgear, which is located in the main electrical room and delivers power throughout the building.</p> <p>No deficiencies were observed or reported at the time of the assessment.</p>	4 - Good
Lighting	<p>The exterior lighting at the building consists of metal halide fixtures that are located along the entire perimeter.</p> <p>The interior lighting is made up of primarily T8 linear fluorescent and compact fluorescent lamp (CFL) fixtures, with additional incandescent fixtures observed throughout the building.</p> <p>Additionally, exit signs and interior emergency light fixtures are seen throughout the facility in appropriate locations. Exterior emergency lighting is not being used for landings unless battery packs are being utilized.</p> <p>Deficiencies noted included exterior wall packs were observed with stained lenses, compromising the lighting output; and damaged emergency lighting fixtures within the gym.</p>	3 - Average

1. Replace all missing or damaged lighting fixture lenses. Additionally, clean and maintain all lenses from staining and any residue build-up for sufficient lighting output. This is especially critical for the emergency lighting system.
2. Service the exit and emergency lighting to ensure all fixtures work in case of emergency.
3. Repair or replace damaged emergency lighting within gym area and install a wire guard for each fixture.
