Umphress Recreation Center Summary

Address	7616 Umphress Road, Dallas, TX 75215
Building Purpose	Recreation Center
Original Year of Construction	1978
Building Area	17,402 SF
Inspection Date	August 4, 2016
Inspection Conditions	101° F, Clear Skies

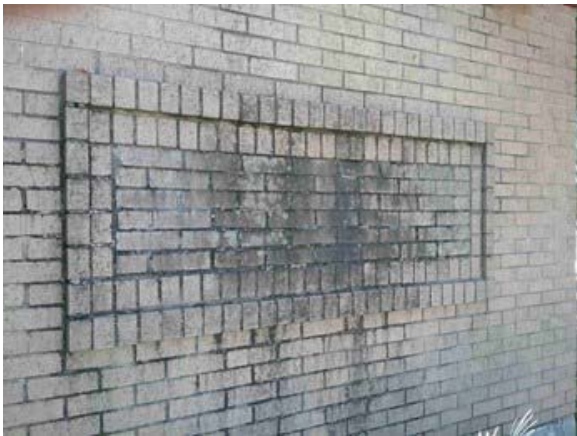
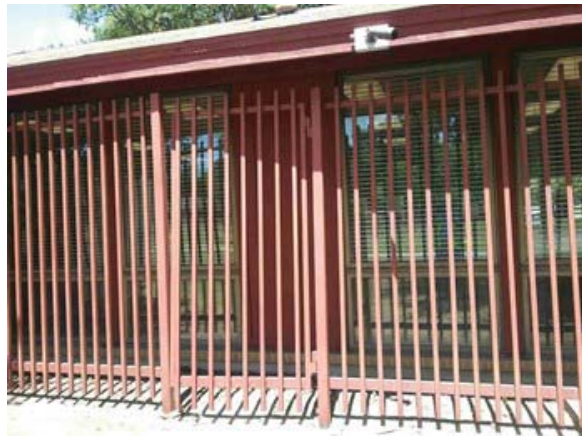
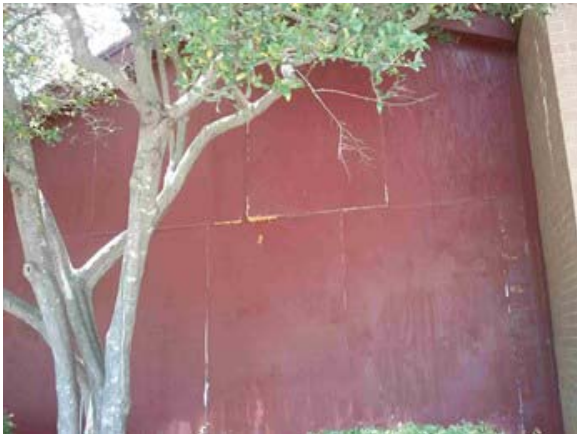
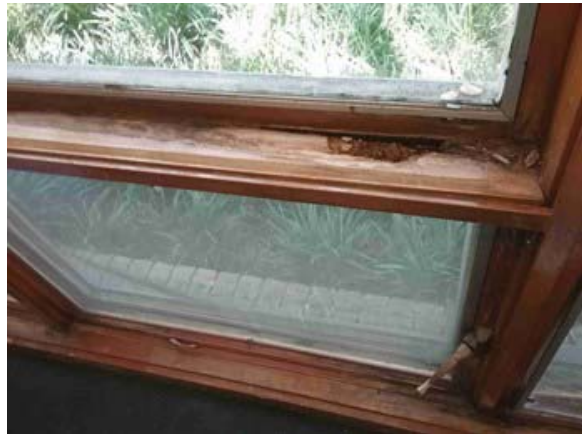
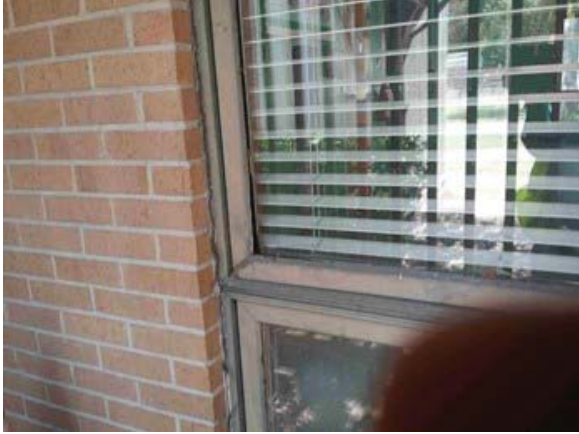
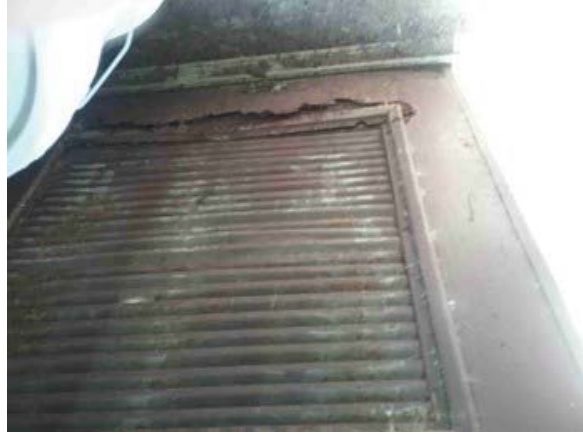
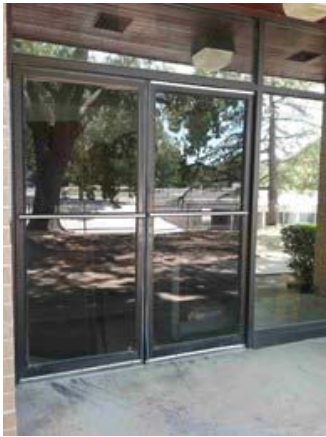
Subsystem	Condition and Deficiency Overview	System Condition Rating
B20 Exterior Enclosure		
Exterior Walls	The exterior walls consist of primarily brick façade around the entire perimeter. East side wall consists of up of wood panels. There is a metal screen on the south side of the building covering rear exterior windows. The portion of the wall above the west side door has wood siding. Deficiencies noted included severe discoloration on the walls caused by rain water. It was noted that the metal screen wall in the back was noted to be leaning toward the glass windows. The wood paneled wall on the east side of the building was damaged and had insulation foam exposed.	3 - Average
Exterior Windows	The exterior windows consist of single pane glass panels in metal frames on the exterior. The same exterior windows contain wood frames on the interior side. Deficiencies noted included significantly deteriorated frames on the north wall. Facility staff reported that water intrusion occurs through the windows during rain events. The sealant between the window frames and the exterior walls was deteriorated on the south side of the building.	3 - Average

Exterior Doors	There is one main entryway located at the north side of the building. All the doors with the exception of the utility room doors are single pane glass in a metal frame. Utility room doors are metal. Deficiencies noted included significantly corroded metal doors for the utility rooms. . It was observed that the west door frame had loose gasket.	3 - Average
B30 Roofing		
Roof	The roof construction is sloped asphalt shingles and appears to consist of three different levels. However, the roof was inaccessible at the time of the assessment due to the slope of the roof. Based on the condition of the roof materials at the time of the assessment, it is estimated that the original roof may have been replaced in 2000. No signs of water intrusion were observed on the interior ceiling finishes so the roof was assumed to be in average condition. Deficiencies noted included moderately deteriorated wood fascia at several locations.	3 - Average

1. Clean the exterior walls to remove discoloration.
2. Stabilize the metal screen located at the rear windows.
3. Investigate the exposed foam on the east walls. Monitor the east wall.
4. Replace the deteriorated north window frames.
5. Repair or replace weather stripping and sealants on rear windows.
6. Apply protective coating to rear window frames.
7. Replace the mechanical room doors.
8. Replace the gaskets for window panels on the west door.

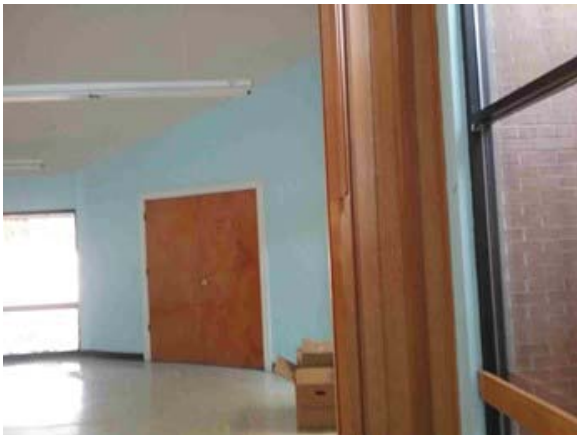
C10 Interior Construction		
Interior Walls	The building consists of concrete masonry units (CMU) interior walls. The partition walls are gypsum board walls. No deficiencies were observed or reported at the time of the assessment.	4 - Good
Interior Doors	The majority of the interior doors are wood doors with wood frames. The doors in the corridor connecting to other areas of the building are single pane glass panel doors in metal frames. There is a sliding wood door for the play area. Deficiencies noted included the sliding wood panel door was non-	4 - Good

Subsystem	Condition and Deficiency Overview	System Condition Rating
	functional due to the damaged panel.	
Interior Specialties	The building has special interior construction such as cabinets, shelves. No deficiencies were observed or reported at the time of the assessment.	4 - Good
C20 Stairs		
Exterior Stairs	System not present.	N/A
Interior Stairs	System not present.	N/A
C30 Interior Finishes		
Interior Wall Finishes	The building primarily contains painted walls. The restroom contains ceramic tile wall finishes. Deficiencies noted included minor cosmetic deficiencies on the painted walls.	4 - Good
Interior Floor Finishes	The building primarily contains linoleum floor finishes. The restrooms floors are covered with ceramic tiles. Utility rooms have unfinished cement floors. The fitness center floor has rubber floor finish. Deficiencies noted included minor scratches on all floor surfaces.	4 - Good

1. Repair the sliding wood door in the play area.

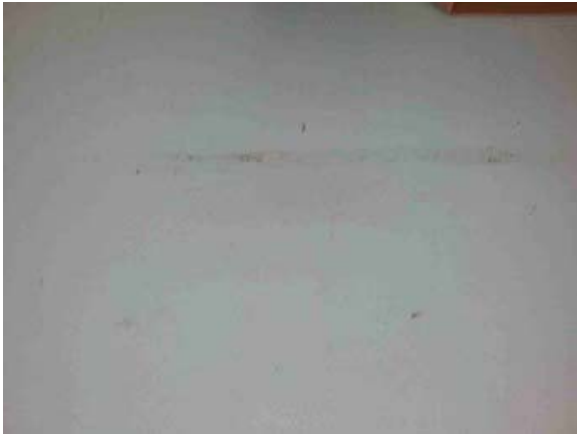
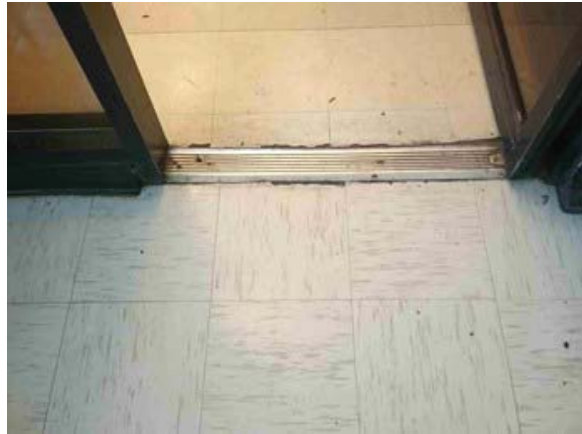
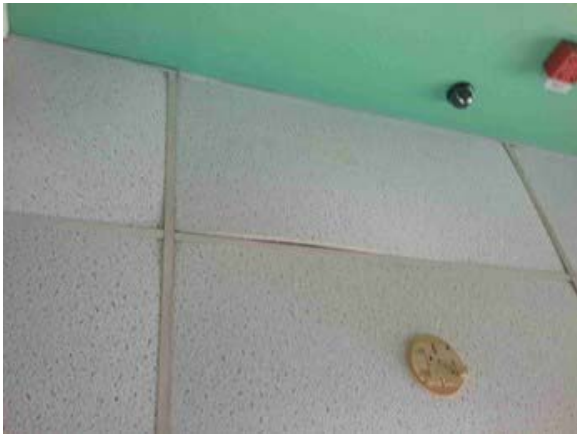
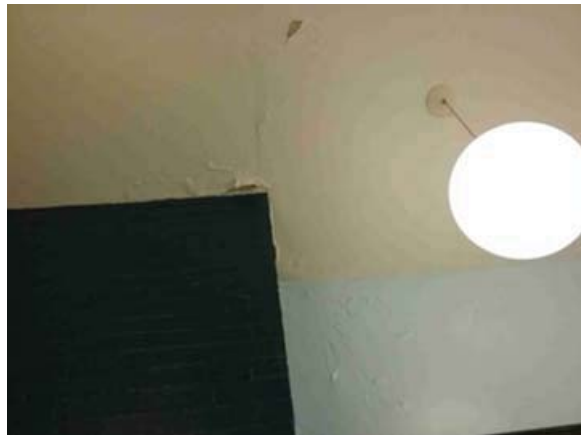
Interior Ceiling Finishes	The majority of the interior spaces are finished with acoustical ceiling tiles (ACT). The ceiling of the lobby has gypsum board ceiling finished with vinyl cover. Deficiencies noted included several loose ACT panels facility staff reported that the lobby ceiling was repaired but the vinyl cover finishing on the gypsum board ceiling was not restored properly.	3 - Average
D10 Conveying		
Elevators, Lifts, and Escalators	System not present.	N/A
D20 Plumbing		
Plumbing Fixtures	The building has public restrooms for men and women located in the workout room and near the interior electrical room. These restrooms have counter-mounted hand sinks with manually-operated faucets, along with wall-hung toilets with manual flushing mechanisms. There are also wall-hung urinals in the men's restroom with manual flushing mechanisms. The building also has a janitorial closet which has a wall-hung mop sink. The water coolers are located in the workout room and near the interior electrical room. Showers are located in both restrooms. Other plumbing fixtures include a two bowl counter-mounted kitchen sink with a garbage disposal and a counter-mounted single bowl sink located in the crafts room. Deficiencies noted included that one lavatory drain was clogged in the men's restroom.	3 - Average

1. Repaint the walls.
2. Monitor the floors for further deterioration of the tile surfaces. Replace when required.
3. Replace the loose acoustical ceiling tiles.
4. Repair and finish patched gypsum board ceiling in the lobby to match the rest of the ceiling.

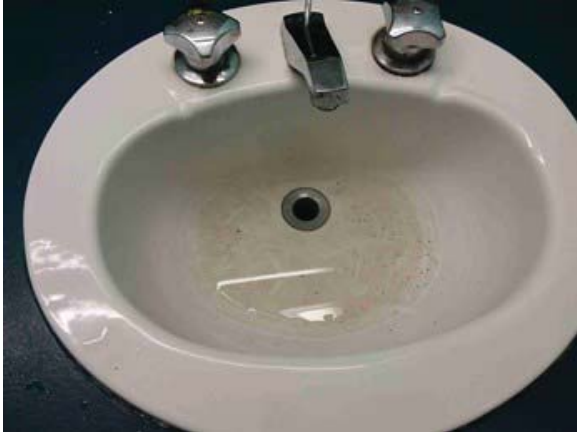
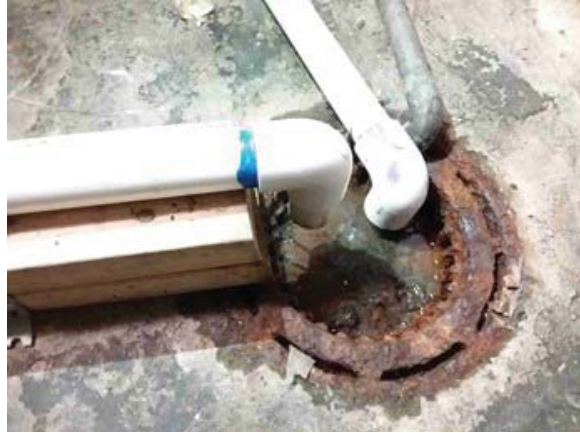
Subsystem	Condition and Deficiency Overview	System Condition Rating
	No deficiencies were observed or reported at the time of the assessment.	
Other Plumbing	<p>Other plumbing assets include floor drains located in the restrooms and one floor sink located in the electrical room.</p> <p>Deficiencies noted included the floor sink that was clogged and corroded in the electrical room.</p>	3 - Average
D30 HVAC		
Mechanical / HVAC	<p>The major mechanical equipment consists of electric furnaces, condensing units and air handling units to service all of the heating, ventilating, and air conditioning (HVAC) system.</p> <p>The condensing units have direct-expansion cooling and 10-ton cooling capacities. The condensing units are located on grade and serve the entire building. The air handling units pair with the condensing units to complete the split systems and are equipped with 25-KW electric furnaces. The air handling units are located in dedicated closets. All HVAC equipment was manufactured by Trane in 2009.</p> <p>There was no supplemental mechanical equipment observed or reported at the time of assessment.</p> <p>Deficiencies noted included the HVAC equipment that uses R22 refrigerant which is being phased out of manufacturing and construction use.</p>	4 - Good

1. Unclog the lavatory drain in the men's restroom.
2. Unclog the drain piping and replace the corroded floor sink in electrical room.

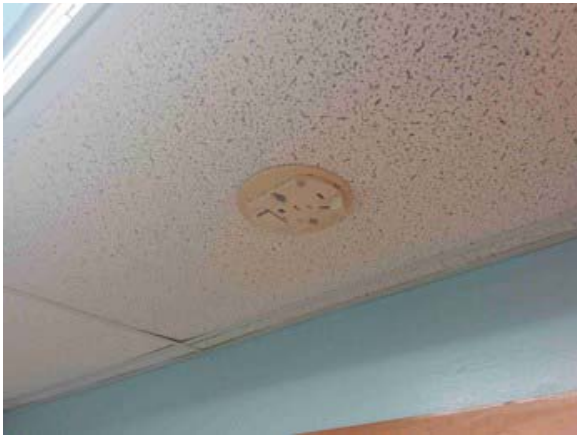
D40 Fire Protection		
Fire Alarm	<p>The building has a fire alarm system that consists of alarm and signaling devices such as strobes, horn/strobe combos, and detectors.</p> <p>The fire alarm system control equipment includes a single zone addressable fire alarm control panel.</p> <p>Deficiencies noted included a broken detector device and devices which were not appropriately placed throughout the building.</p>	2 - Poor
Fire Protection/ Suppression	<p>The building does not have a fire suppression system.</p> <p>The building has portable fire extinguishers for fire suppression.</p> <p>No deficiencies were observed or reported at the time of the assessment.</p>	N/A
D50 Electrical		
Electrical Distribution	<p>The electrical service enters the building fed from an exterior meter located on the north side within the parking lot feeding a 400-amp 120/240-volt B-phase high leg switchgear "A" which is in the main electrical room and delivers power throughout the building.</p> <p>Deficiencies noted included five panelboards which were aged beyond their typical design service lives. The majority of the panelboards were manufactured by federal pacific and identified as potential fire hazards.</p>	2 - Poor

1. Replace the broken detector device.

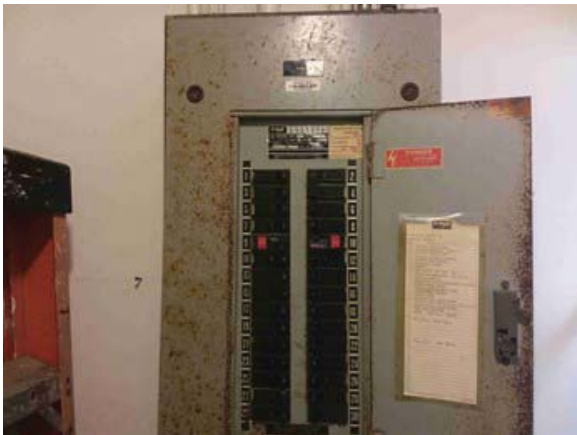
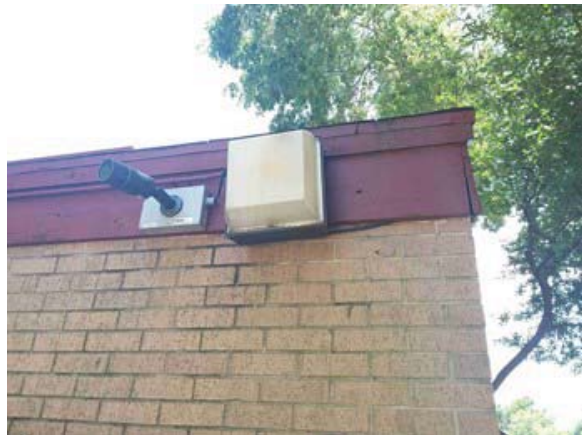
Subsystem	Condition and Deficiency Overview	System Condition Rating
	<p>Additionally, exit signs are seen throughout the facility in appropriate locations. Emergency lighting is not present unless battery packs are being used.</p> <p>Deficiencies noted included dirty lenses on exterior fixtures which compromises the light output.</p>	
Communications & Security	<p>The building has a communication system that consists of telephone, LAN, data points, and Wi-Fi.</p> <p>The building has a security system that consists of cameras (interior and exterior), keypad access, and a security camera monitoring station. The devices can also be monitored over internet protocol.</p> <p>No deficiencies were observed at the time of the assessment.</p>	4 - Good

1. Replace the aged distribution panelboards as they appear past the end of their typical design service life.
2. Clean all exterior lighting fixtures.
