Walnut Hill Recreation Center Summary

Address	10011 Midway Road Dallas, TX 75229
Building Purpose	Recreation Center
Original Year of Construction	1960
Building Area	30,000 SF
Inspection Date	August 1, 2016
Inspection Conditions	90° F, Sunny and Hot

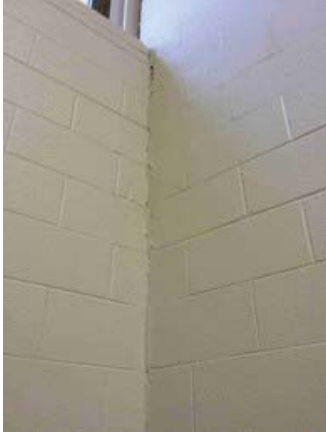
C10 Interior Construction		
Interior Walls	<p>Hallways, offices and activity rooms consist of predominately of gypsum board interior walls. The storage rooms, gymnasium and weight room walls consist of concrete masonry units (CMU), with some areas of exposed brick. There is a large partition that separates the main activity room into room A and room B.</p> <p>Deficiencies noted included cracking that was observed at the corner of</p>	4 - Good

Subsystem	Condition and Deficiency Overview	System Condition Rating
	the northwest CMU wall in the gymnasium. Facility staff reported that water intrusion occurs where the walls meet the foundation in the ballroom, fitness room and northeast emergency exit.	
Interior Doors	The majority of the interior doors are painted wood doors with metal frames. Some of the doors have a small viewing window and a kick plate installed. The doors that separate the hallway from the gym consist of anodized aluminum framed glass doors. No deficiencies were observed or reported at the time of the assessment.	4 - Good
Interior Specialties	The building has special interior construction such as a small kitchen with wood cabinets and collapsible bleachers located in the gymnasium. Stall partitions are located in the restrooms, and extinguisher cabinets are located throughout the building. Deficiencies noted included reports from facility staff that the kitchen was never completed as part of the renovation that took place from 2012-2014.	4 - Good

1. Repair cracked and damaged CMU wall in gym.

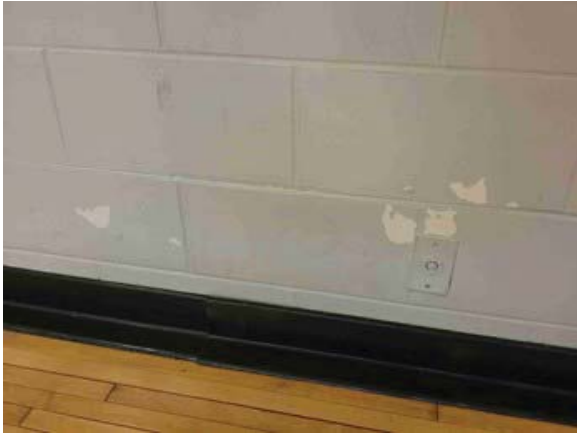
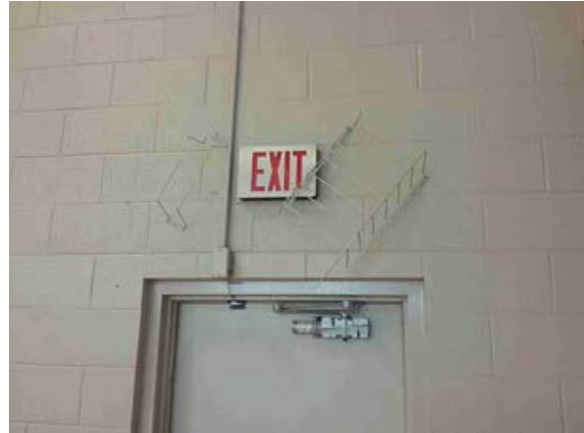
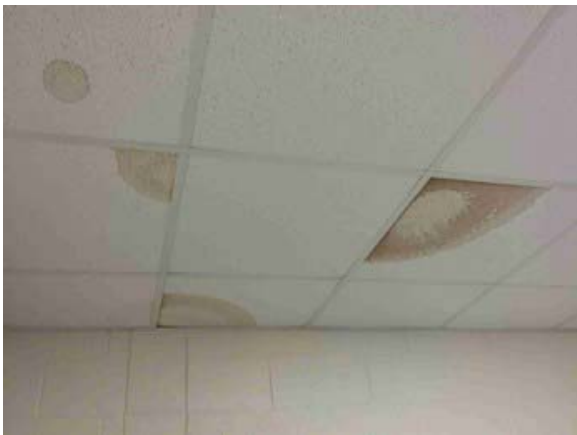
C20 Stairs		
Exterior Stairs	System not present.	N/A
Interior Stairs	System not present.	N/A
C30 Interior Finishes		
Interior Wall Finishes	The recreation center has undergone a major renovation, completed from 2012-2014. The building primarily contains painted CMU and gypsum board interior wall finishes. Restrooms contain ceramic tile interior wall finishes. Deficiencies noted included minor paint cracking and chipping throughout all wall surfaces. The metal shroud around an exit sign in the gym was broken.	4 - Good
Interior Floor Finishes	Linoleum floor tile is found throughout the building in the main hallways and activity rooms (rooms A-D). Wood flooring is present in the gymnasium and the large meeting room (room E). The restroom has a ceramic tile floor finish. No deficiencies were observed or reported at the time of the assessment.	4 - Good
Interior Ceiling Finishes	The building contains primarily acoustical ceiling tile (ACT) interior ceiling finishes. Office areas and storage rooms contain gypsum board interior ceiling finishes. The gymnasium and weight area have an exposed metal ceiling. Deficiencies noted included water damaged ACT in the eastern most storage room and activity rooms.	4 - Good

1. Repair chipped and damaged finish to walls as necessary.
2. Repair metal shroud around exit sign in gymnasium.
3. Replace damaged ACT and investigate water intrusion source.

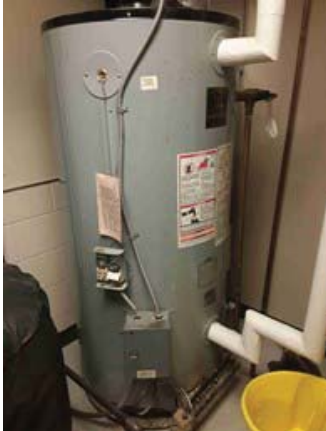
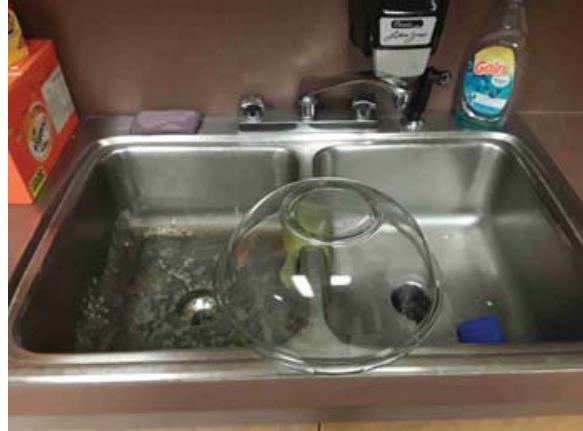
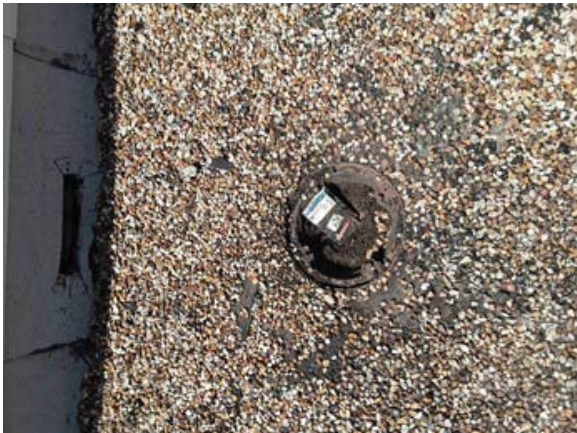
Subsystem	Condition and Deficiency Overview	System Condition Rating
	<p>throughout with wall-mounted water closets and urinals and counter-mounted vitreous china hand sinks. The ADA fixtures located in the public restrooms are electronically operated.</p> <p>The building contains a stainless steel service sink, located in electrical room 1, and wall-mounted ADA water coolers located in the corridors of the facility.</p> <p>Other plumbing fixtures include: a kitchen stainless steel double compartment sink that has manual controls.</p> <p>Deficiencies noted included signs of a clog in the drain piping of the double compartment sink. It was reported by facility staff that the plumbing system had been backed up twice since 2014, both times requiring a sewer line cleanout and once requiring an environmental impact statement due to the backup of sewage into the facility.</p>	
Domestic Water Distribution	<p>The plumbing system has a domestic water service feed from an 80-gallon, 199.9 MBH gas water heater located in an electrical room. There is another 30-gallon electric water heater in good condition.</p> <p>Deficiencies noted included the 80-gallon water heater was installed in 1998 and had surpassed its typical design service life.</p>	2 - Poor

Other Plumbing	<p>Other plumbing assets include floor drains associated with the water heaters, and roof drains.</p> <p>Deficiencies noted included a clogged roof drain with a missing dome.</p>	4 - Good
D30 HVAC		
Mechanical / HVAC	<p>The major mechanical equipment consists of rooftop package air condition units to service all of the heating, ventilating, and air conditioning (HVAC) system.</p> <p>There are 16 rooftop package air conditioning units. The rooftop units are air cooled with gas heat and range in capacity from 3-ton to 7.5-ton and have install dates ranging from 2004 to 2013.</p> <p>Supplemental mechanical equipment for the HVAC system also includes roof mounted exhaust fans serving the restrooms and general exhaust, and a split-system heat pump unit.</p> <p>Deficiencies noted included a failed compressor on one of the rooftop units, and one unit had disconnected condensate piping allowing it to drain on the roof. Five units were using R-22 refrigerant; which is being phased out of construction and manufacturing use. One of the rooftop units appeared to be non-functional at the time of the assessment.</p>	3 - Average

1. Perform inspection on sanitary sewer system serving the facility, make necessary repairs.
2. Replace the 80-gallon water heater, which has surpassed its typical design service life.
3. Remove debris from clogged roof drain and install new dome.

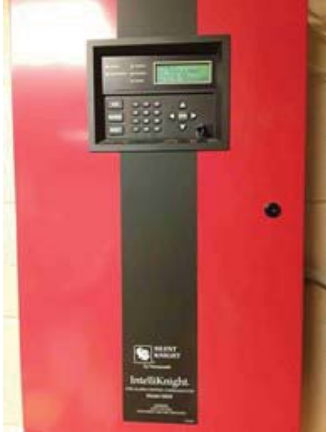
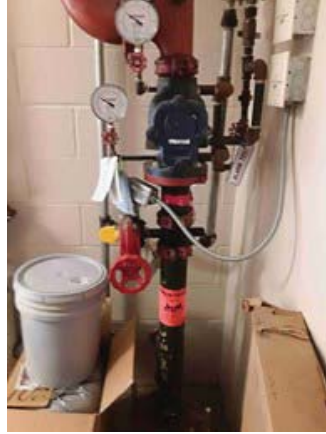
Subsystem	Condition and Deficiency Overview	System Condition Rating
	<p>throughout the facility.</p> <p>It was reported by facility staff that they received frequent calls from the alarm company that indicates a “periodic test with system failure” on the automated message. The error message was not observed at the time of the assessment.</p>	
Fire Protection/ Suppression	<p>The building has a system for fire protection which serves the entire building. The fire protection system service equipment includes a fire riser.</p> <p>The building did not have supplemental, portable fire extinguishers. Deficiencies noted included an expired inspection certification that did not meet the annual inspection requirement, it was reported by facility staff that the system was yellow-tagged by the fire inspector due to a missing duct detector cover on one of the units in the gymnastics gym.</p>	1 - Fail
D50 Electrical

1. Investigate cause of frequent system failure alarm on fire alarm equipment and make necessary repairs or replacement.
2. Repair duct detector cover in gymnastic gym and have fire inspector conduct inspections of the system.

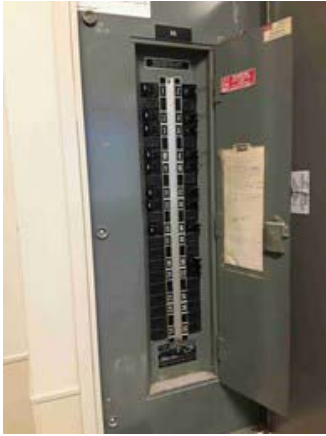
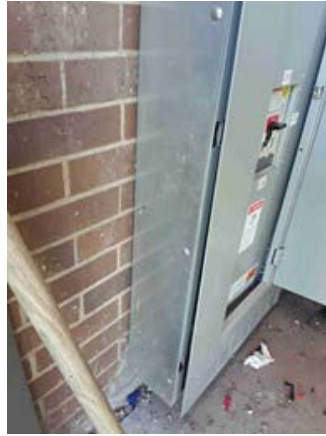
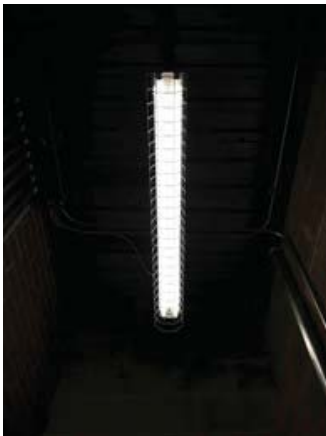
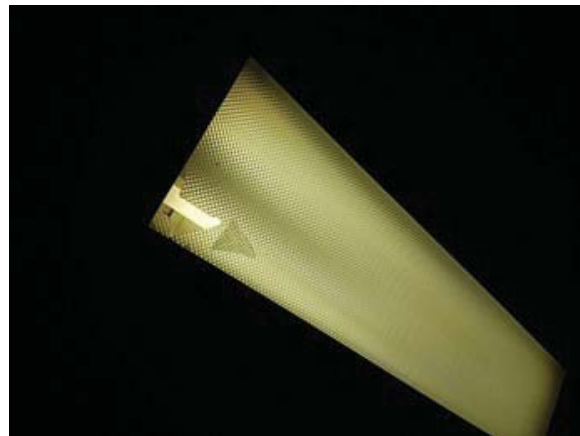
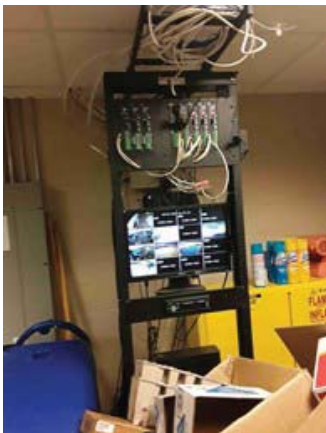
Electrical Distribution	<p>The electrical service enters the building at the 120/208-volt, 3 phase 800-amp main switchgear panelboard (MP) which is located in electrical room 1, and delivers power throughout the building. There are six 120/208-volt panelboards. These distribution and branch panelboards are primarily located in electrical room 1 & 2, the exterior mechanical room, and in one of the assembly rooms. Panel NA appears to be original to building construction in 1960; all other distribution equipment appears to be installed during the 2012-2014 building renovation.</p> <p>The building contains an uninterruptible power supply that serves the IT/server equipment.</p> <p>Deficiencies noted included aged and out-of-date Panel NA which was a Federal Pacific panel and had exceeded its typical design service life. The front cover on Panel AC was not secured. It was reported by facility staff that the gymnasium lacks accessible electrical outlets, and that several groups utilizing the facility for private reservations had frequently tripped the circuit breakers when they had only a few things plugged in at the same time.</p>	3 - Average

1. Replace Federal Pacific Distribution Panelboard NA.
2. Replace missing screws on panelboard housing enclosures.
3. Replace lighting fixture lamps as needed. Replace incandescent and florescent light fixtures with LED as needed.
4. Replace lighting fixture lenses that are missing or broken. Additionally, clean and maintain all lenses from staining and any residue build-up for efficient lighting output.
5. Replace outdated security DVR system and install additional cameras to cover entire building.
