Beckley-Saner Recreation Center Summary

Address	114 West Hobson Avenue, Dallas, TX 75224
Building Purpose	Recreation Center
Original Year of Construction	1949
Building Area	34,510 SF
Inspection Date	July 14, 2016
Inspection Conditions	98°F, Sunny

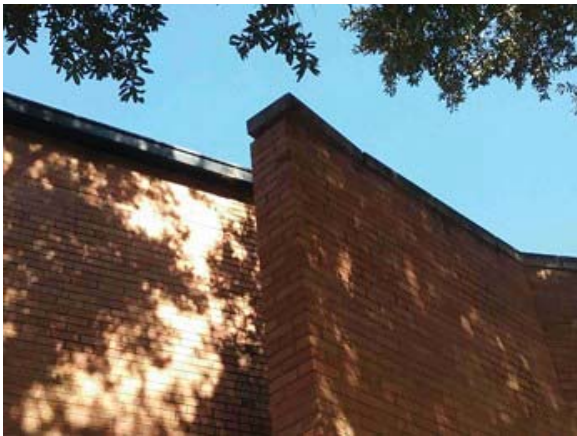
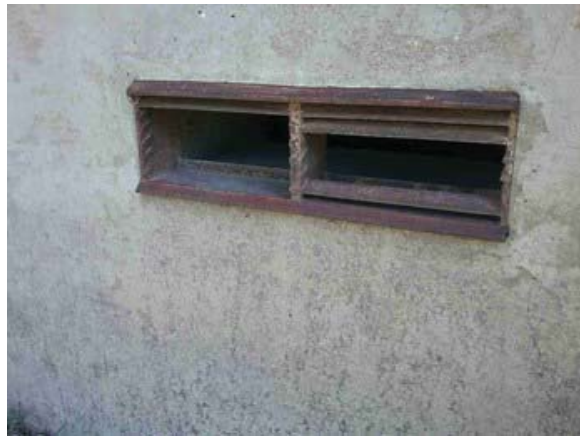
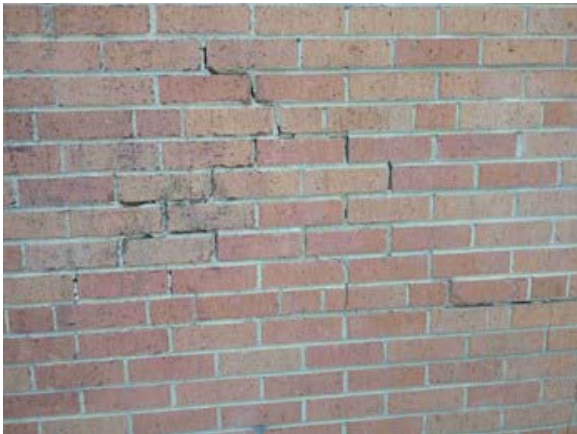
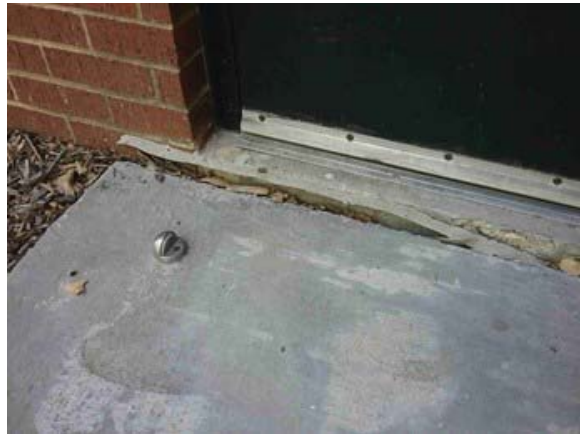
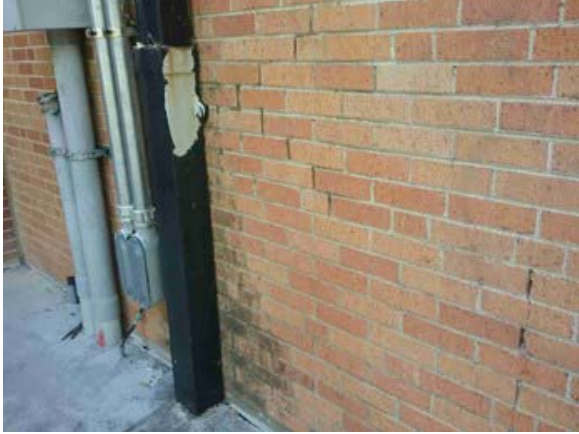
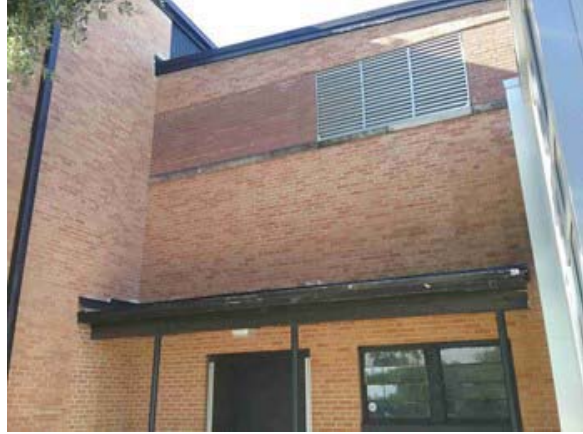
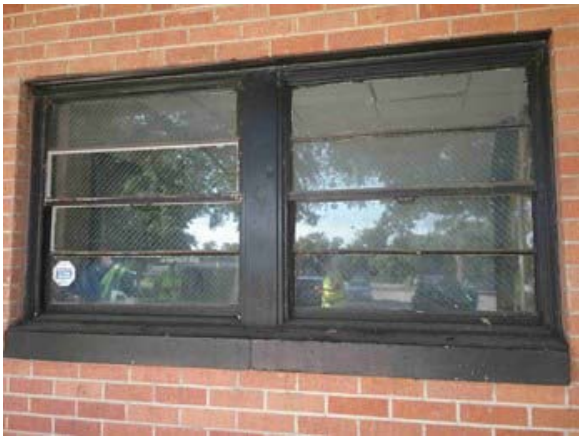
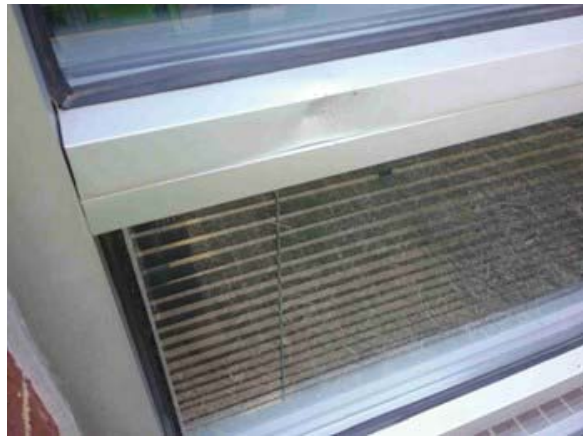
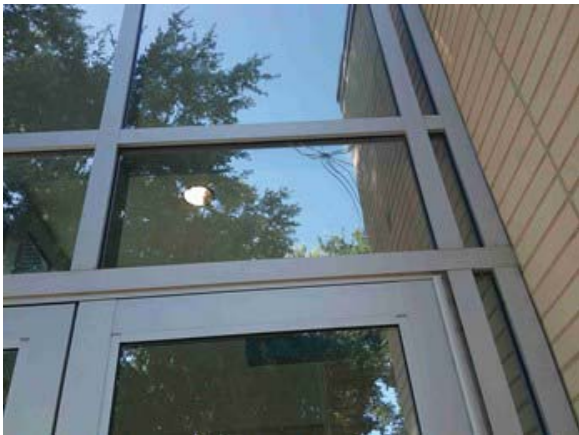
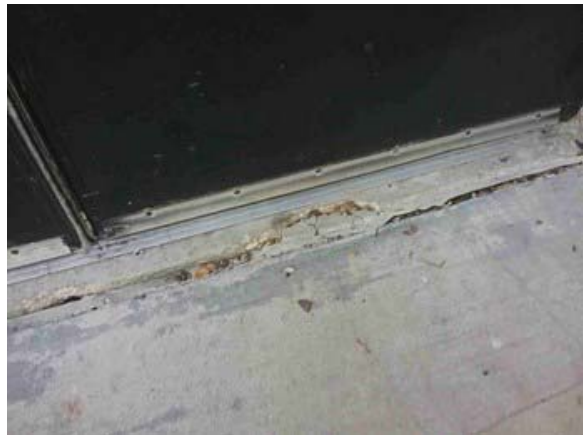
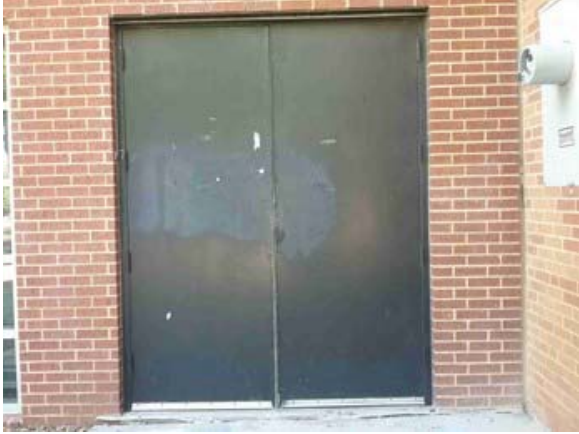
Subsystem	Condition and Deficiency Overview	System Condition Rating
B20 Exterior Enclosure		
Exterior Walls	<p>The exterior wall of the original building consists of a red brick facade. The exterior wall of the addition, reportedly added in 2013, consists of a white brick facade. The main entry wall consists of stucco.</p> <p>Deficiencies noted included deteriorated louvers on the south side of the building. On the east side of the building, near the egress canopy, the block at the top of the wall appeared to be separated from its mortar with the potential of falling off. On the south side of the building large vertical cracks were present in the red brick, the sidewalk appeared to be settling and there was minor cracking in the foundation at the corners. The brick ledge on the north side of the building was stained. A large air vent appeared to contain a bird nest.</p>	3 - Average
Exterior Windows	<p>The exterior window on the original building consists of an approximately 3-foot by 6-foot window with a painted metal frame and metal reinforced glass. The exterior windows on the new addition of the building are primarily glass windows with aluminum frames that are floor-to-ceiling. On the south side of the building, the windows are approximately 6.5-foot by 8-foot. Some windows on the new addition have metal ledges under the window.</p> <p>Deficiencies noted included a dent in the aluminum frame of a window on the south wall. The window and frame on the original building appeared to be painted which may affect operability. There was a crack in the window over the door on the north wall.</p>	4 - Good

Exterior Doors	<p>There is one main public entryway located on the west side of the building with glass doors in metal frames. There is one main public exit on the north side of the building with glass doors in metal frames and interior hardware only. The remaining service doors are primarily metal and located along the entire perimeter of the building.</p> <p>Deficiencies noted included damage to the concrete pad under several service doors. The paint on the service doors was typically worn or scratched.</p>	4 - Good
B30 Roofing		
Roof	<p>The roof construction of the original structure is assumed modified bitumen. The roof was not accessible for assessment. Roof replacement is reportedly scheduled for the near future. A small section of the roof of the original structure is asphalt shingles. The roof construction of the new addition is assumed single ply membrane. The new roof was reportedly installed in 2013.</p> <p>Other roofing features include wood fascia, metal gutters, and egress canopies constructed of wood on the original structure.</p>	3 - Average

1. Repair deteriorated brick at top of walls.
2. Repair or replace louvers on the south side of the building.
3. Power wash stained brick.
4. Remove bird nest from behind vents and remove debris from vents.
5. Investigate operability of the window on the original building.
6. Repair dent in the damaged window frame.
7. Replace broken glazing over the door on the north wall.
8. Repair concrete pad under service doors.
9. Paint exterior metal service doors.

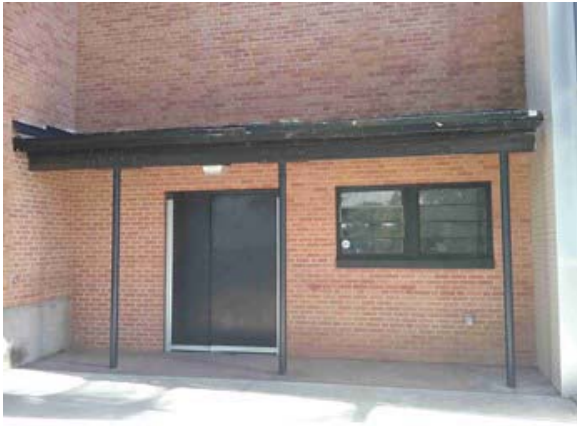
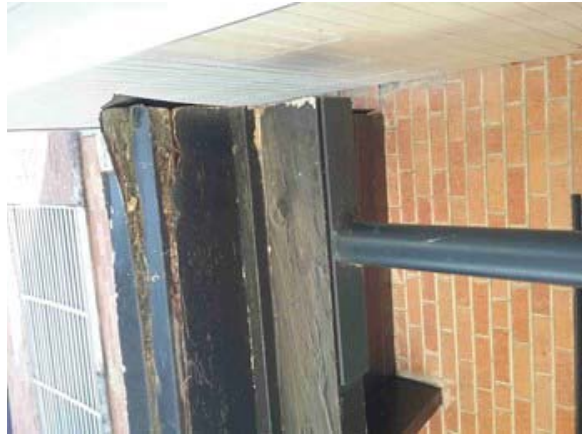
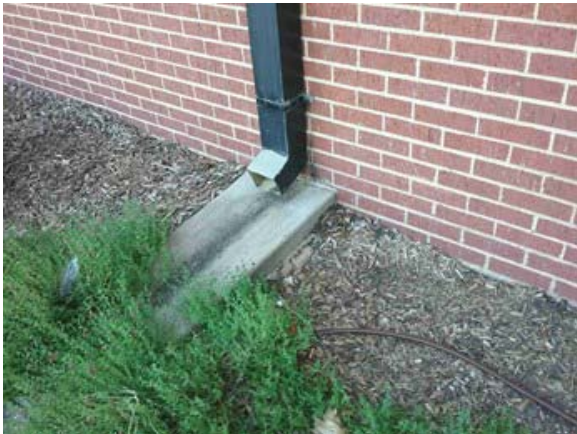
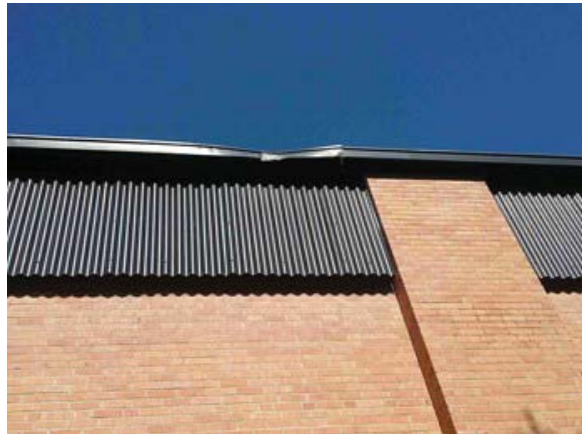
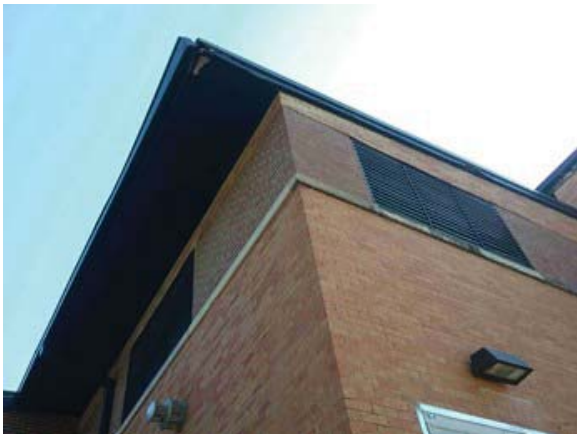
Subsystem	Condition and Deficiency Overview	System Condition Rating
	<p>Deficiencies noted included reported leaks in the gym and multipurpose room. The roof portion containing shingles appeared worn. Deteriorated flashing on the roof of the original structure was observed. The flashing and wood on the egress canopy on the north wall was damaged and the wood appeared to be decaying. In several locations, the gutters were bent, damaged, or detached from the building. Multiple downspouts had chipped paint; several were damaged. In several locations, the soffit was damaged. The egress canopy on the east side of the building appeared to be failing and significantly damaged.</p>	
C10 Interior Construction		
Interior Walls	<p>The main entry into the building consists of brick walls. The main hallways, multipurpose rooms, restrooms, and closets consist of gypsum board walls. There are interior windows with metal frames along the wall of the fitness room. The press box in the gym consists of metal panels and interior windows. The recreation facility walls, flooring, kitchen, and restroom underwent renovations in 2013.</p> <p>Deficiencies noted included a damaged air vent in the wall of the gym. The gypsum board walls in the multipurpose rooms had minor damage.</p>	4 - Good

1. Replace the egress canopies around the perimeter of the building.
2. Replace the flashing when the roof is replaced.
3. Paint the downspouts and replace sections of downspouts that are damaged.
4. Replace damaged sections of gutters.
5. Replace damaged soffit.

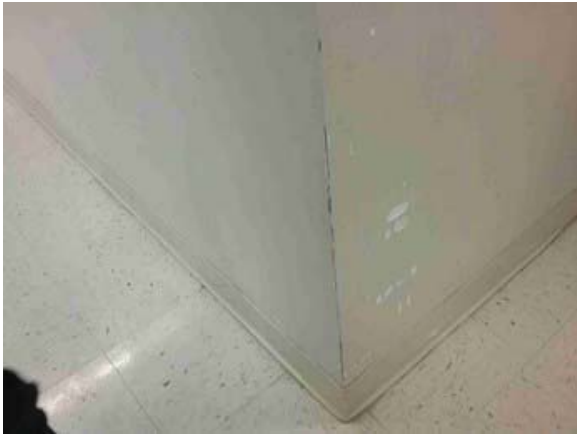
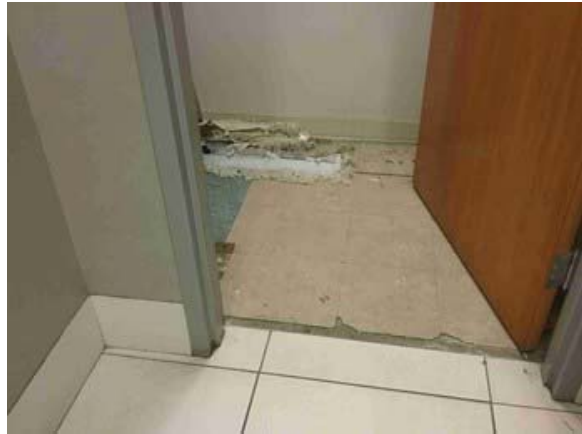
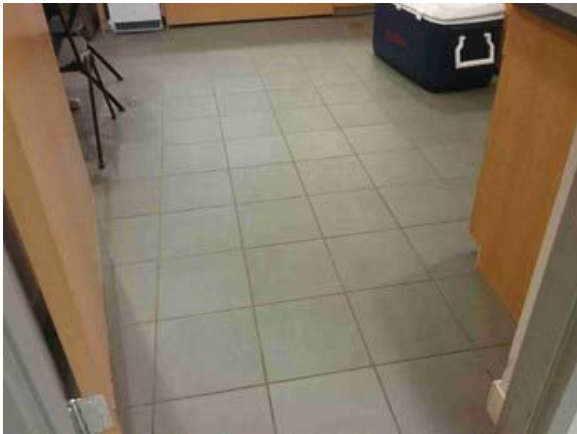
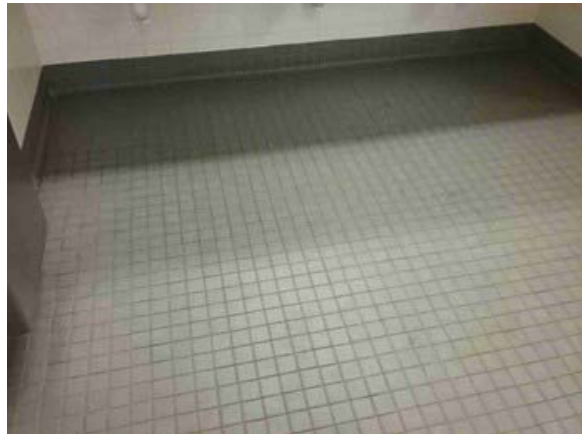
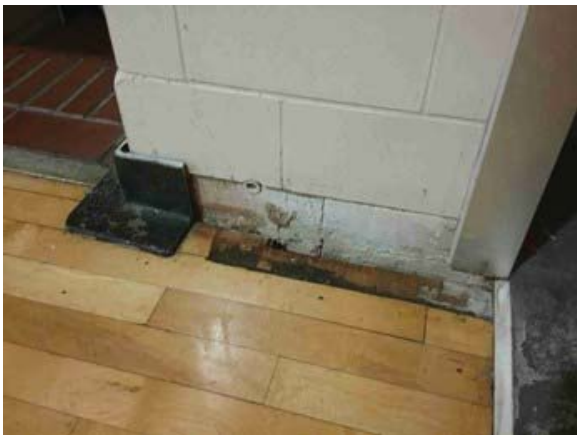
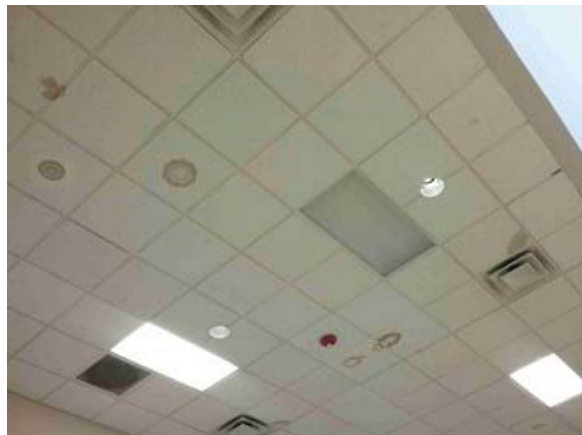
Interior Floor Finishes	<p>The lobby, kitchen, bathroom, closets, and main hallway contain tile flooring. The riser room, multipurpose rooms, and activity rooms have vinyl composition tile (VCT) flooring. The computer room, office, and press box in the gym have carpeting. The mechanical room has</p>	4 - Good

Subsystem	Condition and Deficiency Overview	System Condition Rating
	<p>unfinished concrete flooring. The gym has finished wood flooring. The steps to the storage closets in the gym are brick.</p> <p>Deficiencies noted included chipped and damaged VCT in the storage room and gym supply closet. The grout around the tiles in the bathroom and kitchen was stained. Sections of rubber wall base were missing in the gym.</p>	
Interior Ceiling Finishes	<p>The multipurpose room, gym, and hallways consist of suspended acoustical ceiling tile (ACT). The kitchen contains gypsum board ceilings.</p> <p>Deficiencies noted included multiple damaged ceiling tiles in the gym. There were stains suggesting water damage on some tiles in the multipurpose room. Facility staff noted that they believed leaks in the multipurpose room were new and had not been repaired yet.</p>	3 - Average
D10 Conveying		
Elevators, Lifts, and Escalators	System not present.	N/A

1. Patch and/or repaint areas of damaged gypsum board walls.
2. Replace damaged VCT flooring in the storage room and closet.
3. Clean the grout in the restrooms and kitchen.
4. Install rubber wall base where missing in the gym.
5. Determine source of water leaks in gym and multipurpose room and repair.
6. Replace damaged acoustical ceiling tiles.
