# Campbell Green Recreation Center Summary

<b>Address</b>	16600 Park Hill Drive Dallas, TX 75248
<b>Building Purpose</b>	Recreation Center
<b>Original Year of Construction</b>	1989
<b>Building Area</b>	18,199 SF
<b>Inspection Date</b>	August 15, 2016
<b>Inspection Conditions</b>	77° F, Light Rain

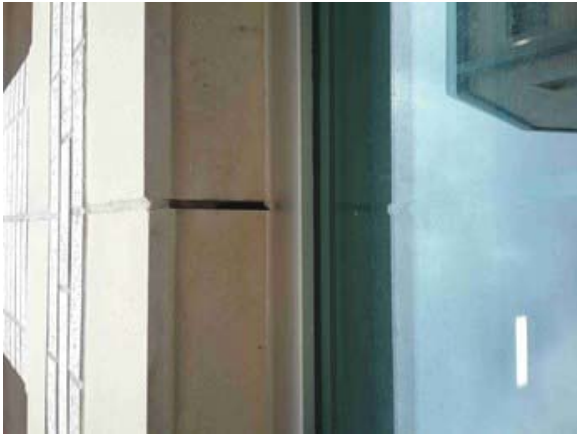
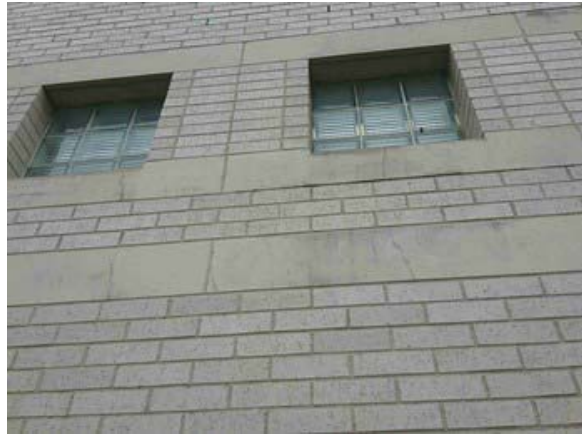
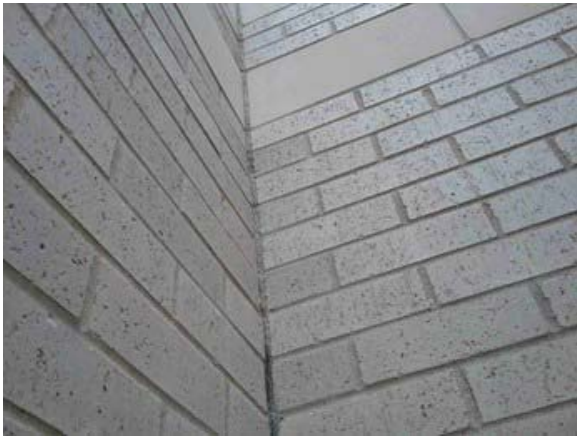
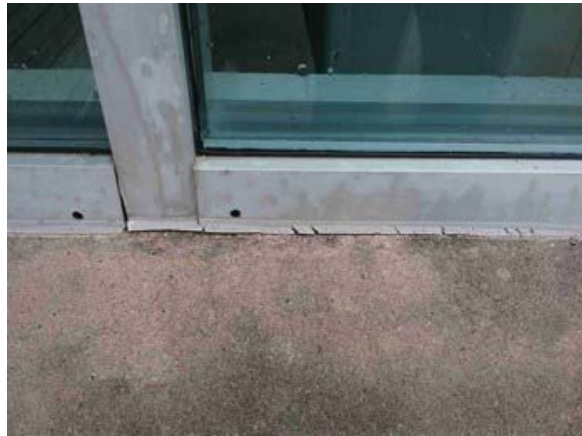
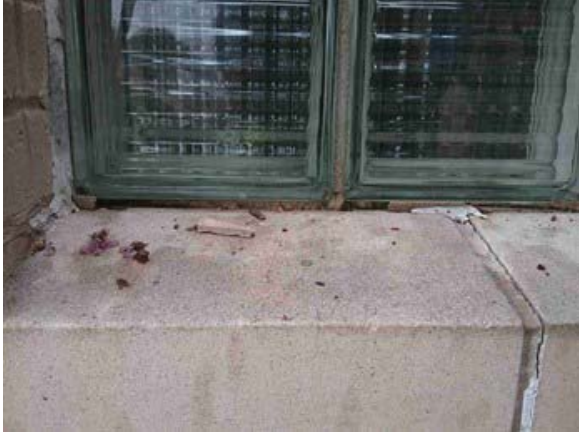
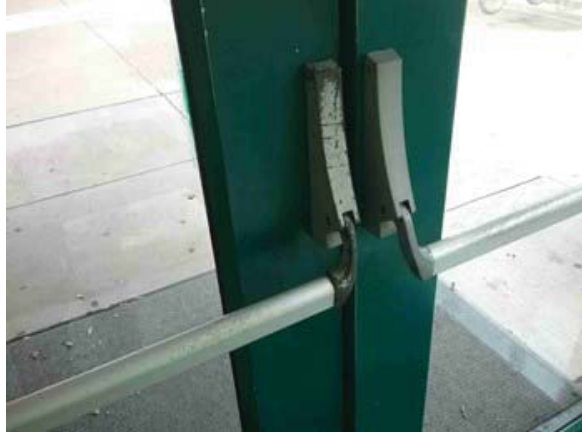
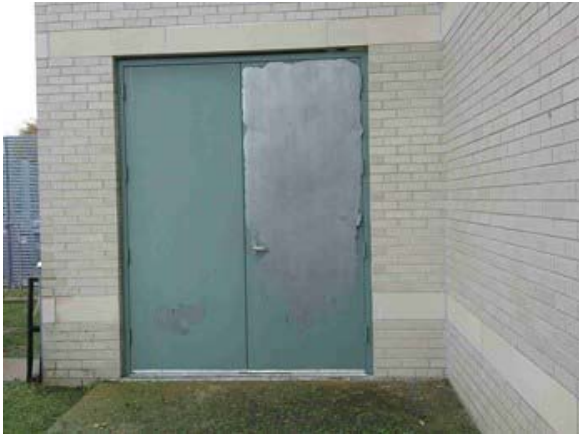
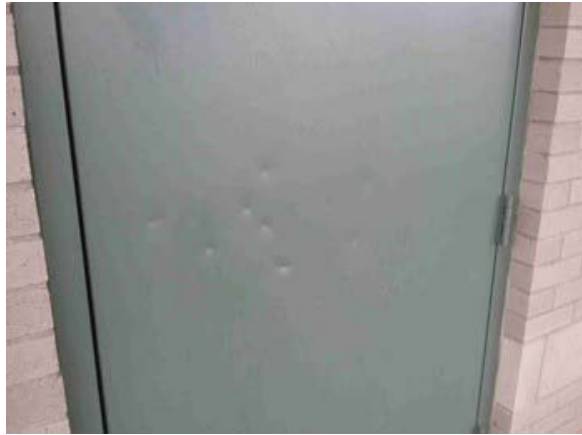
Subsystem	Condition and Deficiency Overview	System Condition Rating
<b>B20 Exterior Enclosure</b>		
<b>Exterior Walls</b>	<p>The exterior walls consist of a brick façade with rows of stone blocks. There are stone lintels and sills at the door and window openings. Deficiencies noted included mortar that was cracking, missing or separating from the stone blocks. There were minor cracks observed in the stone below the windows. The sealant at the interior wall corners was aged and cracking.</p>	3 - Average
<b>Exterior Windows</b>	<p>The exterior windows consist of a combination of approximately 20-inch square windows with metal frames located around the perimeter of the courtyard and 7-inch glass block windows located around the perimeter of the building. There are metal frames installed over the glass panes on the interior side of the windows on the east side of the gym. Deficiencies noted included missing or damaged sealant between the window frame and wall of multiple windows. The grout was missing between the glass block and wall in several locations.</p>	Good

<b>Exterior Doors</b>	<p>There is one main public entryway located at the south side of the building, which consists of glass doors with a metal frame and storefront windows. The service doors are metal with metal frames and located along the south and east sides of the building. There are additional public access doors at the courtyard that consist of double glass doors with metal frames. Deficiencies noted included damage to the closing hardware on the main entry door. The main entry doors did not close completely without being pulled closed and were difficult to open. The hardware on the main entry doors was worn. The paint on the service doors was chipping or worn. There were multiple dents on one of the service doors.</p>	4 - Good
<b>B30 Roofing</b>		
<b>Roof</b>	<p>Roof construction is a steep-slope standing seam metal system. The roof was inaccessible at the time of the assessment due to the steep slope. The roof construction is formed metal standing seam. The fascia under the main entry overhang is plaster. The roof is assumed to be installed in 1991 based upon facility feedback. Other roofing features include: metal flashing, gutters and downspouts. Deficiencies noted included minor damage to the gutters. The downspout in the courtyard was bulging and appeared to be clogged. Several of the downspouts were damaged. Facility staff reported that water intrusion has been observed in the hallway by activity room c and in the closet in the gym. Facility staff reported that they place trash cans below the known locations of water intrusion during rain events.</p>	3 - Average

1. Replace deteriorated mortar between stone blocks and at windows and openings.
2. Monitor the minor cracks in the stone.
3. Replace the sealant at the interior wall corners.
4. Replace the sealant between the window frames and the walls where it is damaged or missing.
5. Replace the grout between the glass block and the wall where it is damaged or missing.
6. Replace the hardware, including the closing hardware, on the main entry doors.
7. Paint the service doors.
8. Replace service doors that have dents.

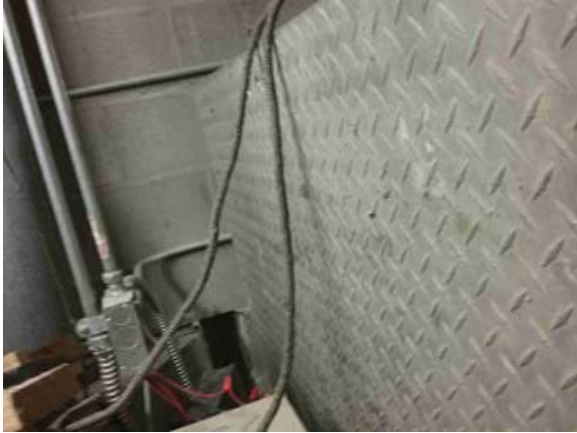
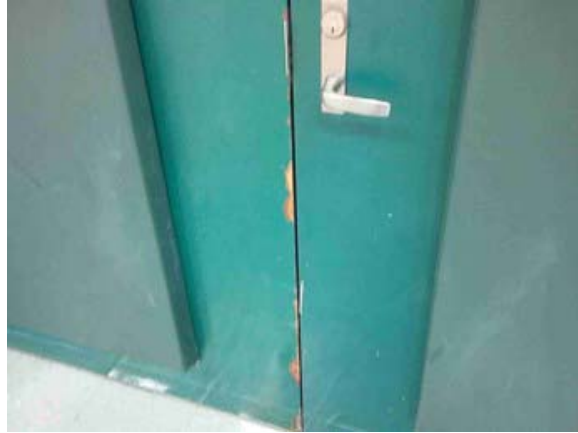
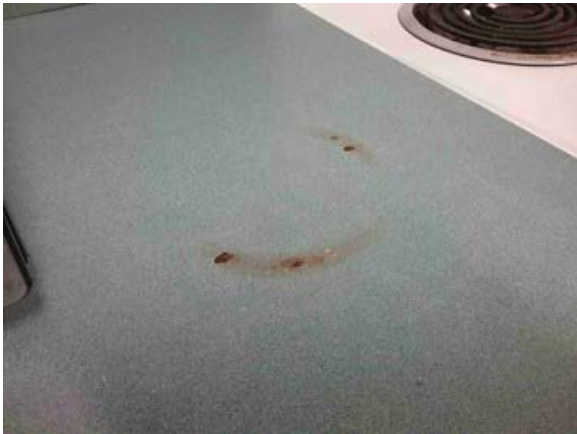
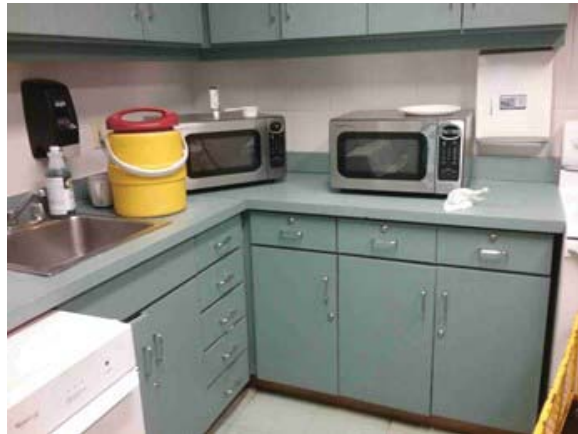
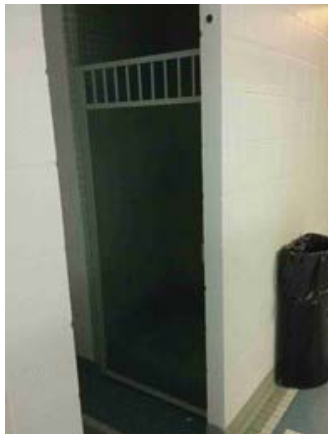
Subsystem	Condition and Deficiency Overview	System Condition Rating
<b>C10 Interior Construction</b>		
<b>Interior Walls</b>	The building contains primarily concrete unit masonry (CMU) interior walls. The walls in the office are gypsum board. There are windows with metal frames located between the activity rooms and the lobby and hallway. There is a store front with windows with metal frames installed around the lobby office. There are glass block windows installed above the gym entrance. The gym has an automatic-retractable partition wall. The activity room has two manually-retractable fabric partition walls. No deficiencies were observed or reported at the time of the assessment.	4 - Good
<b>Interior Doors</b>	The doors to the main rooms are glass. Doors to the mechanical closets, gym, and the office in the lobby are metal. The doors to the gym are approximately 4-foot wide. The doors to the restrooms and storage closets are press board with a laminate finish. The kitchen has two split painted solid-core wood doors. The doors are set in metal frames. Deficiencies noted included a missing handle on the top of the hatch to the mezzanine level in the activity room storage closet. The laminate was damaged on several doors.	Good

<b>Interior Specialties</b>	The building has special interior construction such as lockers, cabinets in the kitchen, fire extinguisher cabinets in the fitness room and gym and partitions between the stalls in the restrooms. Deficiencies noted included damage to the laminate on the kitchen counter. Several of the cabinet doors in the kitchen did not close properly. The glass door to the shower in the restroom was difficult to close.	4 - Good
<b>C20 Stairs</b>		
<b>Exterior Stairs</b>	System not present.	N/A
<b>Interior Stairs</b>	System not present.	N/A
<b>C30 Interior Finishes</b>		
<b>Interior Wall Finishes</b>	The walls are primarily painted concrete unit masonry (CMU). There are acoustical panels installed over the CMU in the fitness room. The walls at the office in the lobby and the check-in desk have a laminate finish. There are 2-inch square ceramic tiles installed behind the water fountain. Deficiencies noted included damage to the metal air return covers. The laminate around the check-in desk was damaged.	4 - Good

1. Replace the handle on the hatch to the mezzanine level in the activity room storage closet.
2. Replace doors with damaged laminate.
3. Replace the damaged portion of the laminate kitchen counter.
4. Replace malfunctioning kitchen cabinet hardware.
5. Replace the hardware on the glass door in the restroom shower.

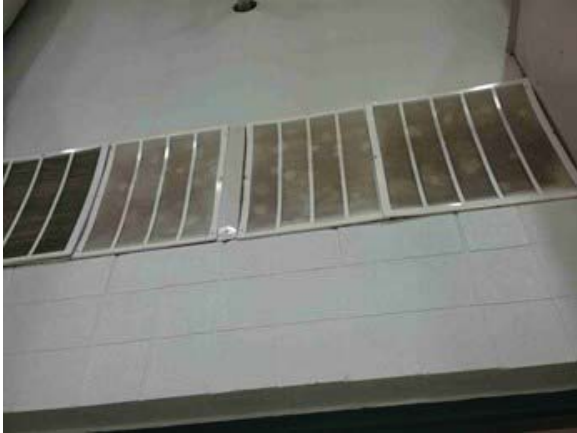
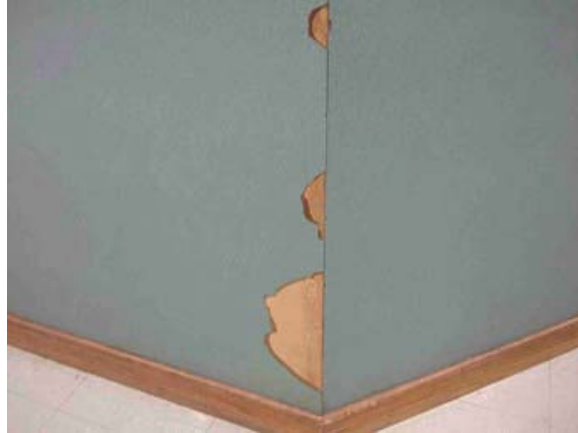
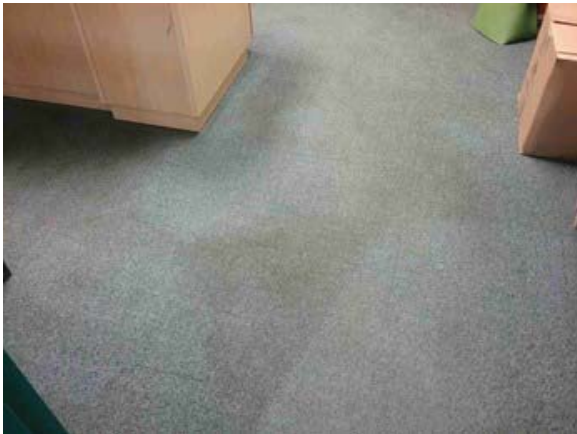
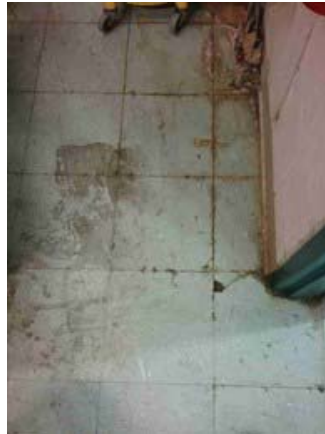
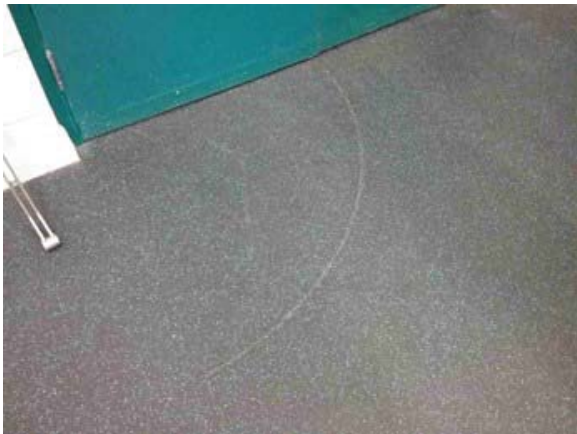
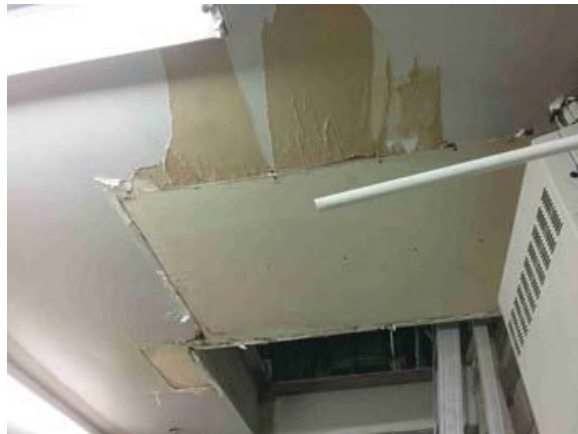
<b>Interior Floor Finishes</b>	The floors are primarily vinyl-composition tile (VCT). The fitness room and activity room have rubber flooring. The office has carpet flooring. The restrooms have 2-inch by 2-inch square ceramic tile floors. The gym has sealed wood floors in the center of the room with VCT around the perimeter of the room. Deficiencies noted included minor stains on the carpet in the office. There were minor chips on several sections of VCT in the gym. The VCT in the storage room was significantly damaged. The rubber floor in the fitness room was damaged at the closet door.	4 - Good
<b>Interior Ceiling</b>	The fitness room and storage closet, activity room C, main lobby,	4 - Good

1. Replace the damaged metal air return covers.
2. Replace the damaged laminate at the check-in desk.
3. Replace the carpet in the office.
4. Replace damaged vinyl-composition tiles (VCT) throughout the building.
5. Replace the damaged rubber floor in the fitness room.
6. Replace damaged gypsum board in the storage closet in the gym and finish and paint to match surrounding ceiling finish.

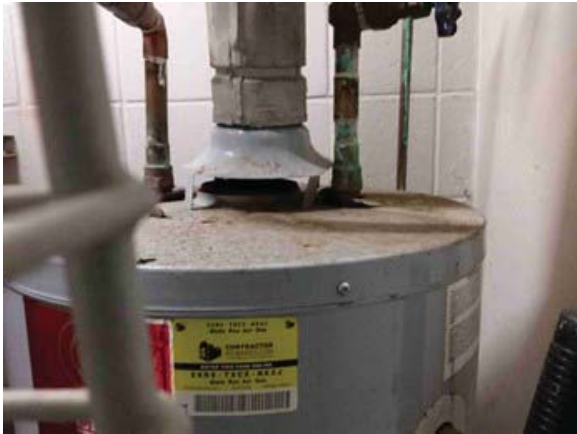
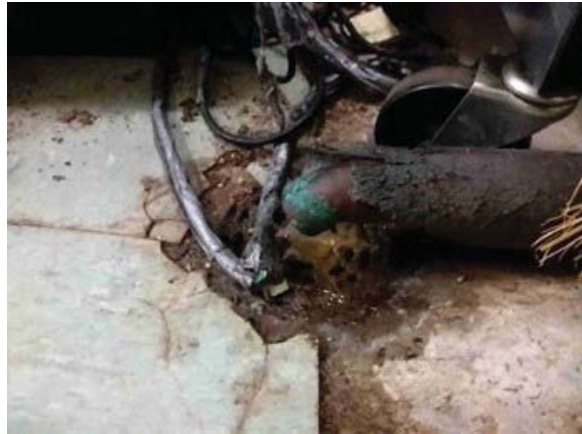
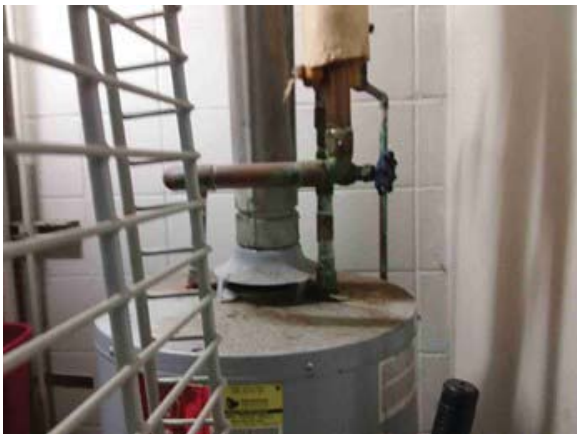
<b>Domestic Water Distribution</b>	The plumbing system has a domestic water service feed to a 40-gallon State tank type water heater with 40-MBH heating input located in the gymnasium storage room.  Deficiencies noted included the water heater was observed with a misaligned gas flue. The piping connections for the water heater were observed with damaged insulation.	3 - Average
<b>Other Plumbing</b>	Other plumbing assets include: floor drains located in the restrooms and gymnasium storage room  Deficiencies noted included the floor drain in the gymnasium storage room was observed with grime built up.	3 - Average
<b>D30 HVAC</b>		
<b>Mechanical / HVAC</b>	The major mechanical equipment consists of condensing units and air handling units to service all of the heating, ventilating, and air conditioning (HVAC) system.  The mechanical system consists of direct-expansion split systems. There are ten condensing units located on grade in a main mechanical area. The condensing units have cooling capacities ranging from 4-ton to 7.5-ton. The air handling units pair with the condensing units. Several of the air-handling units were inaccessible at the time of the assessment.  There was no supplemental equipment for the HVAC system.  Deficiencies noted included aged and out-of-date air handling units that	3 - Average

1. Repair the misaligned gas flue.
2. Repair damaged insulation on water heater piping.
3. Remove debris from gymnasium storage room floor drain to allow for proper drainage.

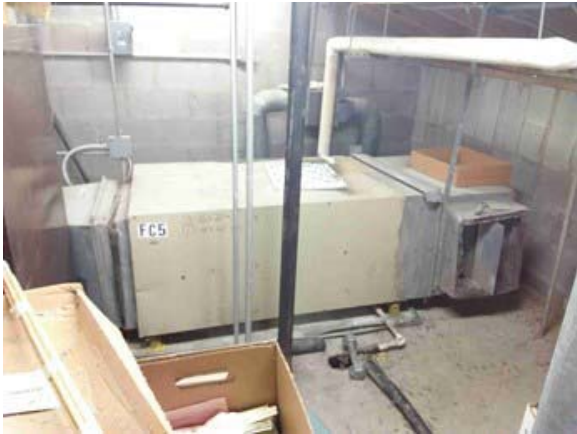
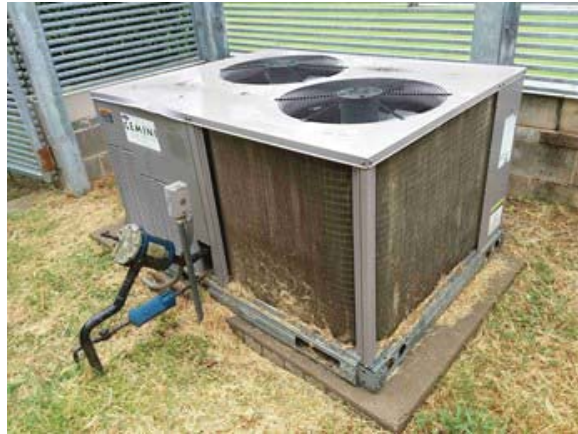
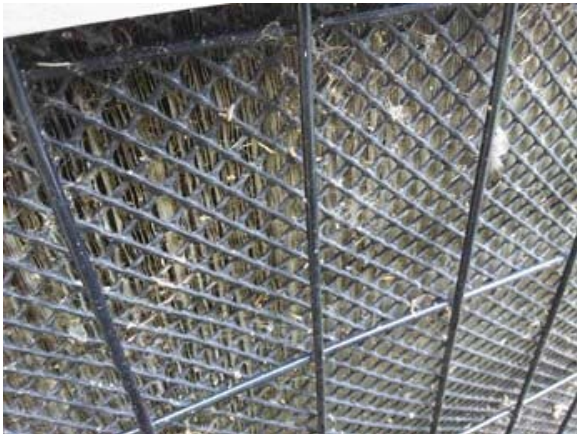
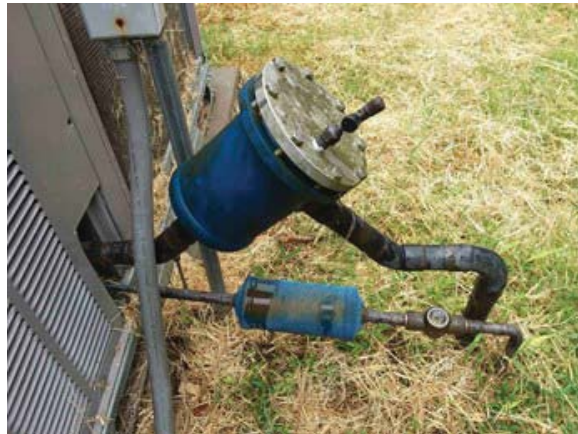
Subsystem	Condition and Deficiency Overview	System Condition Rating
	<p>were installed in 1991 and have exceeded their typical design service life. Several condensing were using R22 refrigerant which is being phased out of manufacturing and construction use. Numerous condensing units had debris or damage to their condensing fins, and four had damaged refrigerant insulation. Several condensing units were lacking refrigerant insulation all together. It was reported by the facility staff that the activity room and the gymnasium had cooling issues.</p>	
<b>D40 Fire Protection</b>		
<b>Fire Alarm</b>	<p>The building has a fire alarm system that consists of alarm and signaling devices such as strobes, horn/strobe combinations, pull stations, and detectors.</p> <p>The fire alarm system control equipment includes an addressable multi-zone Faraday fire alarm control panel.</p> <p>No deficiencies were observed or reported at the time of the assessment.</p>	4 - Good

1. Replace aged air handling units that have surpassed their typical design service life.
2. Plan to replace all equipment that uses R22 refrigerant in the upcoming years.
3. Repair the condenser cooling fins to remove dirt and debris for efficient operation.
4. Replace damaged and cracking insulation on refrigerant lines and install refrigerant insulation on non-insulated lines.

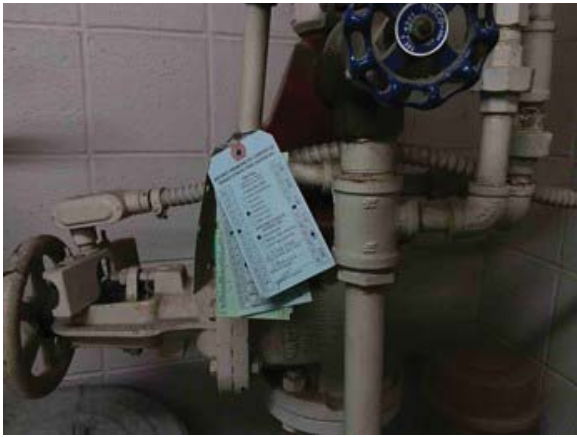
<b>Fire Protection/ Suppression</b>	<p>The building has a wet pipe system for fire protection which serves the entire building. The fire protection system service equipment includes a fire riser located in the mechanical room storage closet. This fire protection system does not have an inspection certification within the last year as required.</p> <p>The building also has supplemental, portable fire extinguishers for fire suppression which have inspection tags dated within the last year as required.</p> <p>Deficiencies noted included that the fire riser was last inspected in July of 2013.</p>	3 - Average
<b>D50 Electrical</b>		
<b>Electrical Distribution</b>	<p>The electrical service enters the building at the with 120/208-volt 800-amp switchgear designated "MSB" which is located in the main electrical room and delivers power to throughout the building. The distribution panelboards have capacities ranging from 400-amp to 600-amp.</p> <p>Deficiencies noted included several aged panelboards located throughout the building.</p>	4 - Good

1. Perform overdue yearly inspection of the fire riser and replace if needed.
