## Cummings Recreation Center Summary

Address	2900 Cummings Street Dallas, TX 75216
Building Purpose	Recreation Center
Original Year of Construction	1970 (Renovated in 2014)
Building Area	19,752 SF
Inspection Date	August 17, 2016
Inspection Conditions	77° F, light rain

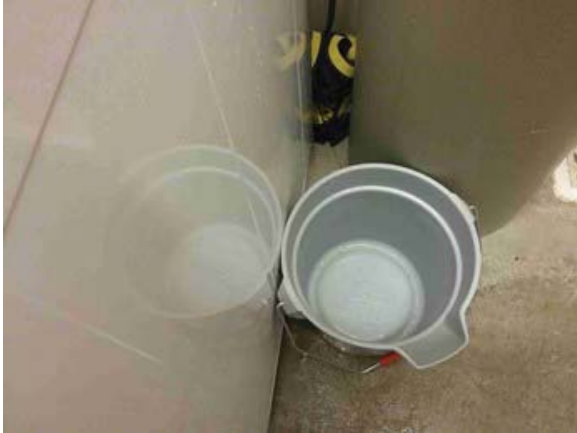
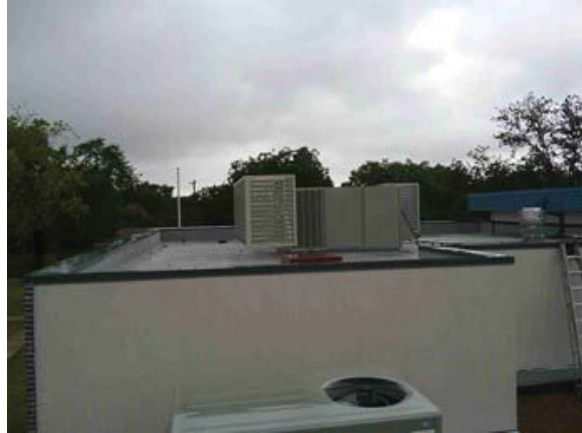
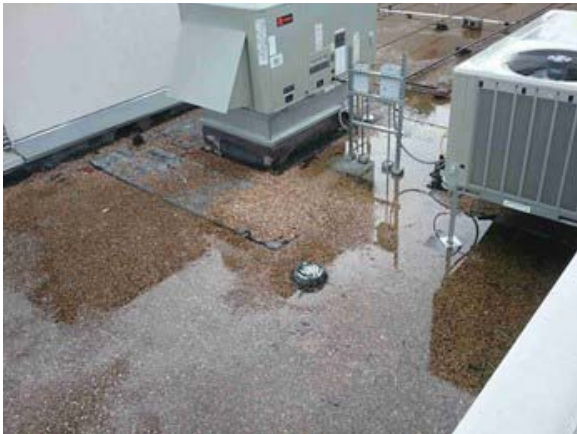
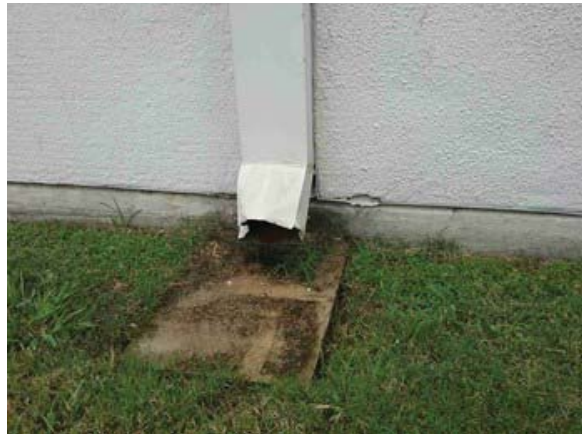
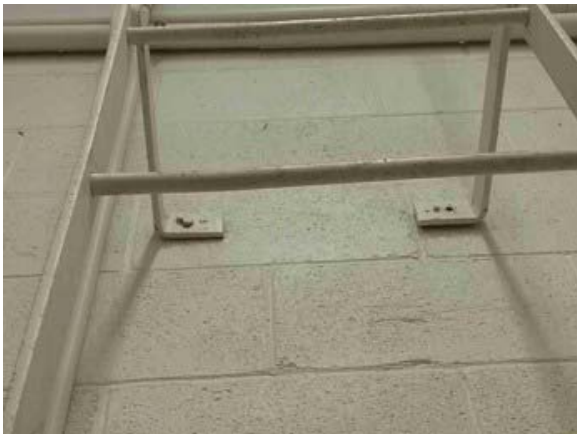
<b>Exterior Doors</b>	<p>There are two main public entryways located at the north and northeast sides of the building, which consist of double glass doors with metal frames. The remaining doors are metal service and emergency exit doors, located on the south, east and west sides of the building.</p> <p>No deficiencies were observed or reported at the time of the assessment.</p>	4 - Good
<b>B30 Roofing</b>		
<b>Roof</b>	<p>The roof covering over the new addition is modified bitumen. The roof is assumed to be installed in 2014, the year the new addition was constructed. The roof covering over the original building is a built-up tar and gravel system. The roof is assumed to be installed in 1995 based on the condition at the time of the assessment, and the typical design service life of the roofing material.</p> <p>Other roofing features include: downspouts around the perimeter of the original building, metal fascia at the new addition, six skylights in the gym, an access hatch and ladder, and metal flashing.</p> <p>Deficiencies noted included reports from facility staff of water intrusion throughout the building. Facility staff reported that the water intrusion was the origin of staining to the interior ceiling finishes in the multi-purpose room. During the assessment water dripping from the ceiling was observed. Water was observed to be ponding on the built-up section of the roof. Several downspouts were damaged at the outlet or separated at a connection point. The ladder to access the roof had several bolts that were loose or missing.</p>	2 - Poor

1. Determine the source of the water intrusion into the building addition, and repair the roof to prevent future water intrusion.
2. Replace the built-up roof system over the original building.
3. Address various sloping and drainage issues on the roof of the original building.
4. Replace or repair damaged downspouts.
5. Repair roof access ladder.

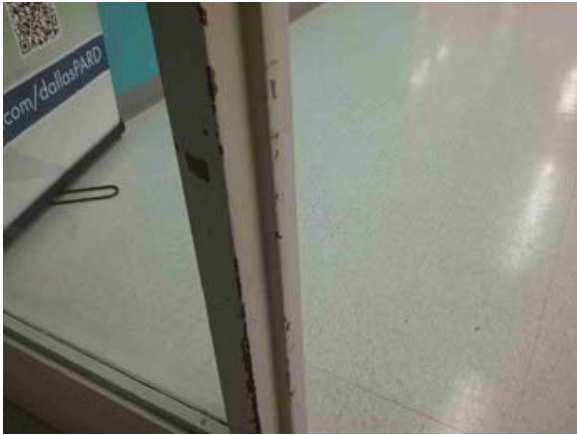
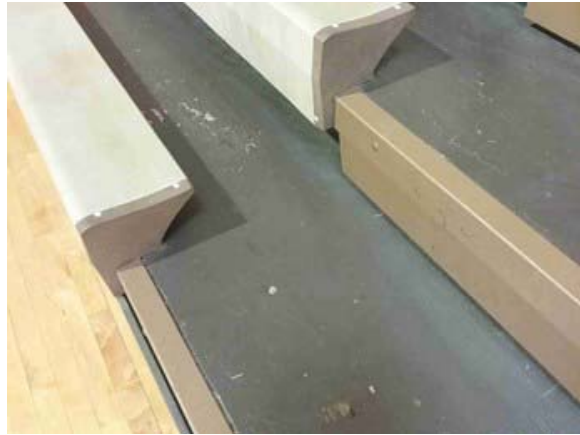
Subsystem	Condition and Deficiency Overview	System Condition Rating
<b>C10 Interior Construction</b>		
<b>Interior Walls</b>	<p>The building contains primarily gypsum board walls. The hallway and gym contain concrete masonry unit (CMU) walls. There are floor to ceiling windows with metal frames in the hallway, located at the fitness room and activity center. There are additional various sized windows in the hallway. The control room has store front windows.</p> <p>No deficiencies were observed or reported at the time of the assessment.</p>	4 - Good
<b>Interior Doors</b>	<p>The majority of the interior doors are wood veneer with metal frames. The multipurpose room has double doors and the door to the computer room is 4-foot wide. The doors to the gym and fitness room are metal with a metal frame. The fitness room doors have a window. There is an automatically operated metal gate in the computer room. There is a manually operated metal overhead door that is approximately 3-foot by 4-foot in the control room.</p> <p>Deficiencies noted included paint that was chipping on the metal door frames.</p>	4 - Good

1. Paint the metal door frames.
2. Paint the wood floor boards on the bleachers in the gym.

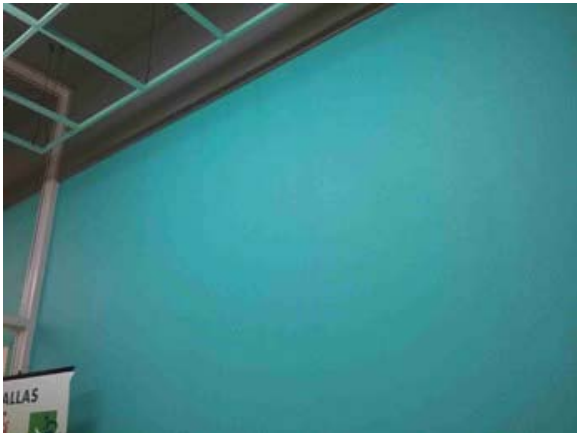
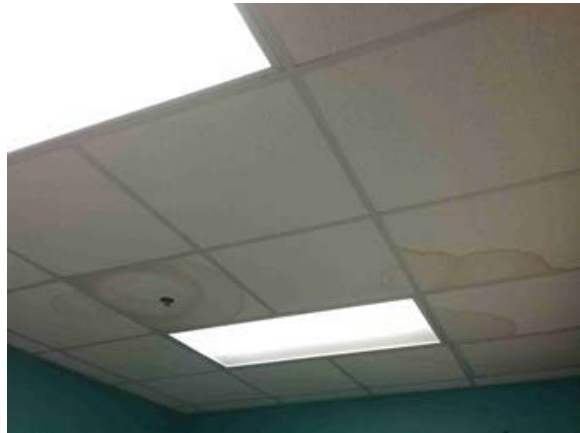
<b>Interior Specialties</b>	<p>The building has special interior construction such as stainless steel counters in the kitchen, partitions between the stalls in the restrooms, retractable metal bleachers with plastic benches and wood floor boards in the gym, built-in laminate desks in the computer room and check-in desk, and fire extinguisher cabinets.</p> <p>Deficiencies noted included paint that was chipping on the wood floor boards on the bleachers.</p>	4 - Good
<b>C20 Stairs</b>		
<b>Exterior Stairs</b>	System not present.	N/A
<b>Interior Stairs</b>	System not present.	N/A
<b>C30 Interior Finishes</b>		
<b>Interior Wall Finishes</b>	<p>The building has primarily painted wall finishes. The kitchen has 6-inch square ceramic tiles. There are acoustical panels installed over the CMU block walls in the gym. The restrooms and showers have 1-foot by 2-foot ceramic tiles. The hallway has decorative acoustical panels. The foyer has a column with a stone tile façade.</p> <p>Deficiencies noted included water stains on the wall in an activity room where facility staff reported that water runs down the wall during rain events.</p>	4 - Good

1. Determine the source of water intrusion into the building and correct the issue. Paint walls where markings from water intrusion are observed.
2. Replace acoustical ceiling tiles (ACT) where water stains are observed.

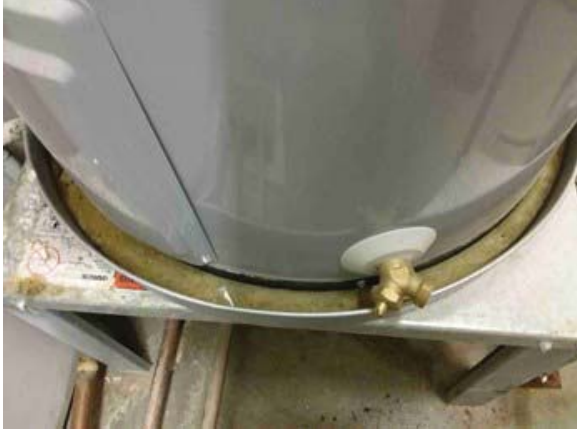
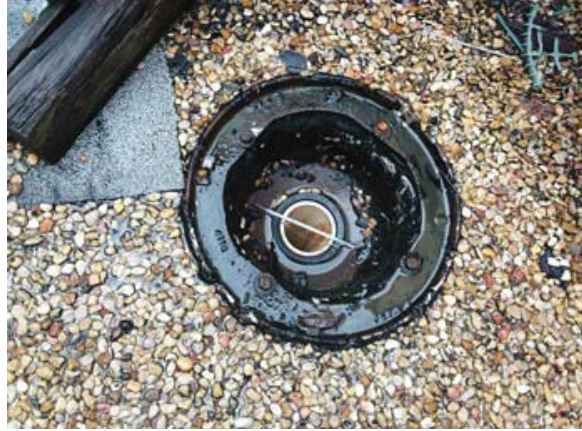
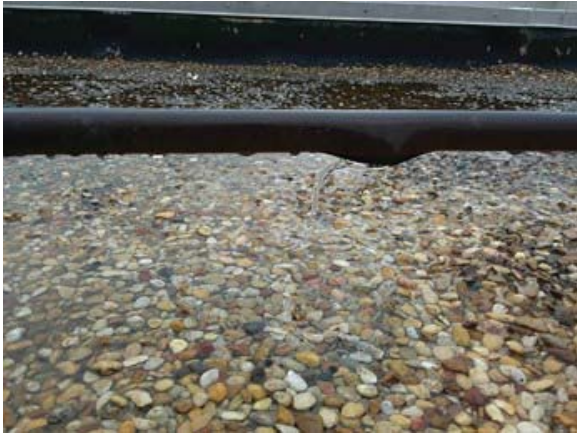
<b>Domestic Water Distribution</b>	<p>The plumbing system has a domestic water service feed from a 2-inch reduced pressure zone backflow preventer located in the fire riser room to two water heaters; both water heaters are 50-gallon State tank-type water heaters with 100-MBH gas heating input. WH 1 is located in the room Janitor 128, and WH 2 is located in the utility room Both water heaters were installed in 2014 and are equipped with expansion tanks.</p> <p>Deficiencies noted included water dripping through the roof from one of the water heater's dual vent roof penetrations.</p>	4 - Good
<b>Other Plumbing</b>	<p>Other plumbing assets include: roof drains, floor drains and floor sinks. Floor drains are located in restrooms, janitorial closet and kitchen. Floor sinks are located in the kitchen and utility room.</p> <p>Deficiencies noted included a missing roof drain dome, and a broken main branch condensate pipe that was leaking water directly onto the roof.</p>	4 - Good

1. Repair dual vent roof penetration.
2. Replace missing roof drain dome.
3. Replace broken condensate piping.

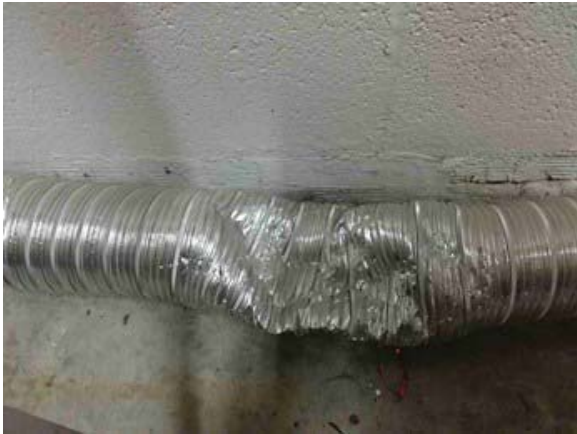
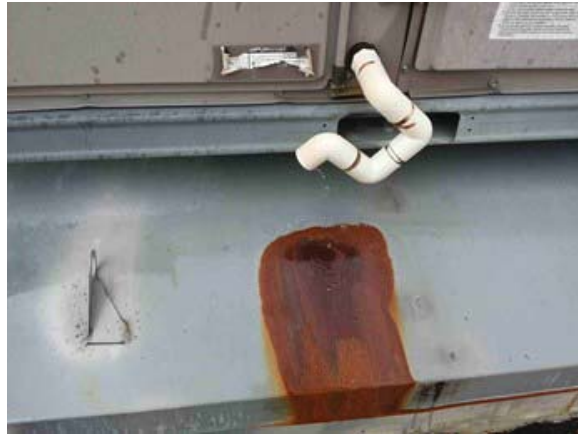
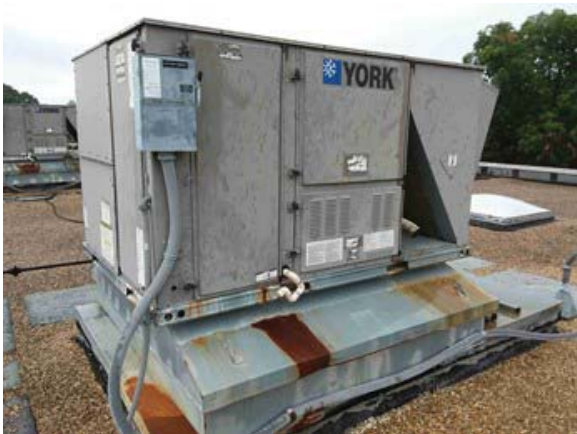
Subsystem	Condition and Deficiency Overview	System Condition Rating
	<p>heating capacities ranging from 60-MBH to 400-MBH. All package units are located on the roof. Six package units were manufactured in 2014 by Trane while the other three were manufactured in 2005 by York. The York units serve the basketball court while the Trane units serve all other areas. There is also an evaporative cooler located on the roof.</p> <p>Supplemental mechanical equipment for the HVAC system also includes three roof-mounted exhaust fans and four roof-mounted gravity ventilators. There is also a remote condenser for the ice maker located on the roof.</p> <p>Deficiencies noted included obstructed airflow due to a crushed exhaust duct on the dryer, condensate leaking from the York rooftop units and the use of R22 refrigerant in the York units; which is being phased out of manufacturing and construction use.</p>

1. Replace crushed dryer exhaust ductwork.
2. Install condensate piping for units PKGAC 2, PKGAC 3 and PKGAC 4 and discharge at a code compliant receptacle.
3. Plan to replace all equipment using R22 refrigerant in the upcoming year.

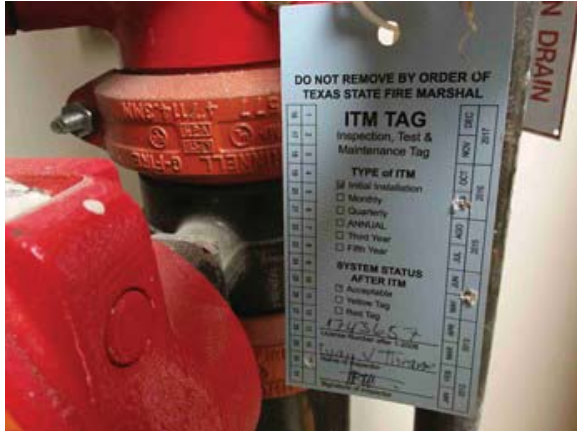
<b>D40 Fire Protection</b>		
<b>Fire Alarm</b>	<p>The building has a fire alarm system that consists of alarm and signaling devices such as annunciators, strobes, horn/strobe combinations, pull stations, and detectors.</p> <p>The fire alarm system control equipment includes an addressable single zone Silent Knight fire alarm control panel.</p> <p>No deficiencies were observed or reported at the time of the assessment.</p>	4 - Good
<b>Fire Protection/Suppression</b>	<p>The building has a wet pipe system for fire protection serving all of the building.</p> <p>The fire protection system service equipment includes a fire riser. The fire suppression system includes an automatic fire extinguishing system for the kitchen hood.</p> <p>The building also has supplemental, portable fire extinguishers for fire suppression with inspection tags dated within the last year as required.</p> <p>Deficiencies noted included outdated inspection on the fire riser, as it was last inspected in September of 2014 which exceeds the annual inspection requirement.</p>	3 - Average

1. Perform overdue yearly inspection of the fire riser and continue regular inspections of all fire protection equipment, as required. .

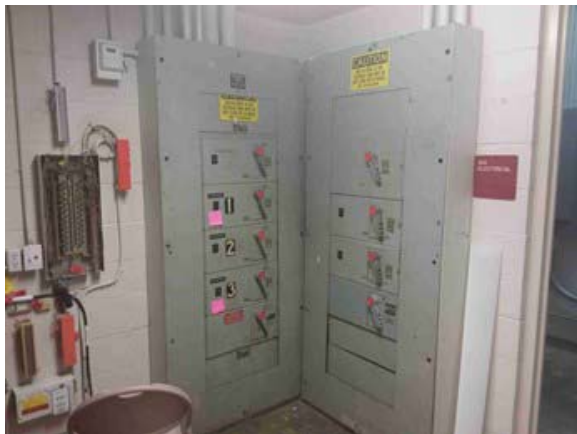
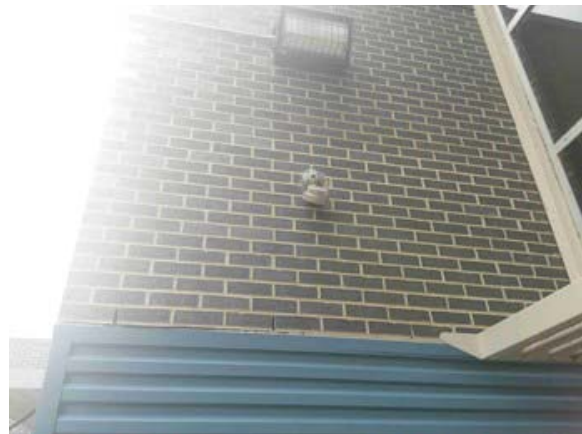
<b>D50 Electrical</b>		
<b>Electrical Distribution</b>	<p>The electrical service enters the building at the 1200-Amp 120/240-Volt B-phase high leg main switchgear which is located in the main electrical room and delivers power throughout the entire building.</p> <p>Deficiencies noted included that panelboard "A", panelboard "B", and switchgear "MP" are aged and out-of-date.</p>	4 - Good
<b>Lighting</b>	<p>The exterior lighting at the building consists of metal halide wall pack fixtures that are located along the entire perimeter.</p> <p>The interior lighting is made up of primarily T8 linear fluorescent fixtures with additional metal halide high bay fixtures observed.</p> <p>Additionally, exit signs are seen throughout the facility in appropriate locations. No emergency lighting was present.</p> <p>Deficiencies noted included a broken floodlight on the exterior.</p>	4 - Good

1. Replace all aged electrical distribution panelboards as they are past their typical design service life.
2. Repair or replace the broken exterior floodlight.
