Fireside Recreation Center Summary

Address	8601 Fireside Drive Dallas, TX 75217
Building Purpose	Recreation Center
Original Year of Construction	1971
Building Area	15,070 SF
Inspection Date	August 17, 2016
Inspection Conditions	77° F, Overcast

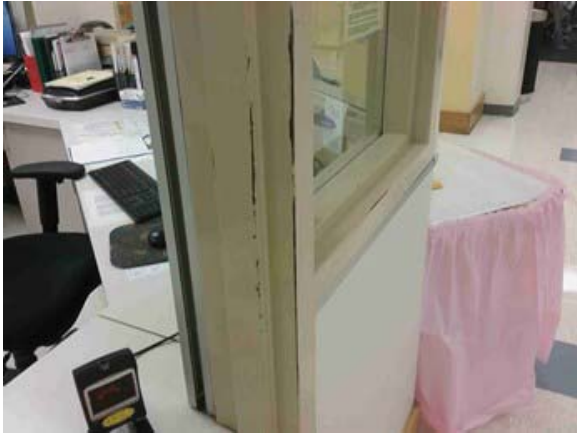
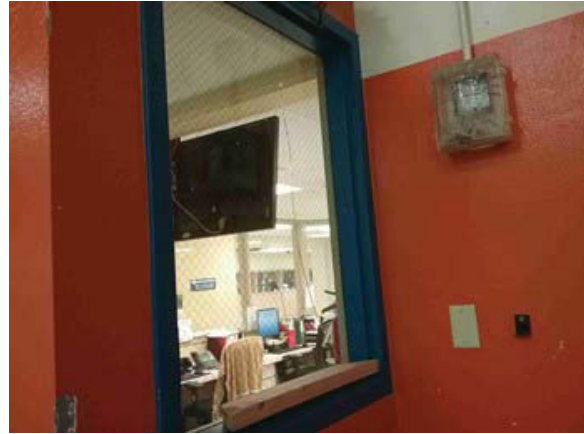
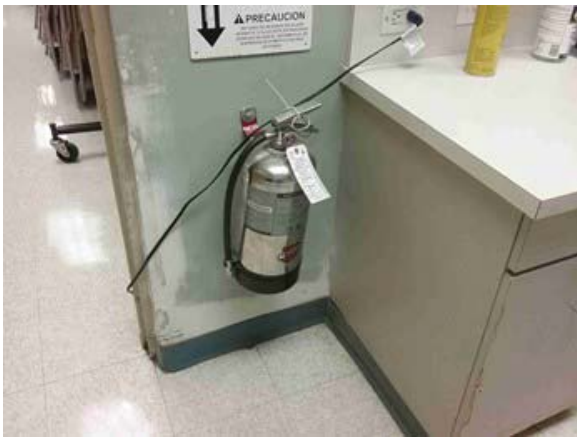
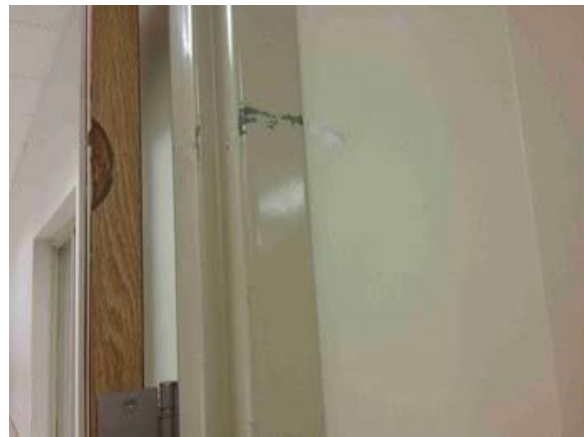
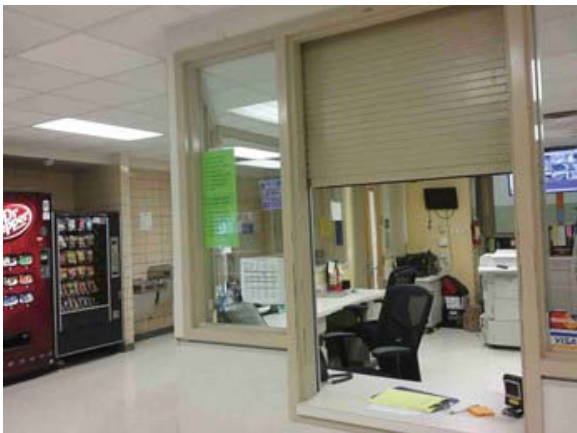
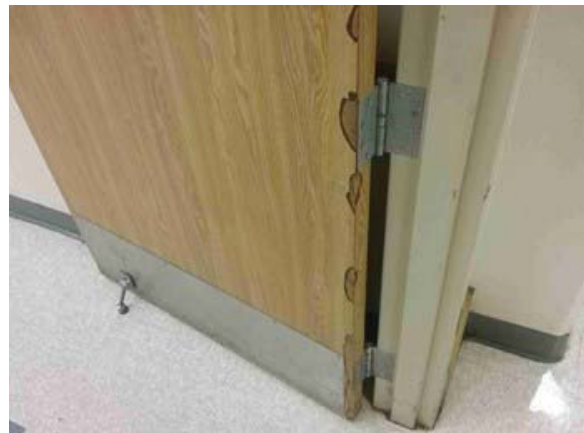
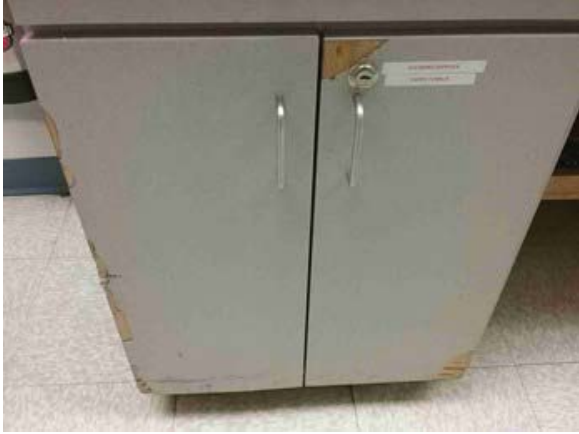
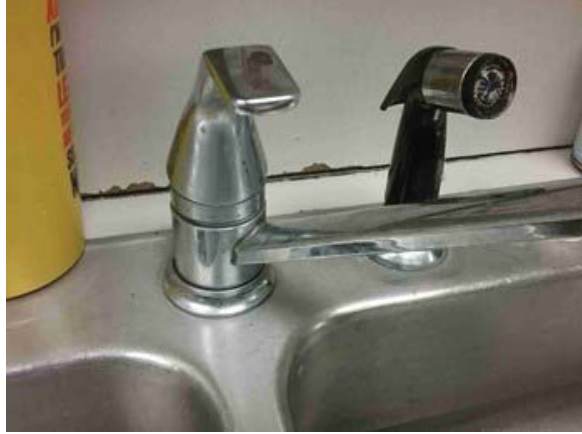
Interior Construction

Subsystem	Condition and Deficiency Overview	System Condition Rating
	Deficiencies noted included scuffed and chipped paint on the frame around the press box windows. Two of the windows at the press box had cracked glass. The metal corner of the gypsum board wall was exposed on a corner of the press box. A wall in the kitchen had damage to the gypsum board that was observed to be partially patched.	
Interior Doors	The majority of the interior doors are wood veneer with a metal frame. The doors to the multipurpose room have a window. The storage room and gym have metal doors with a metal frame and metal reinforced glass. There is a manual metal overhead door at the control room. Deficiencies noted included scuffs or paint chipping on the metal frames of most of the metal door frames. The paint on the metal doors was chipping. The metal overhead door was missing a cord to facilitate opening the window and was difficult to operate. The seal under the overhead door was worn and damaged. The wood veneer on the multipurpose room door was damaged along the hinged side of the door.	4 - Good

Interior Specialties	The building has special interior construction such as laminate counters and cabinets in the kitchen and control room, retractable metal bleachers with plastic benches in the gym, a counter in the fitness room, partitions between the stalls in the restrooms, lockers, and a trophy case. Deficiencies noted included damage to the laminate on the counters and cabinets in the kitchen. There was damage behind the sink in the kitchen.	4 - Good
C20 Stairs		
Exterior Stairs	System not present.	N/A
Interior Stairs	System not present.	N/A
C30 Interior Finishes		
Interior Wall Finishes	The building primarily consists of painted gypsum board walls. The walls in the hallway and fitness room contain ceramic tile finishes. The restrooms and the closet in the kitchen have 3-inch square ceramic tile wall finishes. The gym has 3-inch by 5-inch ceramic tiles from the floor to approximately 6-feet up. There are laminate panels with a metal trim installed in the main entry. Deficiencies noted included grout that was missing or damaged between the ceramic tiles in the fitness room. There were multiple tiles in the fitness room that were worn or damaged. There were large sections of paint chipping in the gym. There was minor damage to the paint finish in other rooms throughout the building.	4 - Good

1. Paint the press box window frames.
2. Replace the cracked glass in the press box windows.
3. Repair damaged gypsum board walls.
4. Paint worn or chipped metal doors and door frames.
5. Replace the metal overhead door at the control room.
6. Replace damaged wood veneer doors.
7. Replace cabinet doors where damage to the laminate is observed.
8. Replace the backsplash and counter in the kitchen.

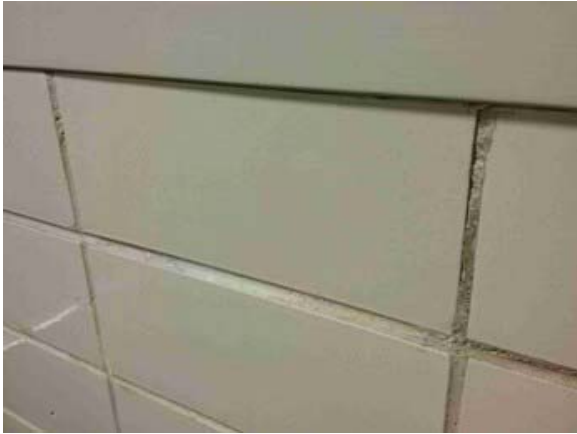
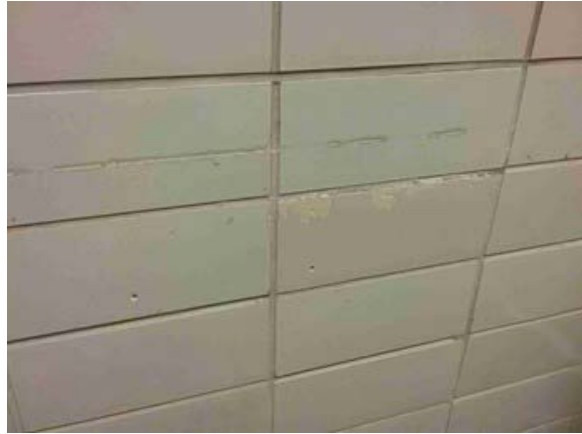
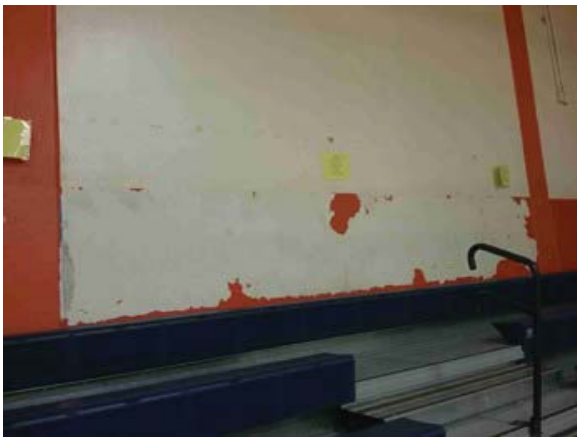
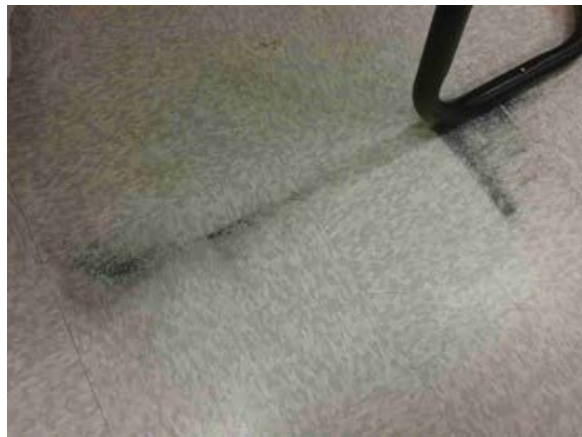
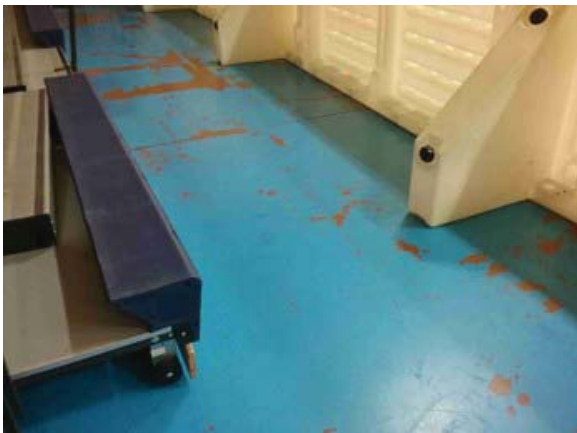
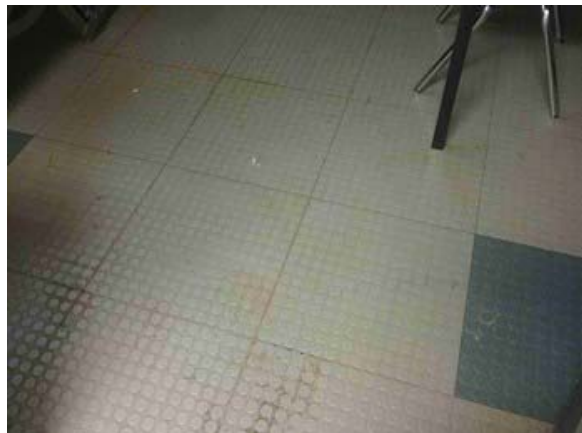
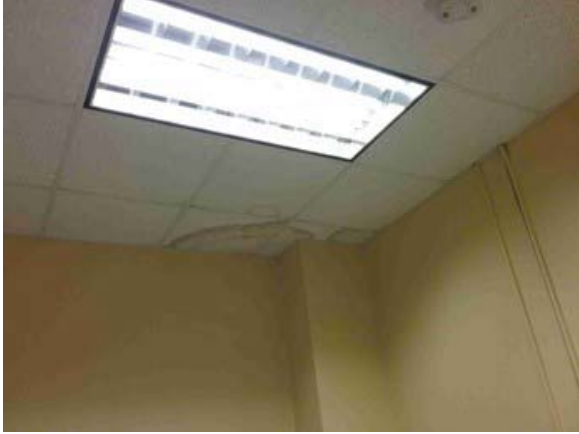
Interior Finishes

Subsystem	Condition and Deficiency Overview	System Condition Rating
	<p>Deficiencies noted included wear and marks on the VCT in the classroom. The paint on the electrical room and gym floors was chipping and worn. The rubber tiles in the storage room appeared worn.</p>	
Interior Ceiling Finishes	<p>The building primarily contains suspended acoustical ceiling tiles (ACT). The gym has acoustical tiles and the ceiling is exposed to the structure above. The restrooms and storage closets have painted gypsum board ceilings.</p> <p>Deficiencies noted included water stains observed on ACT throughout the building. The gypsum board in the women's restroom was damaged. Facility staff reported the damage was caused by water intrusion during a rain event. Acoustical tile in the gym was stained. Facility staff reported that the water stain in the manager's office appeared the week of the assessment.</p>	4 - Good

1. Replace damaged and missing grout between ceramic tiles.
2. Replace worn or damaged ceramic tiles in the fitness room.
3. Paint chipping wall finishes.
4. Replace damaged vinyl-composition tiles (VCT).
5. Paint the electrical room and gym concrete floors.
6. Replace the rubber tiles in the storage room.
7. Determine the source of water infiltration and correct the issue. Replace damaged ceiling tiles, gypsum board, and acoustical tiles that are observed to have damage caused by water intrusion.

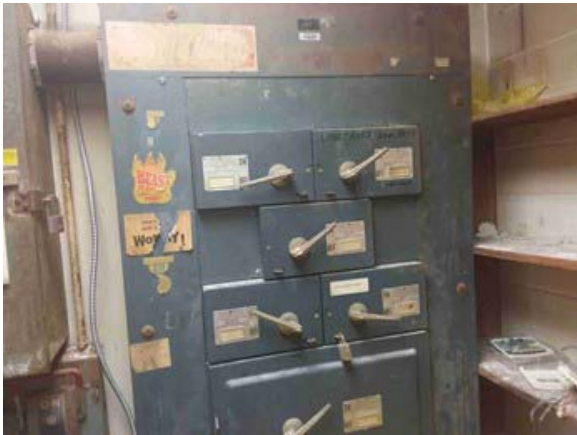
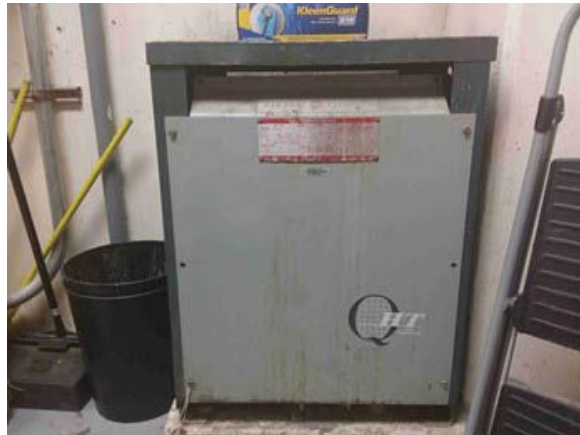
Fire Protection/ Suppression	<p>The fire suppression system consists of an automatic fire extinguishing system for the kitchen hood. This fire suppression system has inspection tags dated within the last year as required. There is no wet pipe system serving the remaining spaces of the building.</p> <p>The building also has supplemental, portable fire extinguishers for fire suppression which have inspection tags dated within the last year, as required.</p> <p>Deficiencies noted included one missing portable fire extinguisher.</p>	N/A
D50 Electrical		
Electrical Distribution	<p>The electrical service enters the building at the 400-amp 277/408-volt main switchboard which is located in the main electrical room and delivers power throughout the building. There is one 480-volt primary switchboard that steps-down to one 120/208-volt secondary transformers which feeds power to a two-section 120/208-volt panelboards. These transformers and distribution panelboards are primarily located in the storage room.</p> <p>Additionally, the building has an emergency uninterruptible power supply (UPS) that provides back-up power to a small IT rack.</p> <p>Deficiencies noted included the switchgear M and transformer 2661 were aged and out-of-date</p>	3 - Average

1. Replace the aged electrical distribution panelboard as it appears its typical design service life.
2. Replace the aged transformer as it appears past its typical design service life.
