2015 ROOF INSPECTION REPORT

Project Name: State Fair of Texas
Automobile Building
Dallas, TX 75210

July 11, 2015

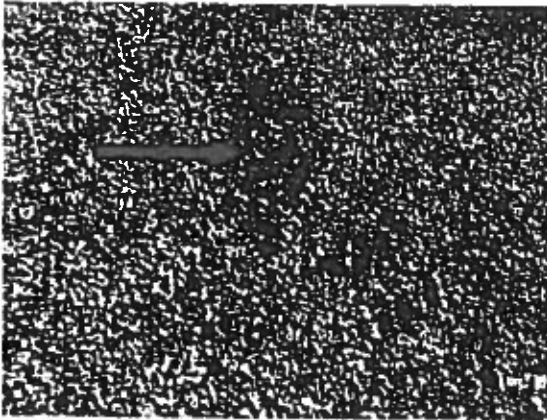
BLISTERS IN THE ROOF MEMBRANE

- Typical view of a blister at a seam in the roof membrane. This condition exists at four (4) locations on the roofs of this building.

- Spud the gravel roof surfacing at areas where work is to be performed.
- Cut out the blistered roof membrane at one (1) location. Clean, prime and apply new modified bitumen roof membrane over the area. Total of approximately nine (9) square feet.

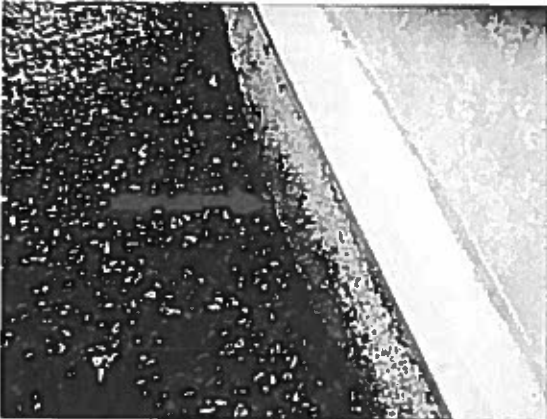
BLISTERED BASE FLASHING MEMBRANE

- Typical view of blistered base flashing membrane. This condition exists at four (4) locations on the roofs of this building.

- Cut out the blistered base flashing membrane at four (4) locations. Clean, prime and apply new modified bitumen flashing membrane over the areas. Total of approximately twenty (20) lineal feet.

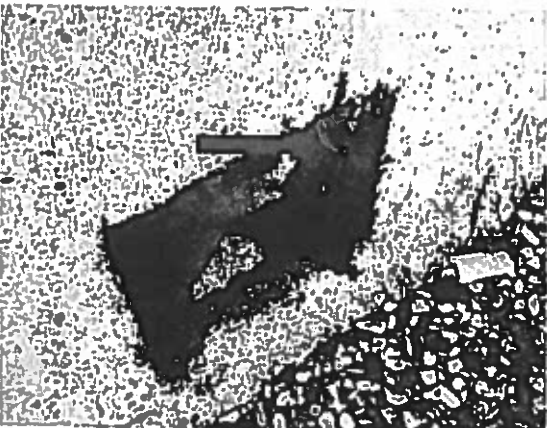
DELAMINATED SCUPPER FLASHING MEMBRANE

- View of delaminated and open flashing at a scupper. This condition exists at one (1) location on the roofs of this building.

- Clean, prime and apply three course flashing materials and aluminum coating over one (1) delaminated and open scupper flashing.
- Clean, prime and apply three course flashing materials and aluminum coating over two (2) delaminated and open laps in the base flashing membrane.

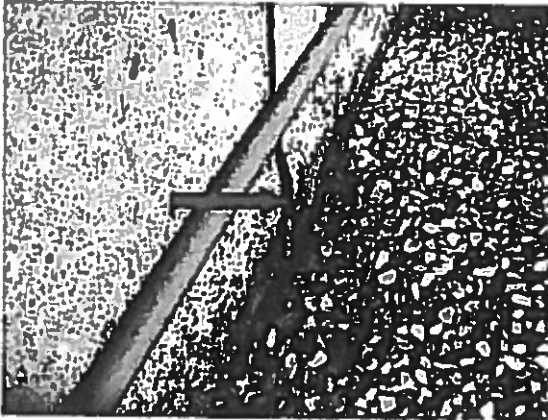
DELAMINATED LAP IN THE BASE FLASHING MEMBRANE

- Typical view of a delaminated and open lap in the base flashings. This condition exists at two (2) locations on the roofs of this building.

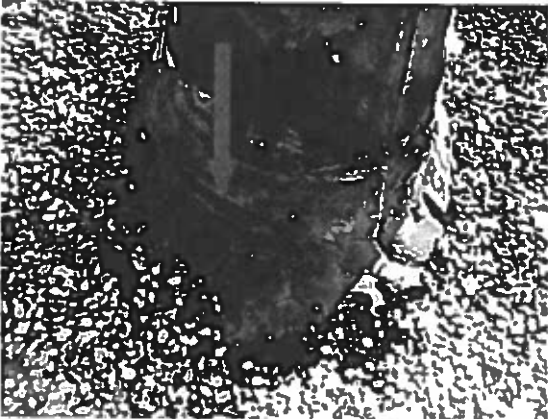
DELAMINATED STACK FLASHING

- Typical view of delaminated and open flashing on a stack penetration. This condition exists at three (3) locations on the roofs of this building.

- Remove the deteriorated and flashing from three (3) stack penetrations. Clean, prime and reflash the stack penetrations.
- Remove any loose/delaminated existing stripping ply membrane from the expansion joint. Clean, prime and overlay the expansion joint with new modified bitumen membrane.

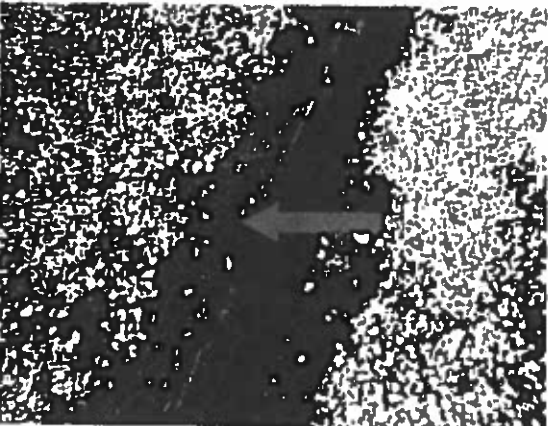
DELAMINATED STRIPPING PLY MEMBRANE

- View of delaminated and open stripping ply membrane on the expansion joint. This condition exists at one (1) location on the roofs of this building.

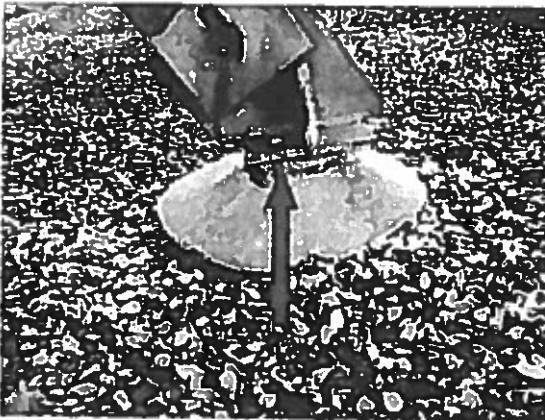
RAIN COLLAR SEALANT

- Typical view of deteriorated and open sealant on a rain collar. This condition exists at fourteen (14) locations on the roofs of this building.

- Remove the deteriorated and open sealant from fourteen (14) rain collars. Remove the rain collars from the supports. Clean, prime and apply three course liquid flashing materials to the prepared areas.

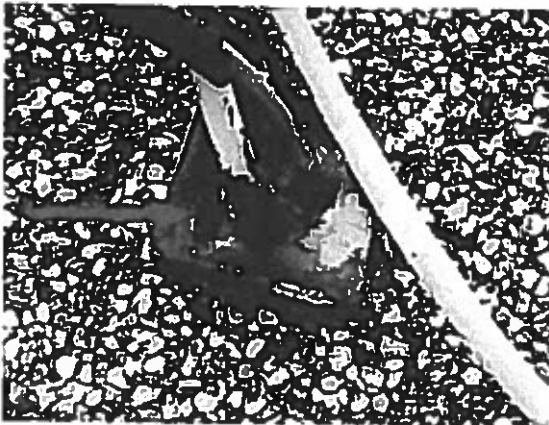
PITCH POCKET FILL

- View of separated and open sealant in a pitch pocket. This condition exists at one (1) location on the roofs of this building.

- Refill one (1) pitch pocket.
- Remove the deteriorated and open sealant from around six (6) wall louvers. Clean, prime and apply new sealant to the prepared areas.

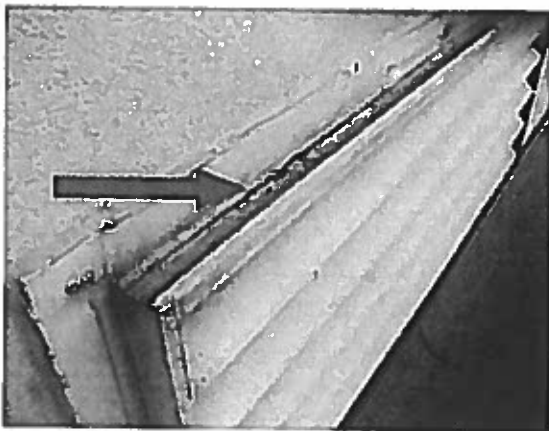
WALL LOUVERS

- Typical view of deteriorated and open sealant on a wall louver. This condition exists at six (6) locations on the roofs of this building.

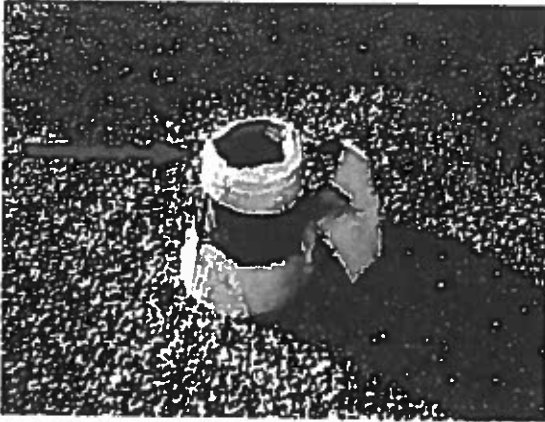
STACK CAP

- View of a loose/unattached cap on a stack penetration. This condition exists at one (1) location on the roofs of this building.

- Furnish and install one (1) stack cap.
- Remove and dispose of the debris from the roof surface and from the roof drain strainers.

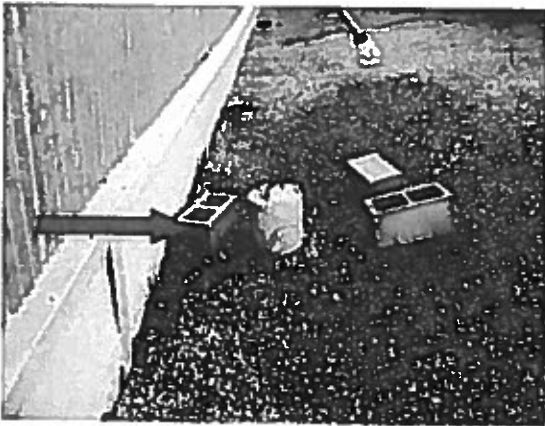
DEBRIS

- Typical view of debris left lying on the roof surface. This condition exists at various locations across the roof surface.

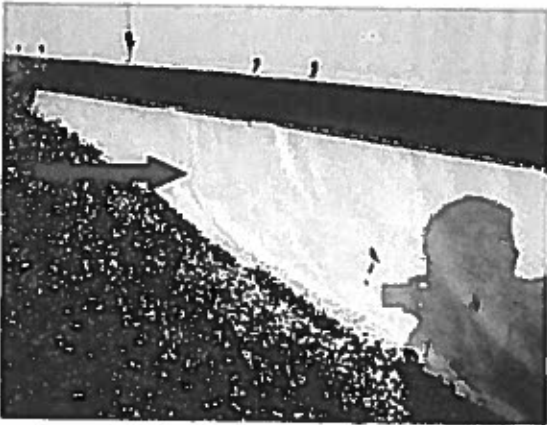
RACKED AND WRINKLED BASE FLASHING

- Typical view of racked and wrinkled base flashing membrane. This condition exists at seven (7) locations on the roofs of this building.

- Remove the racked and wrinkled base flashing membrane from seven (7) locations. Clean, prime and apply new modified bitumen flashing membrane to the prepared areas. Total of approximately 175 lineal feet.
- Apply urethane sealant over one (1) crack in the stucco wall covering above roof level.
- Reattach one (1) loose access panel on the roof top equipment. We recommend that the appropriate contractor be contacted to address this condition.
- Once the two (2) existing roof top units are raised by others, install proper supports for the units. We recommend that the appropriate contractor be contacted to address this condition.
- Trim back the overhanging tree from the roof surface. We recommend that the appropriate contractor be contacted to address this condition.

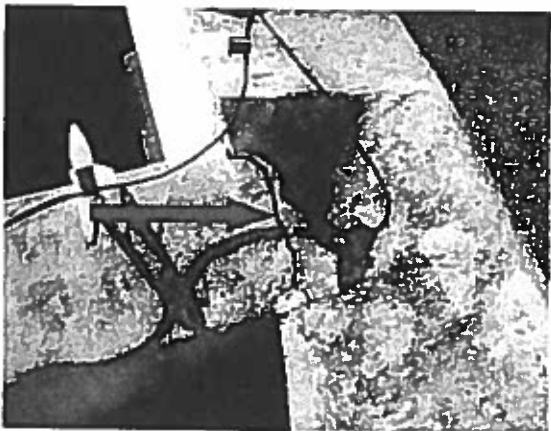
STUCCO WALL COVERING

- View of a crack in the stucco wall covering. This condition exists at one (1) location on the roofs of this building.

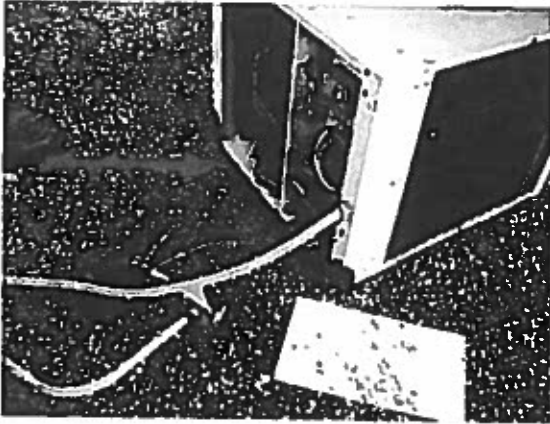
ROOF TOP EQUIPMENT PANELS

- Typical view of a loose/unattached access panel on the roof top equipment. This condition exists at one (1) location. We recommend that the appropriate contractor be contacted to address this condition.

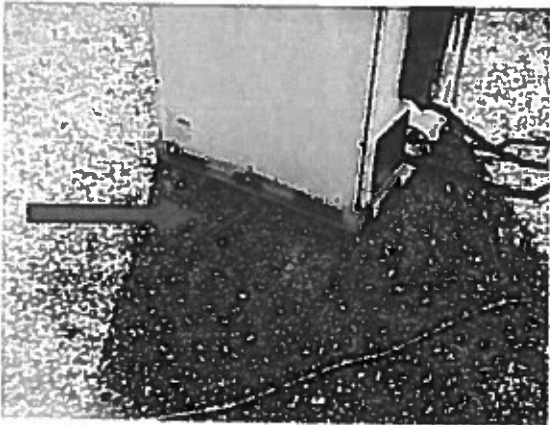
IMPROPER EQUIPMENT SUPPORT

- Typical view of improper supports under the roof top equipment. This condition exists at two (2) locations on the roofs of this building. We recommend that the appropriate contractor be contacted to address this condition.

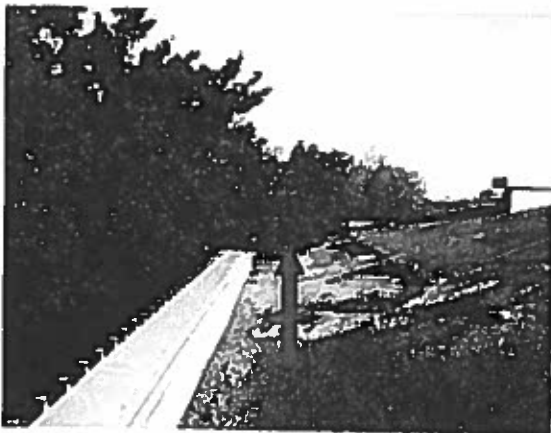
TREE OVERHANG

- View of a tree overhanging the roof surface. This condition exists at one (1) location. We recommend that the appropriate contractor be contacted to address this condition.
